***Enterococci* levels in the Hans Groot Kill and Mohawk River, Schenectady, NY**

Geology Department, Union College, Schenectady, NY

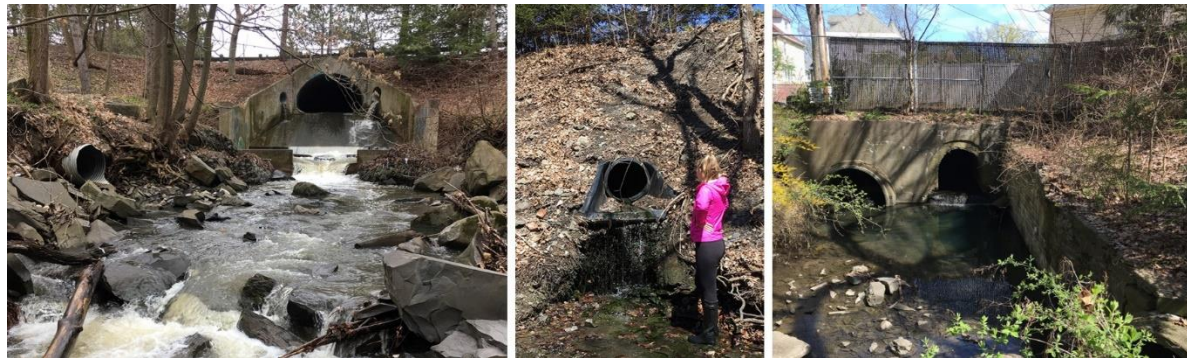
Figure 2: Examples of pipes that empty into the channel of the Hans Groot Kill. Left: Site HGK-2, with a tunnel and pipe outfalls at center and a pipe outfall at left. Center: Site HGK-5 Pipe, which commonly has the highest *Enterococci* levels. Right: Site HGK-7, the upstream end of the exposed HGK, where the Sheridan Avenue (left), The Plaza (center), and Rugby Avenue (lower right) storm sewer outfalls provide source water for the stream.

The HGK is a relatively small stream with bank-full width of ~4-6 m and typical low-flow width <2 m; its depth, though variable along the channel, rarely exceeds 0.5 m and is more typically <0.2 m. The bedrock exposed in the stream channel is interbedded sandstone and shale of the Schenectady Formation. The upper regions of the exposed stream are incised, while the lower regions on campus are bordered by floodplain. Multiple pipes enter the channel walls along the incised sections of the stream (Figure 2).

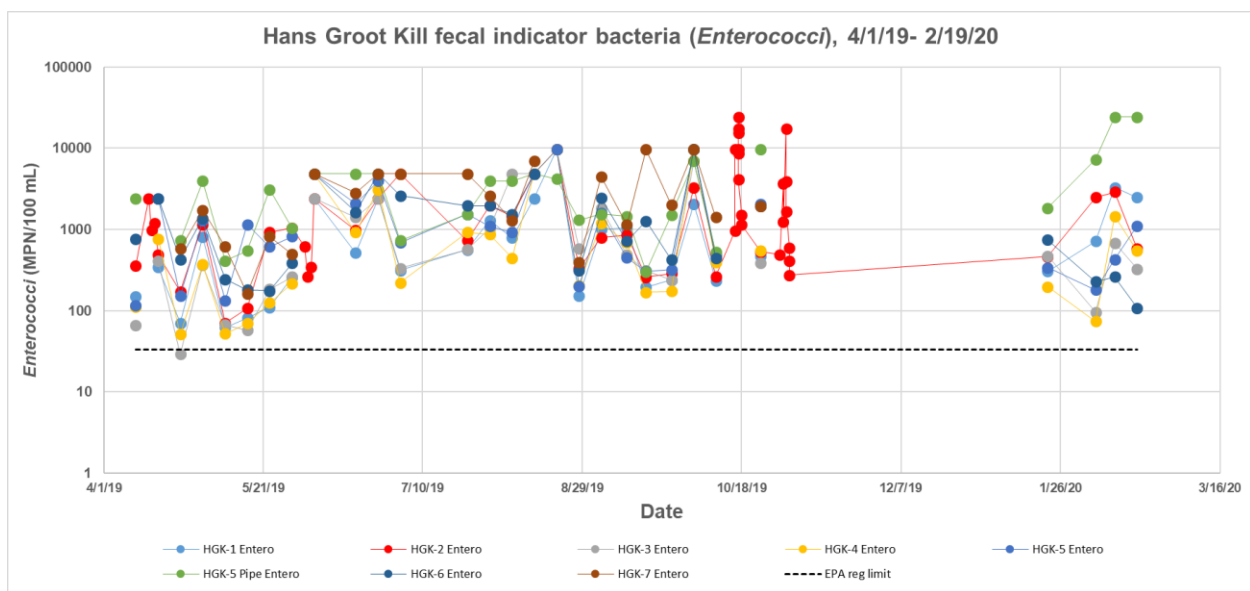
Figure 3: Individual *Enterococci* data for HGK samples, 4/1/19 through 2/19/20. All but one single sample exceeds the EPA advisory limit for recreational waters 33 MPN/100 mL; black dashed line). Some of the plotted values were saturated so their values represent minima.

Enterococci values were well above the EPA guidelines for recreational waters in all but one of the 248 HGK samples taken over a 10-month period (Figure 3). Although *Enterococci* values at some sites are typically higher than at others (HGK-5 Pipe, for example), there is a general decrease in water quality in the upper reaches of the creek. The overall upstream trend is apparent in the geometric means (Figure 4).

The highest single value (>24,196 MPN/100 mL) came from HGK-5 Pipe on 2/19/20 (Figure 3). The highest geometric mean was also from HGK-5 Pipe (2,250 MPN/100mL; Figure 4). Sample site HGK-5, located approximately 5 meters downstream from HGK-5 Pipe, has a geometric mean of 884 MPN/100 mL, however. The second highest geometric mean was at HGK-2 with a value of 866 MPN/100 mL.

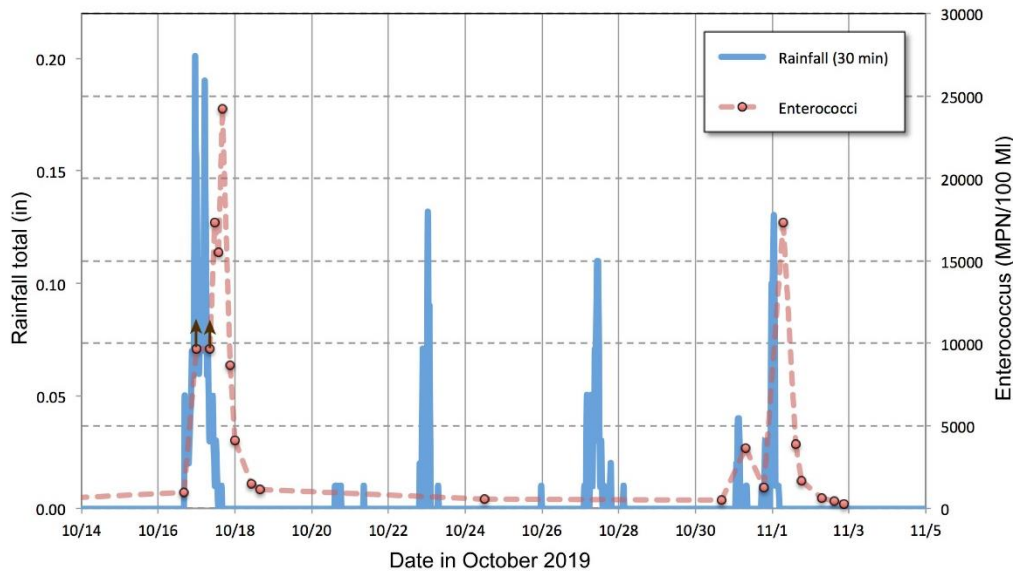
Figure 5: *Enterococci* sampling at HGK-2 during two rainfall events in October 2019. Samples with arrows are minimum values (sample saturated). Weather data from Union College Geology station. There is an apparent ~6 hr lag in rainfall versus *Enterococci* peak.

The evidence for significant *Enterococci* contamination in the Hans Groot Kill is incontrovertible and suggests that raw sewage is entering the stream. Bacteria levels dramatically higher during rain events, indicating stormwater as a vehicle for transporting entrained sewage (Figure 5). In this drainage there are no CSOs, so overflow is not a cause of impairment. The sources of sewage in the HGK likely include both leaking sanitary sewer and stormwater pipes in close proximity to each other, or sanitary sewer pipes that were illegally connected to stormwater sewers, or both (pers. comm, January 2020, James R. Hart, Assistant Civil Engineer, City of Schenectady, NY). The high concentration of microplastic particles in the HGK documented during a 2018 rain event supports the hypothesis that sewage (a source of fibers) and stormwater both contribute to the pollution loads in the stream (Smith et al., 2020, this volume).

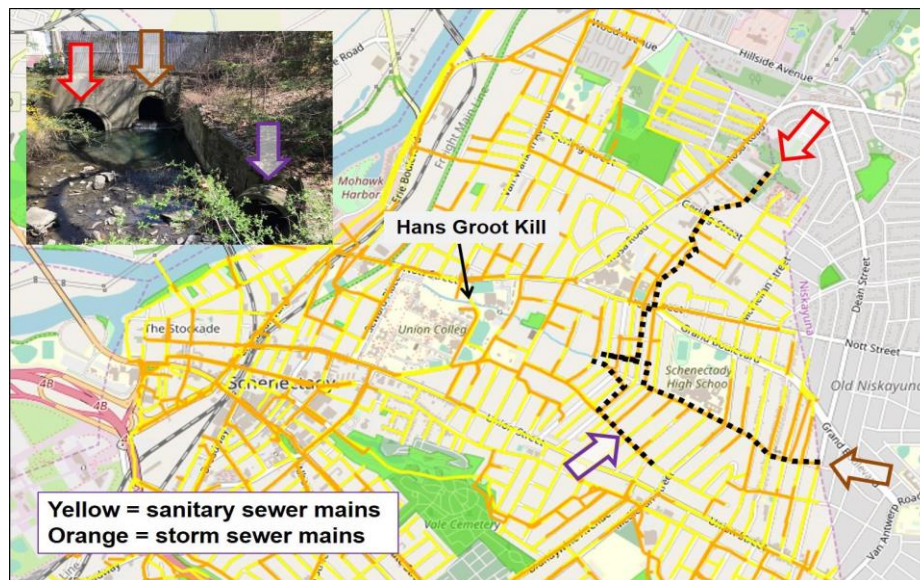
Figure 5: Base map provided by Schenectady County, using SIM GIS, shows storm and sanitary sewer mains. Dashed black lines indicate the three major storm sewer mains that provide the source water for the Hans Groot Kill. Inset photo shows the outfalls for the three storm sewer mains (red arrow = Sheridan Avenue, brown arrow = The Plaza, purple arrow = Rugby Avenue).

The HGK was once a natural stream with a topographically-determined watershed (Schoendorf, 2010). Residential development in the early 1900s led to the enclosure of the original HGK in the Sheridan Avenue stormwater main and the addition of the stormwater mains running beneath The Plaza and Rugby Avenue as sources of stream flow (Figure 6). Schenectady County maps of the stormwater system adjacent to the HGK suggests that some stormwater pipes outfall directly into the HGK, which is consistent with our observation of pipes in the channel wall (Figure 2). HGK-5 Pipe may be one such outfall; the high levels of *Enterococci* from this pipe suggest that it is also a sanitary sewer outfall.
