Performance Evaluation of iPVC™ Fitting with Turner Lock Gasket

Submitted to:

PPI Pipe
1085-11, Boedeul-ro, Jangan-myeon
Hwaseong-city
Gyeonggi-do, Korea

Cornell University
School of Civil and Environmental Engineering
Cornell University
Hollister Hall
Ithaca, NY 14853
August, 2022

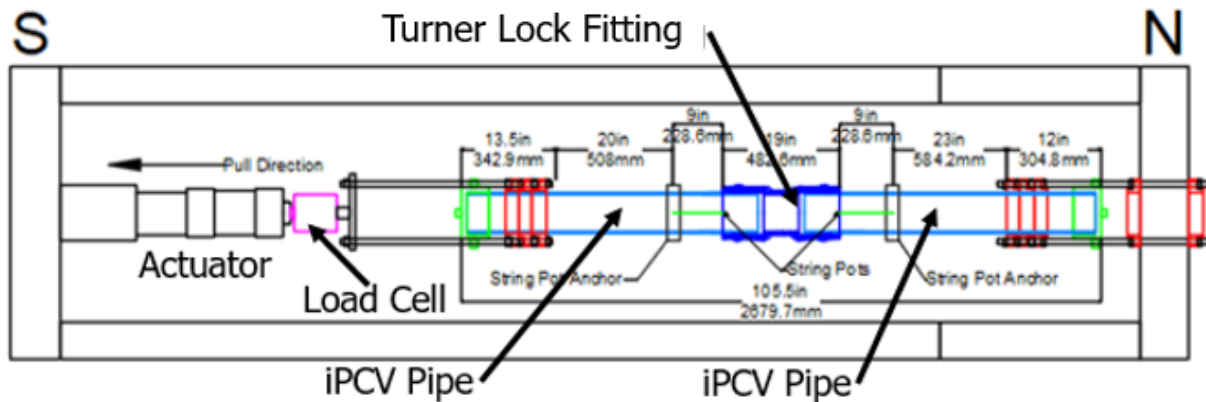
Figure 3.1. Plan View of Axial Tension Test

Figure 3.1 shows a plan view of the setup and equipment for the first axial tension test. A 55-kip (245-kN) MTS actuator with 6 in. (150 mm) of stroke, load cell, and load frame were used to apply tensile load to the test specimen. An iPVC™ fitting, as described in Section 2, was connected to two nominal 6 in. (150 mm) diameter DR 18, AWWA C 900 iPVC pipes provided by PPI. The test specimen was fitted at either end with end caps to allow for internal pressurization during loading. The orientation of the test specimen is shown with respect to north (N) and south (S).

The test setup and equipment for the second axial tension test were very similar to those shown in Figures 3.1 and 3.2. The description previously provided for the first tension test applies also for the second tension test, and the reader is referred to Section 3.1 for a detailed description of the test procedures and setup. Table 3.2 lists the instrumentation for the second tension test according to name, description, and location. The instrumentation differed for the second tension test in that only one station of strain gages was used. That location was approximately 24 in. (610 mm) north of the center of the iPVC™ fitting. The strain gage station was equipped with 8 strain gages, located at the 12, 3, 6, and 9 o'clock positions (crown, east springline, invert, and west springline,

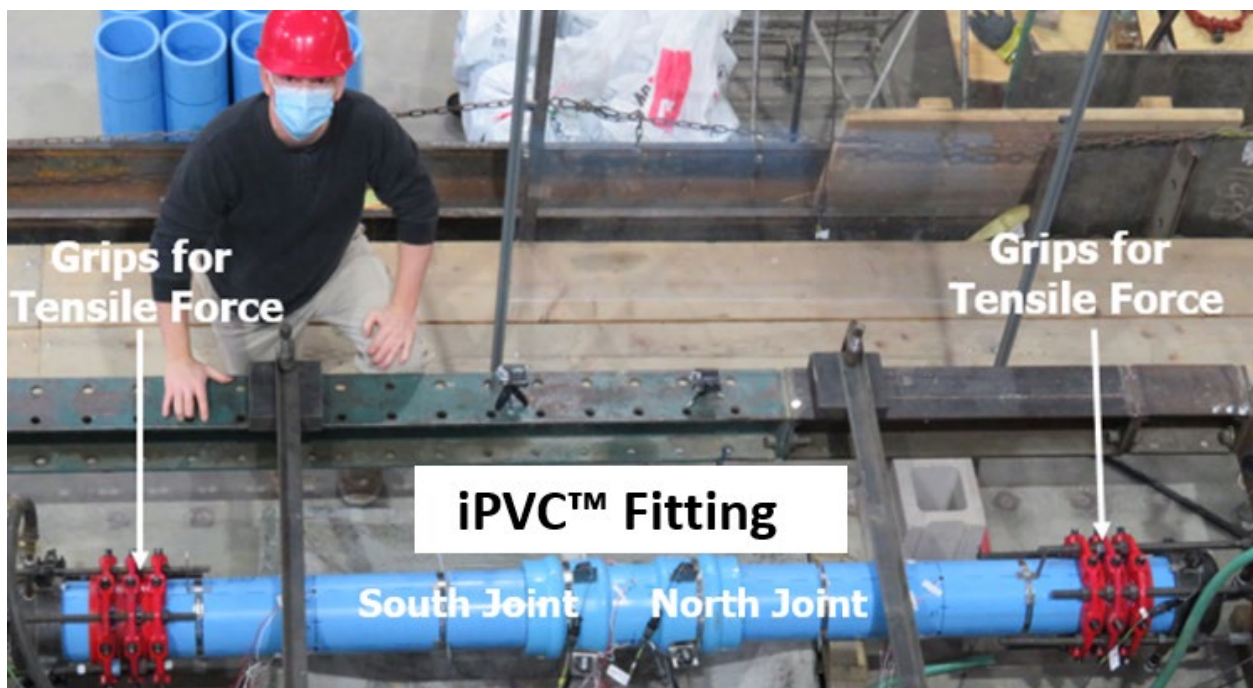
Figure 3.2. Test Specimen in the Direct Tension Frame

A photo of the test setup is shown in Figure 3.2. The figure shows the iPVC™ fitting and gripping collars near both the north and south ends of the test specimen. A series of three Stargrip® Gen2 restraining collars were used at either end of the specimen to transfer load from the actuator and loading frame to the specimen. The three restraining collars acted as a grip for the pipes during axial load application. Four 0.75 in. (19 mm) threaded rods, spanning the restraining collars, carried the tensile force. The test specimen is oriented in the figure so that north is to the right. Both north and south joints of the iPVC™ fitting are shown in the figure.

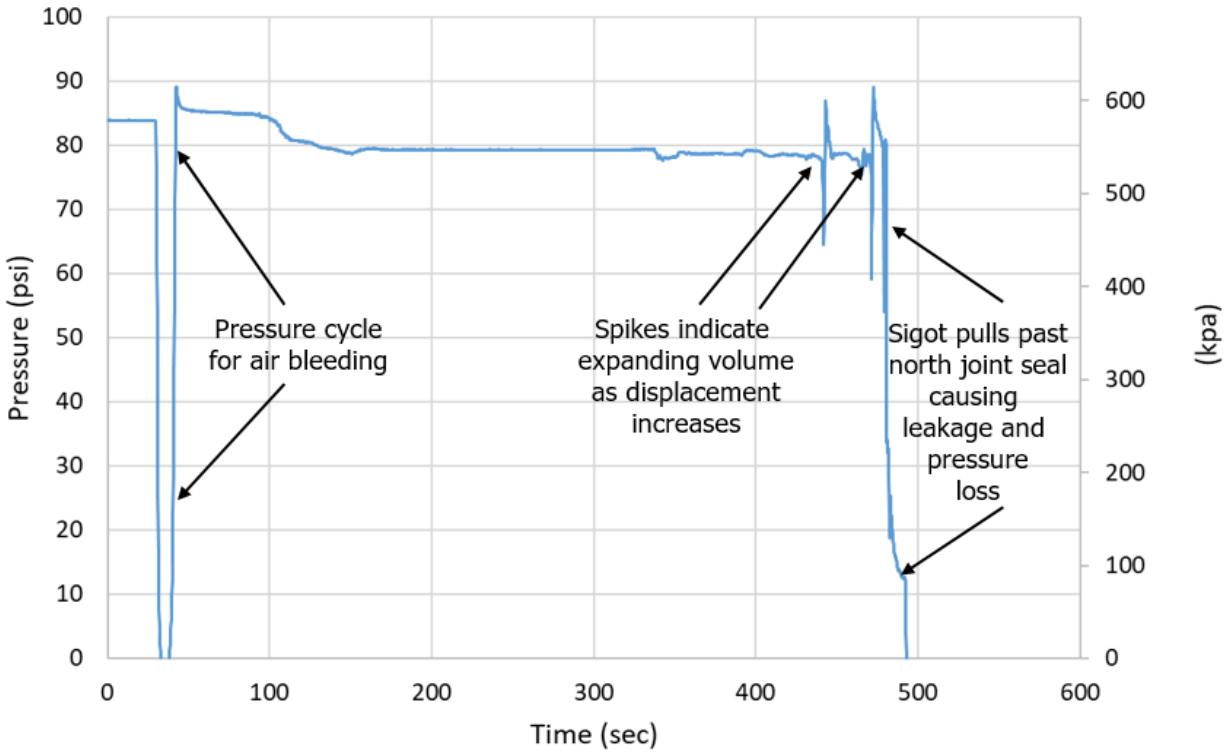
Figure 3.3 Internal Pressure vs. Time for First Tension Test

Approximately 80 psi (550 kPa) of internal water pressure was applied during the first tension test. Figure 3.3 presents the pressure plotted relative to time. Initially the pressure spiked to nearly 90 psi (620 kPa), then air was bled from the test specimen. Most of the time the pressure remained steady at approximately 80 psi (550 kPa). During the application of tensile load the iPVC™ fitting and adjoining pipes were expanding axially and thus reducing the pressure. In response, the pressure was increased automatically through the introduction of additional water, providing an average pressure of about 78 psi (536 kPa). At the end of the test, the spigot pulled past the north joint seal, causing leakage and pressure loss. In the plot, various labels and arrows point toward a part of the pressure vs. time plot.

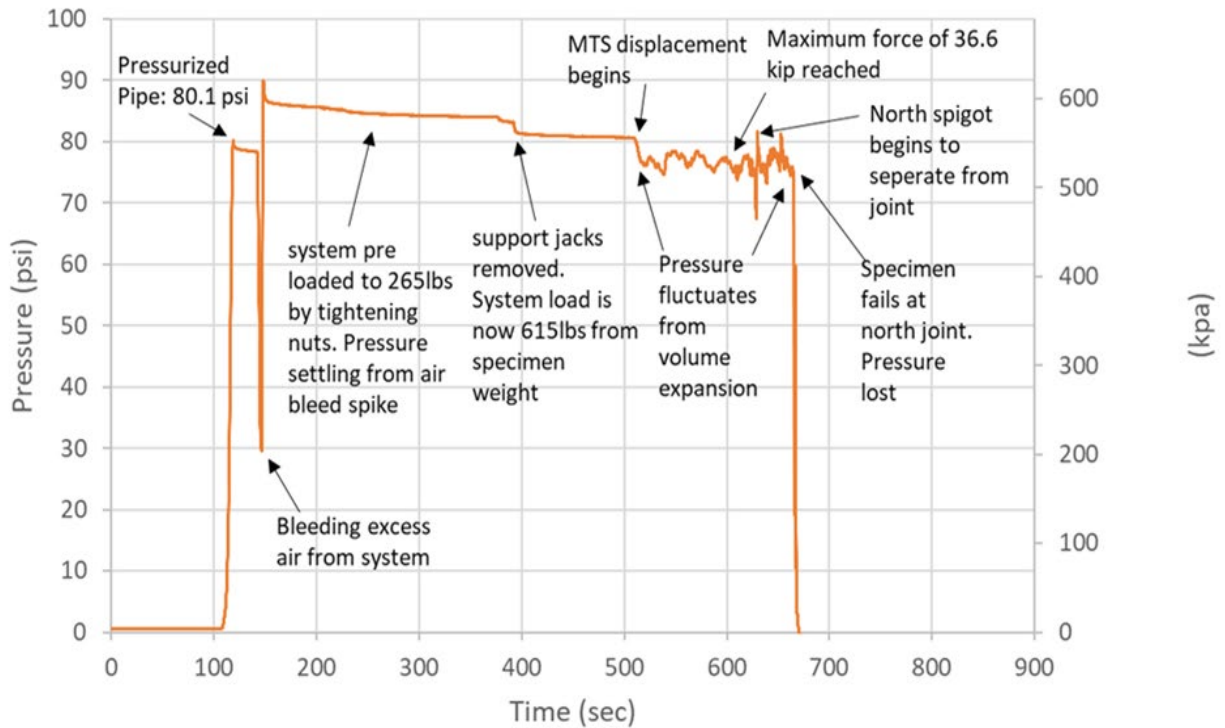
Figure 3.7 Internal Pressure vs. Time for Second Tension Test

Figure 3.7 presents the pressure plotted relative to time. Initially the pressure spiked to nearly 90 psi (620 kPa), then air was bled from the test specimen. In the plot, various labels and arrows are used to show when various aspects of the test occurred. After the test was started, when the MTS displacements began, the pressure fluctuated from approximately 75 psi (516 kPa) to 80 psi (550 kPa). During the application of tensile displacements, the iPVC™ fitting and adjoining pipes

expanded axially and thus reduced the pressure. In response, the pressure was increased automatically by the flow meter through the introduction of additional water, providing an average pressure of about 77 psi (530 kPa). At the end of the test, the spigot pulled past the north joint seal, causing leakage and rapid loss of pressure.

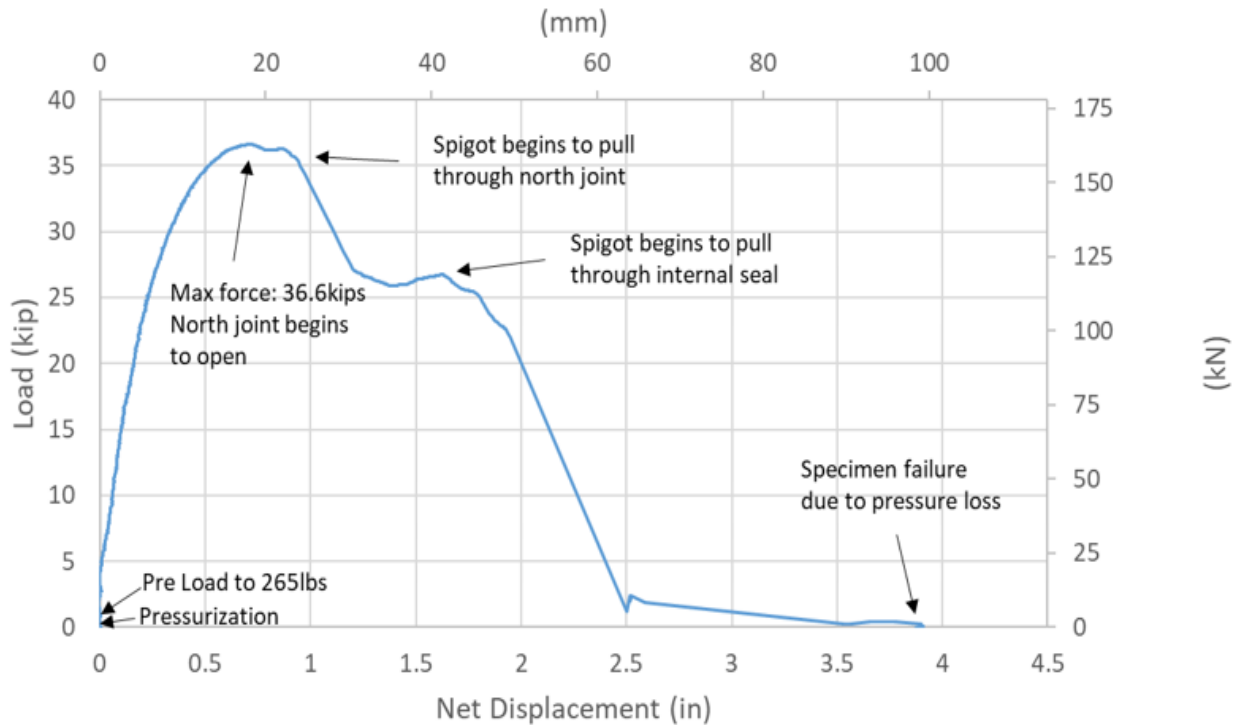
Figure 3.8 Axial Load vs. North Joint Net Displacement for Second Tension Test

Like Figure 3.4, Figure 3.8 presents a plot of the load vs. net displacement of the iPVC™ fitting north joint, for which net displacement is the same as that for the first tension test. It is the displacement corrected for the elastic elongation of the pipe between the locations of the string pot anchors and the gripping teeth of the iPVC™ fitting. The elastic displacement correction to obtain the net displacement is very small, and similar in magnitude to that of the first tension test. The net displacement is the actual movement of the north joint without any elastic extension of the pipe and iPVC™ fitting. Virtually all the net movement was concentrated at the north joint.

Labels for various events are presented in Figure 3.8 A maximum load of 36.6 kips (162.9 kN) occurred at approximately 0.7 in. (18.0 mm). Unlike the first tension test, no crack formed along

the knit line of the iPVC™ fitting. A close examination of the data and video of the iPVC™ fitting during testing shows that movement occurred rapidly from about 2.5 in. (64 mm) to approximately 3.8 in. (97 mm). The north spigot pulled past the gasket in the north coupling of the iPVC™ fitting, when substantial and uncontrollable leakage occurred. This displacement is consistent with dimensions presented in Figure 2.1 that show a distance of about 3.64 in. (92.5 mm) between the end of the spigot and the middle of the gasket. North joint net displacement of approximately 3.8 in. (97 mm) was actually measured when high leakage started. This movement was large enough to carry the end of the spigot past most of the gasket in the north joint.

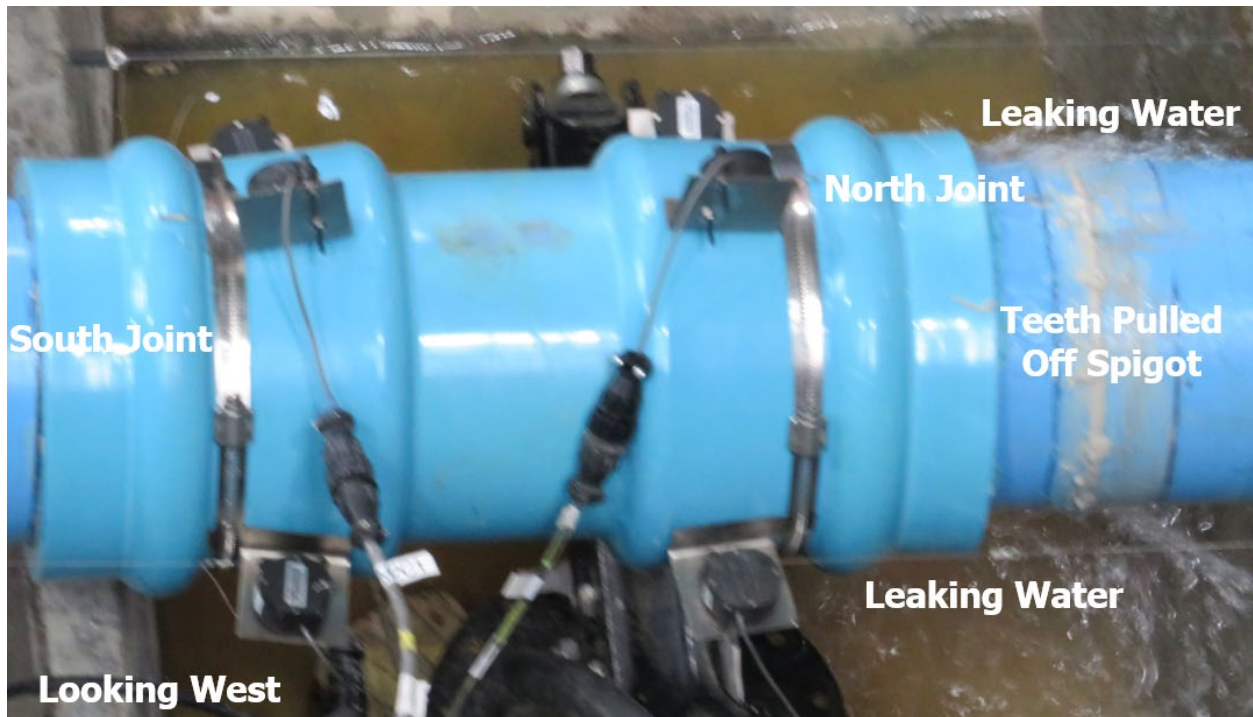
Figure 3.9 Photo of Leaking iPVC™ Fitting for Second Tension Test

Figure 3.9 shows the leaking and failed iPVC™ fitting, looking west. All teeth pulled off the barrel of the spigot leaving a white residue. At failure, the teeth were located inside the bell of the north joint. There was a small crack at the knit line of the north joint of the iPVC™ fitting, but it did not penetrate through the joint wall like that of the first tension test. Accordingly, higher normal force and resistance to pullout were generated during the second tension test. The gasket maintained its pressure seal until the end of the spigot was displaced to the outside end of the gasket.

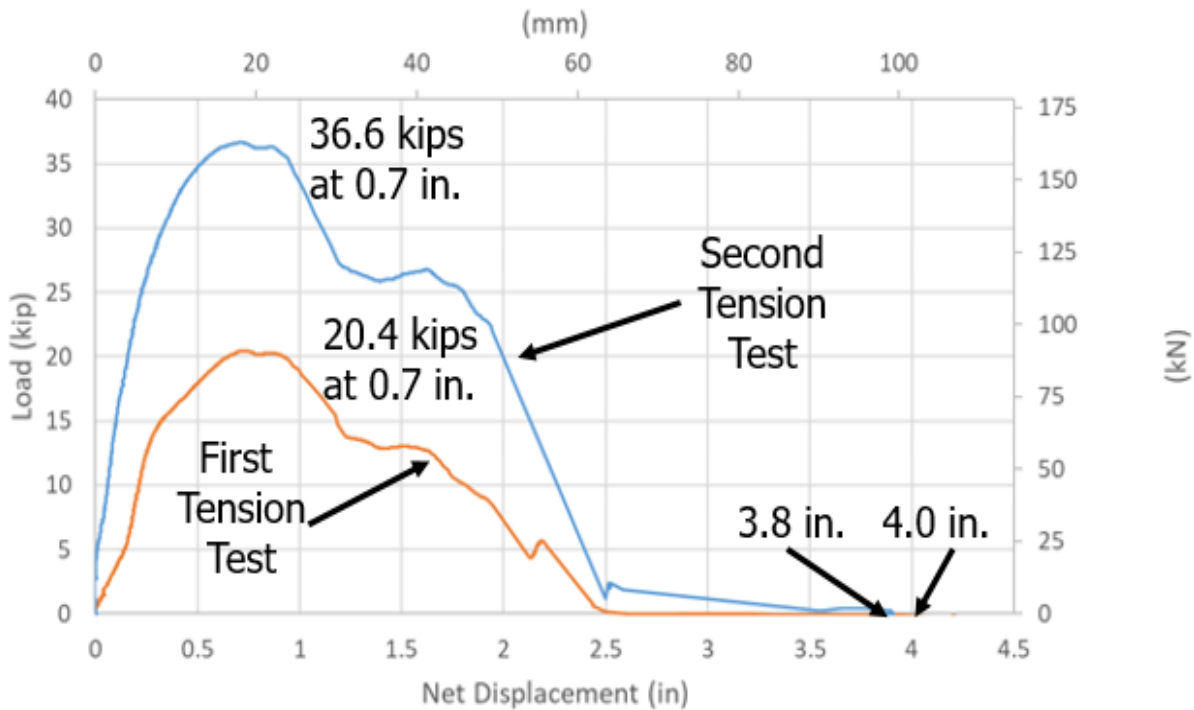
Figure 3.10. Load vs North Joint Net Displacement for First and Second Tension Tests

Figure 3.10 compares the loads vs net displacement of the north joint of the iPVC™ fitting for both the first and second tension tests. The shape of both plots is similar, although the maximum force for each test is significantly different. The force peaks for both tests at approximately the same north joint net displacement. The maximum force is lower for the first tension test because the specimen cracked along the knit line of the iPVC™ fitting. When cracked the circumference of the bell was able to expand more than that of the second tension test. More load normal to the

spigot was able to be carried by the second tension test, which was accompanied by greater pull-out force.

kN) peak load in the second tension test (see Figure 3.10) at an axial displacement of about 0.7 in. (18 mm) to 0.9 in. (23 mm). Adding 1.4 in. (36 mm) to 0.9 in. (23 mm) results in 2.3 in. (58 mm), which is the displacement that can be accommodated at a tensile axial load of 36.6 kips (163 kN). Please note that the net displacement in Figure 3.10 occurs at only the north joint.

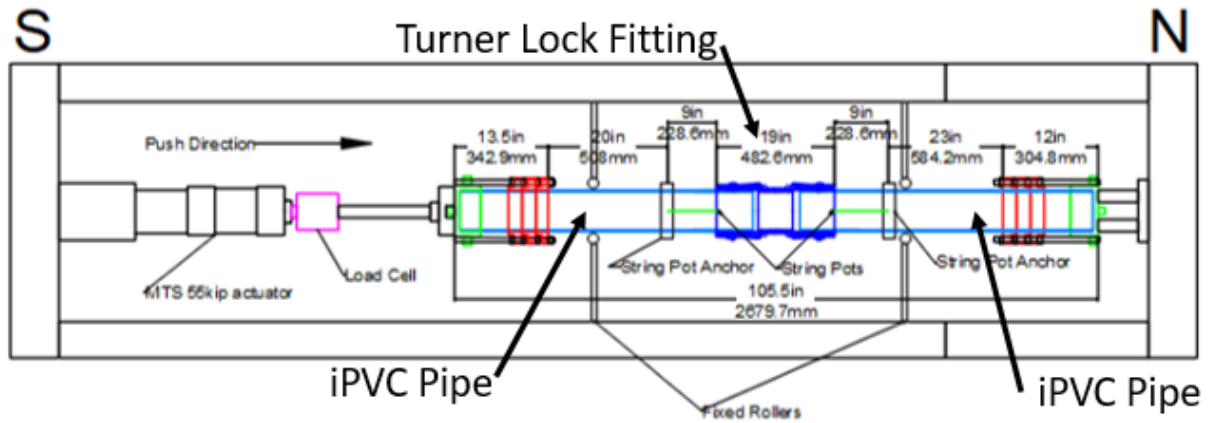
Figure 4.1. Plan View of Axial Compression Test

Figure 4.1 shows a plan view of the setup and equipment for the axial compression test. The orientation of the test specimen is shown with respect to north (N) and south (S). The test set up is similar to that of the tension tests, and the reader is referred to Section 3.1 for a detailed description. The main differences in the setups for the compression and tension tests were the direction of the actuator movement, way in which load was conveyed to the specimen, and stabilization of the specimen.

Tensile force was conveyed from a 55-kip (245-kN) MTS actuator through gripping collars very near both the north and south ends, whereas compressive force was conveyed through special end caps at each end of the test specimen. The end caps also provided for internal pressurization during loading. As shown in Figure 4.1, fixed rollers were located at the north and south pipes to stabilize the specimen against beam buckling. In the field, the iPVC™ fitting and adjoining pipe would be constrained by the adjacent soil against beam buckling.

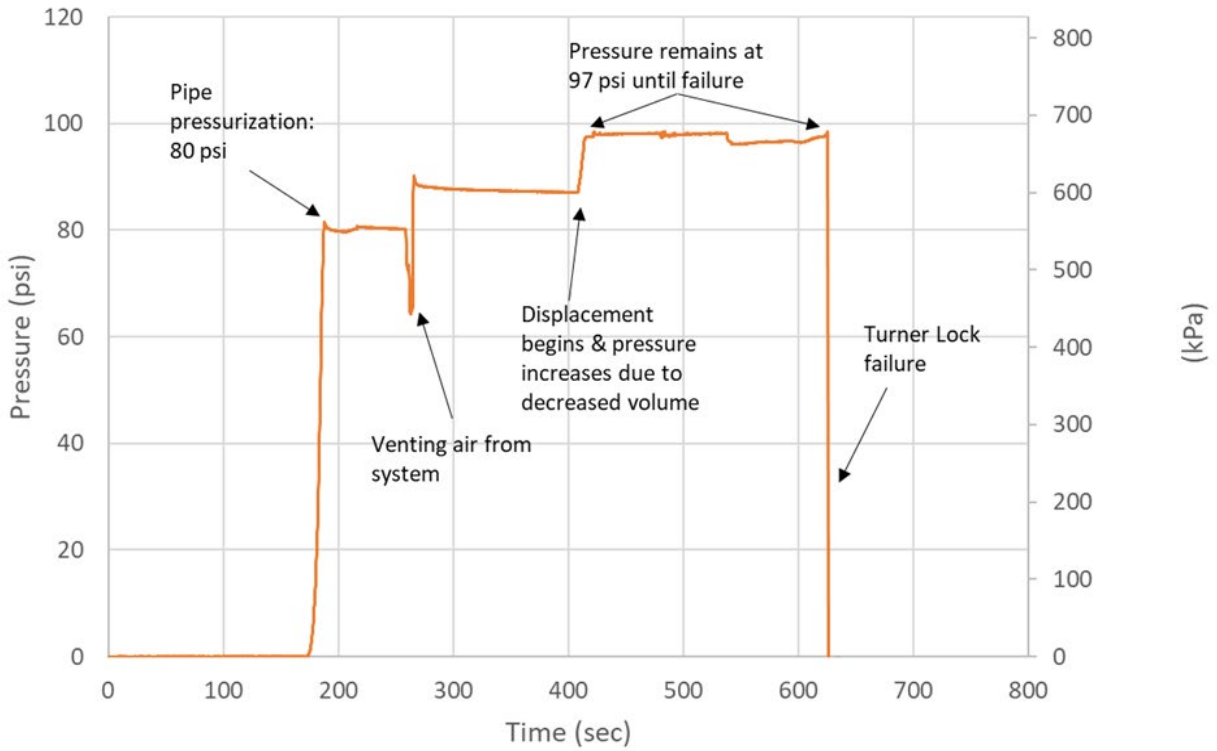
Figure 4.3 Internal Pressure vs. Time for Compression Test

Figure 4.3 presents the pressure plotted relative to time. In the plot, various labels and arrows point to different episodes in the pressurization and iPVC™ fitting response. The pressure was initially applied at approximately 80 psi (550 kPa). In response to compressive displacement and axial shortening of the test specimen, the pressure increased to approximately 97 psi (667 kPa), where it was held at a relatively constant value and monitored by the flowmeter. The pressure dropped precipitously when the specimen failed.

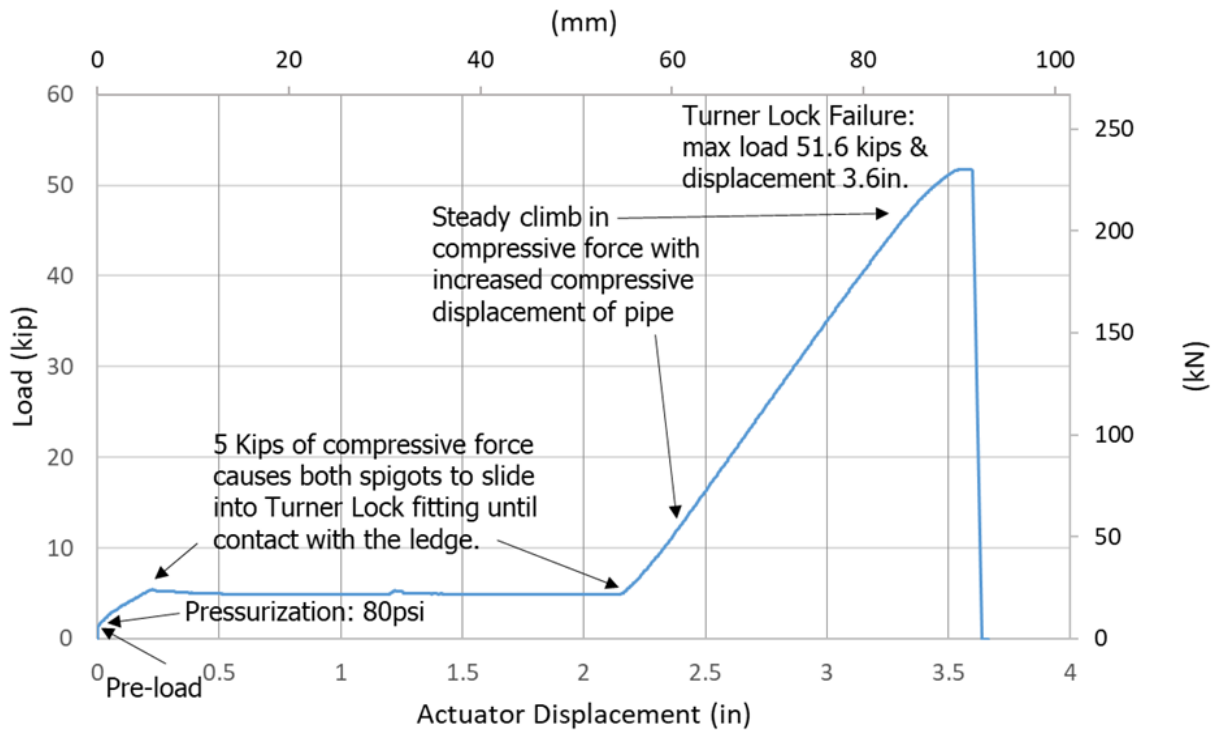
Figure 4.4 Axial Load vs. Actuator Displacement for Compression Test

Figure 4.4 presents a plot of the load vs. actuator displacement. Labels for various events are presented in the figure. Axial loads and displacements associated with preloading and pressurization are shown. At a load of 5 kips (22 kN) both the north and south spigots slid forward in the iPVC™ fitting until further penetration was stopped when each spigot made contact with a ledge in both the north and south portions of the iPVC™ fitting. The axial load then increased from 5 kips (22 kN) to a maximum of 51.6 kips (230 kN) at a displacement of approximately 3.6 in. (91 mm). At this combination of load and displacement, the iPVC™ fitting failed.

The actuator displacement involves 1) spigot penetration into the north and south joints of the iPVC™ fitting, 2) compression of the test specimen, and 3) machine displacement. The machine displacement in turn is composed primarily of a small compression of the actuator/load frame system as well any slip of the gripping collars. The machine displacement was on the order of 0.1 in. (2.5 mm) to 0.2 in. (5.0 mm).

As shown in Figure 4.4 there was a total spigot slip of approximately 2.2 in. (56 mm) into the north and south joints of the iPVC™ fitting. Then, there was an additional displacement of 1.4 in. (36 mm) caused by axial compression of the test specimen. This compression was accompanied by a steady increase in load from 5 kips (22 kN) to a maximum of 51.6 kips (230 kN). If the stress vs strain relationships in Figures 2.3 and 2.4 are used, one can calculate a strain of 0.001 associated with 5 kips (22 kN) and a strain of 0.015 associated with 51.6 kips (230 kN). Multiplying the net strain of 0.014 by the 105.5-in (268-mm) length of the test specimen results in approximately 1.5 in. (38 mm) of displacement, which is very close to the measured displacement of 1.4 in. (36 mm).
