# Performance Evaluation of Aqua-Pipe under Earthquake-Induced Ground Deformation

## Interim Report

Cornell University

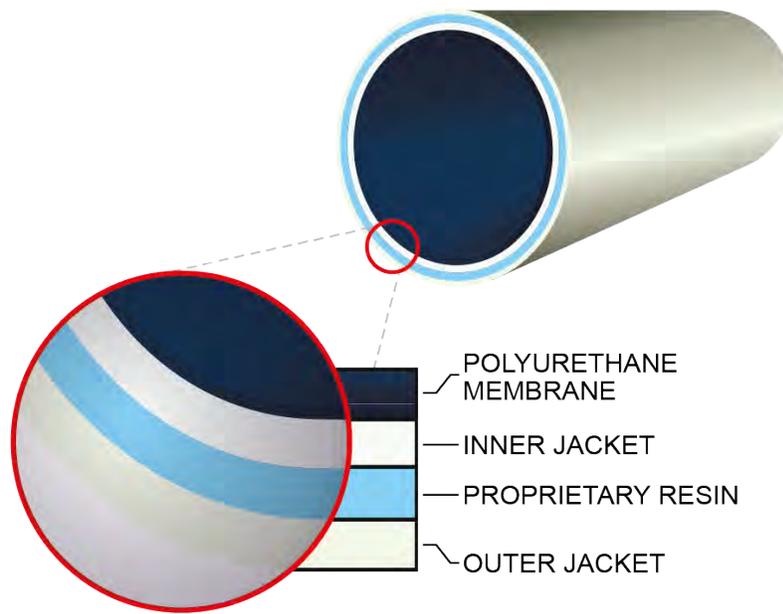
Figure 1.1. Aqua-Pipe™ Lining Components

As shown in, Figure 1.1, Aqua-Pipe™ is an epoxy resin-impregnated lining consisting of an inner and outer layer, or jacket, each composed of seamless, circular woven fabric. Each layer of woven fabric consists of polyethylene thermoplastic (PET) yarns in the longitudinal, or warp, direction and PET yarns in the circumferential, or weft, direction, as shown in the warp and weft schematic in Figure 1.2. The two jackets are impregnated with epoxy. The lining interior layer in contact with pipeline water is composed of a thermoplastic polyurethane (TPU) waterproof membrane.

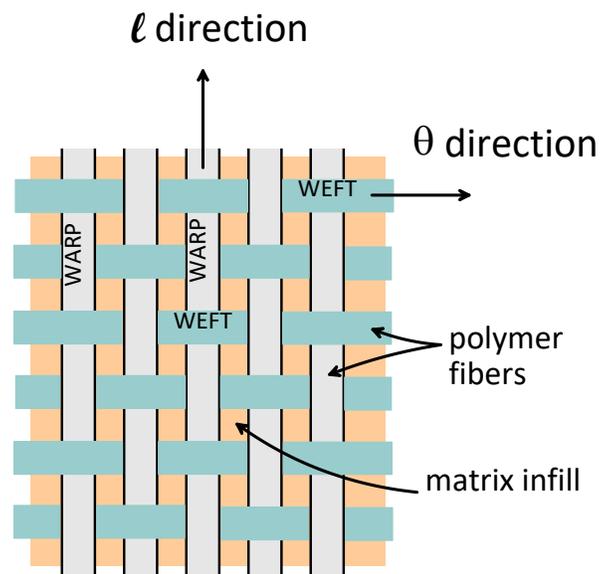
Figure 1.2. Schematic of Warp and Weft Yarn Pattern

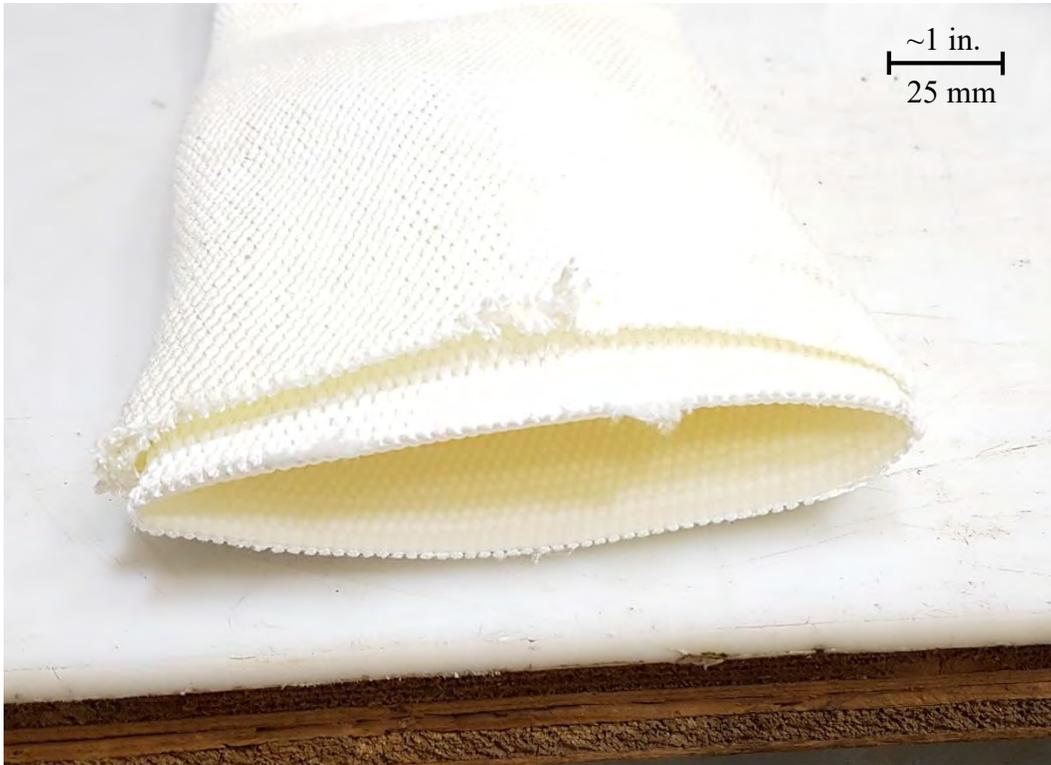
Figure 1.3. Aqua-Pipe™ Generation 1 (AP1) Woven Fabric Lining before Curing

The installation of AP1 results in a fold perpendicular to the circumference because the jackets are purposely chosen slightly oversized in diameter to ensure proper contact with the inner surface of the host pipeline once inflated onto it. Figure 1.3 shows the two layers of AP1 fabric before being impregnated with epoxy and cured in place. Figure 1.4 shows the AP1 lining after curing inside of an existing pipeline, where a limited-sized fold can be observed. The fold is virtually absent after the installation of AP2.

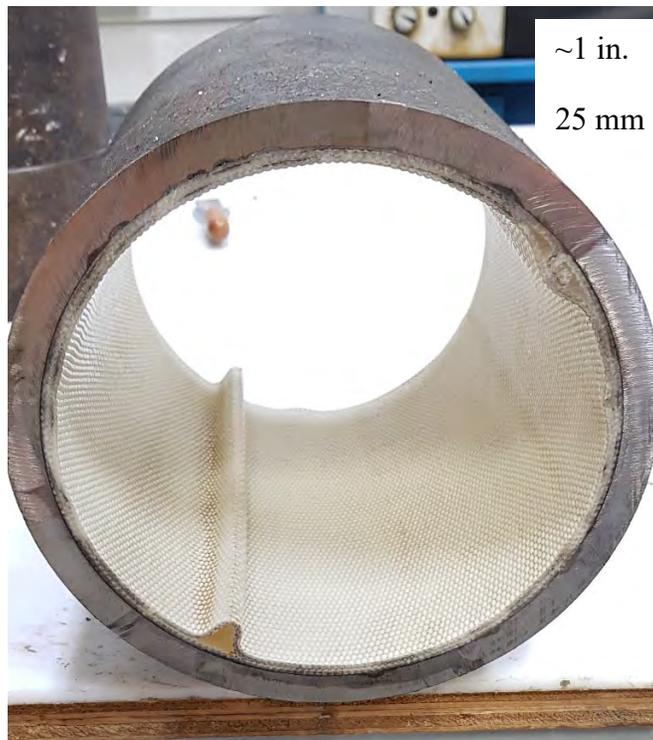
Figure 1.4. Aqua-Pipe™ Generation 1 (AP1) Woven Fabric Lining after Curing

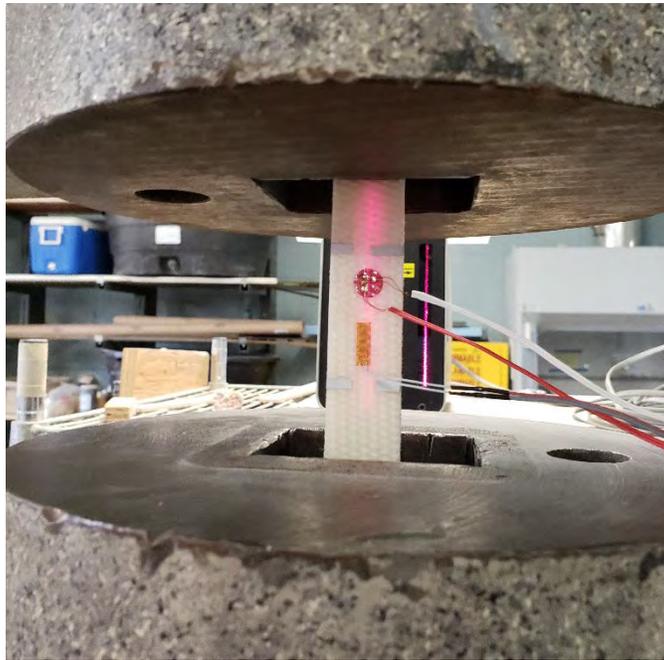
Figure 2.1. Tensile Coupon Test Setup with Aqua-Pipe™ Material

A Baldwin Hamilton 60 BTE Universal Testing Machine was used to apply the tensile loads to the AP1 specimens. The load frame was fitted with a pressure sensor to measure axial force. Tensile strain was measured using strain gages epoxied to the specimen surface. A laser extensometer was used to measure specimen elongation. Figure 2.1 is a photograph of an Aqua-Pipe™ specimen for the warp direction in the testing apparatus. The photograph shows axial and transverse gages on the test specimen as well as the laser extensometer strips that were used for measurements of extension with a laser beam.

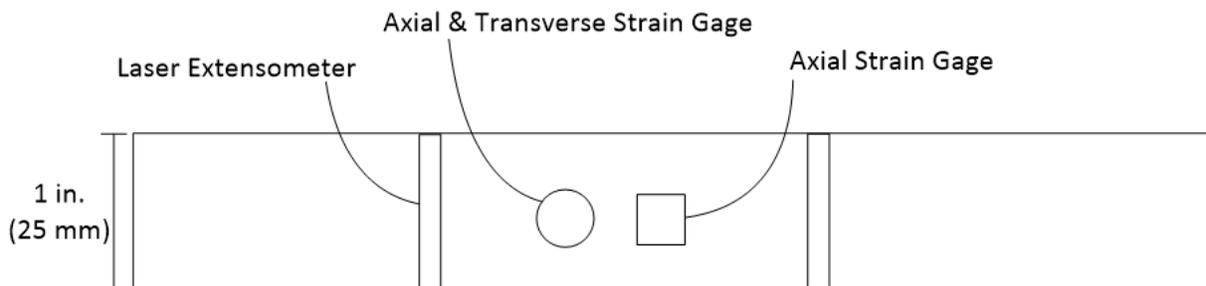
Figure 2.2. Schematic of Aqua-Pipe™ Tensile Coupon Specimen in the Warp Direction

Six tensile coupon specimens were tested. Three specimens were cut in the warp direction, and three specimens were cut in the weft direction. All six specimens were instrumented with axial and transverse strain gages. Schematics and dimensions of the specimens in the warp and weft directions are provided in Figure 2.2 and Figure 2.3, respectively. The thickness of the specimens was approximately 0.17 in. (4.3 mm) in the warp and weft directions. The gages were mounted in the center of the specimen. Such gages frequently debond at tensile strains of 2 to 4%. To provide supplemental measurements of strain beyond the 2 to 4% range, the laser extensometer was used to measure axial strain to failure. The extensometer provides for reliable assessment of strain at larger values than the strain gages, specifically those beyond the initiation of plastic deformation.

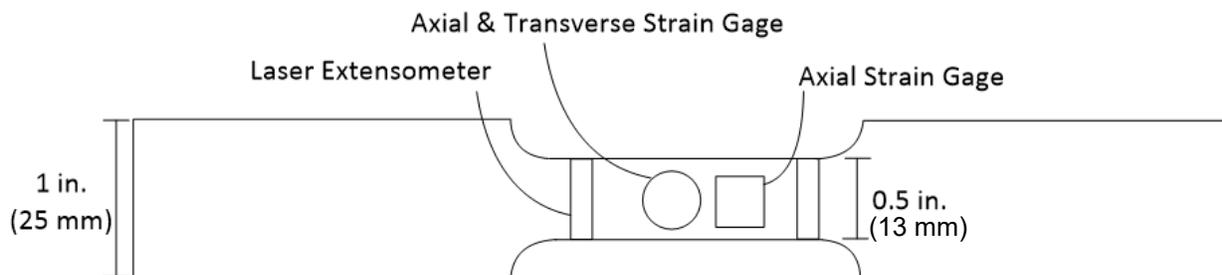
Figure 2.3. Schematic of Aqua-Pipe™ Tensile Coupon Specimen in the Weft Direction

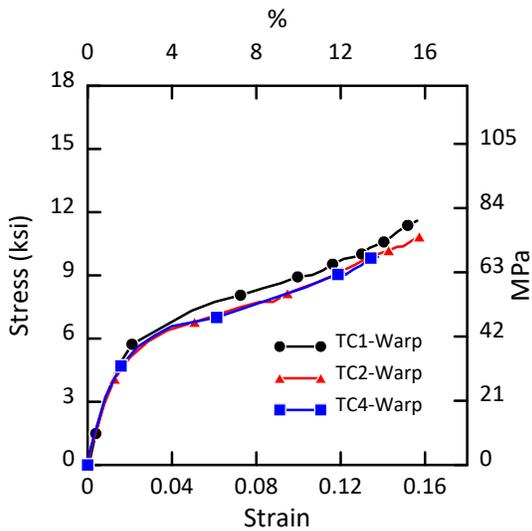
Figure 2.4. Stress versus Strain Plots to Failure for AP1 Specimens in the Warp Direction

The stress applied throughout the uniaxial tension test was computed by dividing the measured force by the original cross-sectional area of the tensile coupon. This strain generally is referred to as engineering strain. The uniaxial stress versus axial strain plots are shown in Figure 2.4 and Figure 2.5 for specimens in the warp and weft directions, respectively.

The results of the tensile coupon tests in each direction show good agreement. Each test was run until the woven fabric structure of the specimens tore apart, indicating failure. Axial stress versus strain data were used to determine the stress and strain at failure in each direction, as shown in Figure 2.4 and Figure 2.5 by the maximum measured stress. The average failure stress and strain for Specimens 1, 2, and 4 in the warp direction were 10.9 ksi and 15%, respectively, with standard deviations of 0.94 ksi and 1.2%. The average failure stress and strain for Specimens 3, 4, and 5 in the weft direction were 15.3 ksi and 11.1%, respectively, with standard deviations of 1.68 ksi and 1.6%. The ratio of the average stress at failure in the weft versus warp direction is 1.40, which is nearly identical to the ratio of stress at failure reported by the manufacturer.

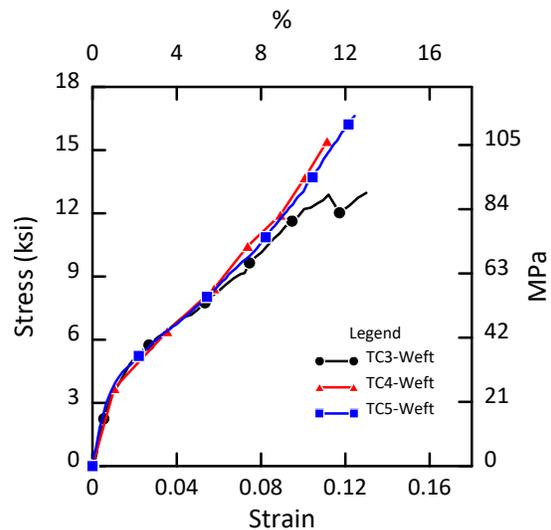
Figure 2.5. Stress versus Strain Plots to Failure for AP1 Specimens in the Weft Direction

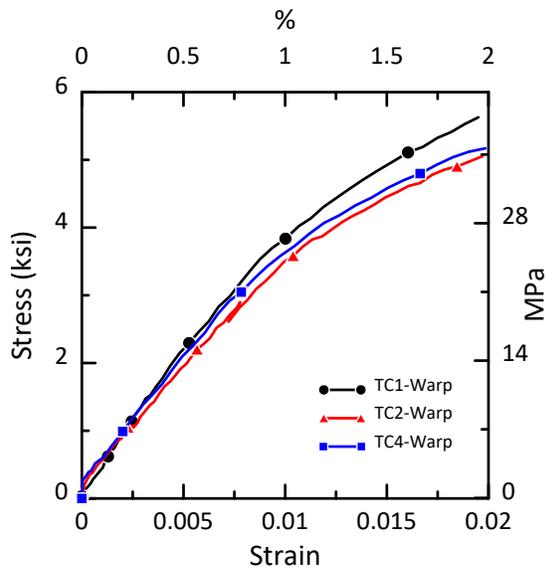
Figure 2.6. Expanded Stress versus Strain Plots for AP1 Specimens in the Warp Direction

Expanded views of the stress versus strain data are shown in Figure 2.6 and Figure 2.7 for the weft and warp directions, respectively. Young's modulus,  $E$ , was computed using the linear range of the stress versus strain plots. It was determined by performing linear regressions for stress versus strain from 0 to approximately 0.5% strain. The average Young's modulus for Specimens 1, 2, and 4 in the warp direction is 390 ksi (2.69 MPa) with a standard deviation of 60.7 ksi (0.42 MPa). The average Young's modulus for Specimens 3, 4, and 5 in the weft direction is 414 ksi (2.86 MPa) with a standard deviation of 29.0 ksi (0.20 MPa).

Table 2.1 and Table 2.2 provide summaries of the Young's modulus, tensile stress and strain at failure, and Poisson's ratio in the warp and weft directions, respectively. A close examination of the plots in Figure 2.6, Figure 2.7, Figure 2.8 and Figure 2.9 shows a departure from linearity at a strain of between 0.5% and 1.0%. The Young's modulus and Poisson's ratio in both the warp and weft direction decreases at strains between 0.5% and 1.0%.

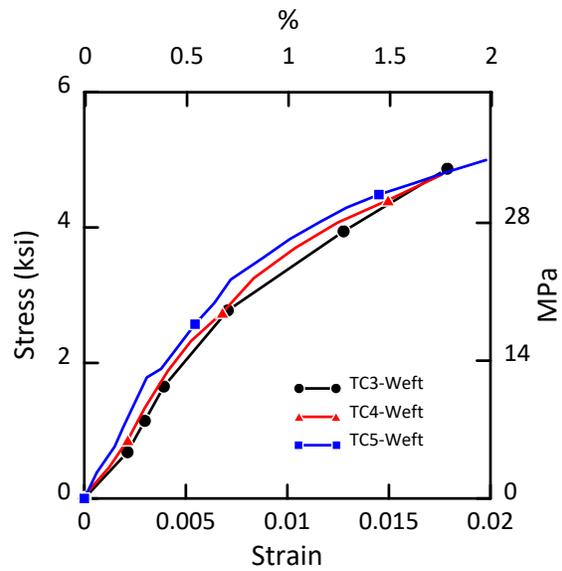
Figure 2.7. Expanded Stress versus Strain Plots for AP1 Specimens in the Weft Direction

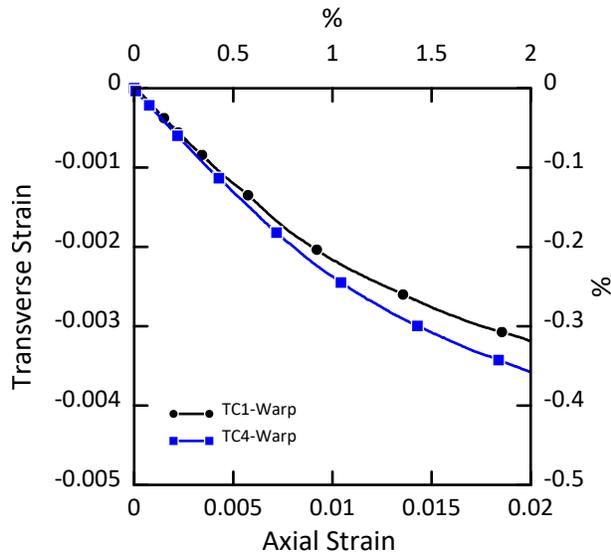
Figure 2.8. Transverse versus Axial Strain for Tensile Stress for AP1 Specimens in the Warp Direction

Poisson's ratio,  $\nu$ , is the negative ratio of transverse strain to axial strain for uniaxial loading. Poisson's ratio was derived from the transverse versus axial strain plots. As shown in Figure 2.8 and Figure 2.9, the linear range in the warp direction of the transverse versus axial strain terminates at approximately 0.05 axial strain, beyond which axial strain accumulates at a faster rate than the transverse strain. The average Poisson's ratio for Specimens 1 and 4 in the warp direction is 0.23 with a standard deviation of 0.016. The average Poisson's ratio for Specimens 3, 4, and 5 in the weft direction is 0.25 with a standard deviation of 0.010.

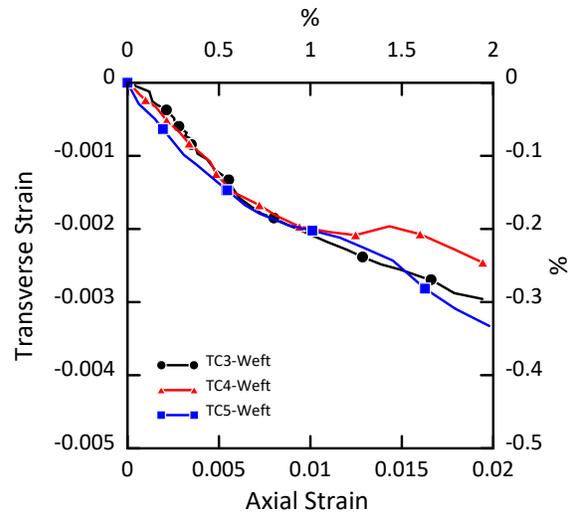
Figure 2.9. Transverse versus Axial Strain for Tensile Stress for AP1 Specimens in the Weft Direction

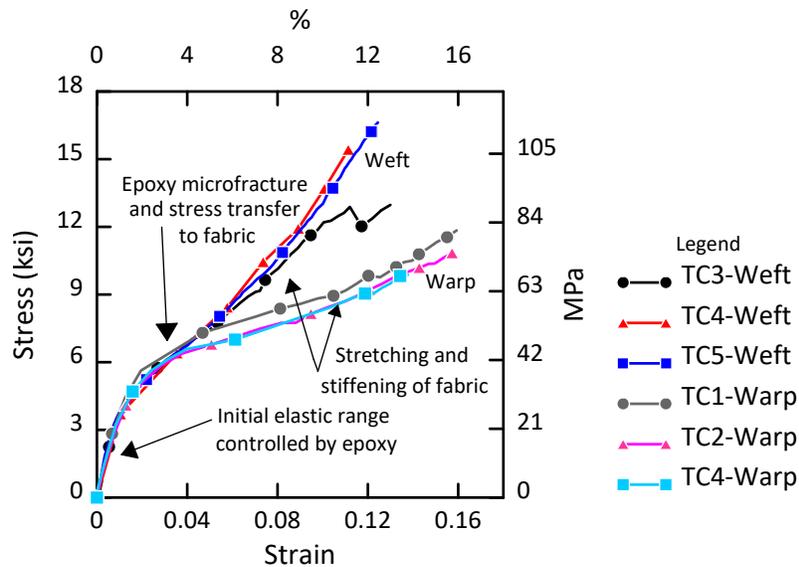
Figure 2.10. Stress versus Strain Plots for AP1 Specimens in the Warp and Weft Directions

In Figure 2.10, the stress versus strain data for the warp and weft directions are plotted at the same scale. From zero to between 0.5% and 1.0% strain, the lining responds as a linear elastic solid. The Poisson's ratio is approximately 0.24 in both directions, and the difference in the Young's modulus is less than 7% lower in the warp than in the weft direction. In this range of tensile strain, the Young's modulus and Poisson's ratio are controlled principally by the epoxy.

As the strain approaches and exceeds 1.0%, micro-fractures develop in the epoxy, and stress is transferred increasingly from the epoxy matrix to the fabric. This stress transfer results in a reduction of modulus. Moreover, the fabric stretches more in the warp direction than in the weft direction, where the failure strain is smaller. As tensile strain exceeds approximately 5%, the fibers stretch and tighten, leading to increased modulus in both the warp and weft directions. The stiffness and strength in the weft direction exceed those in the warp direction due to the higher crimp in the latter direction.

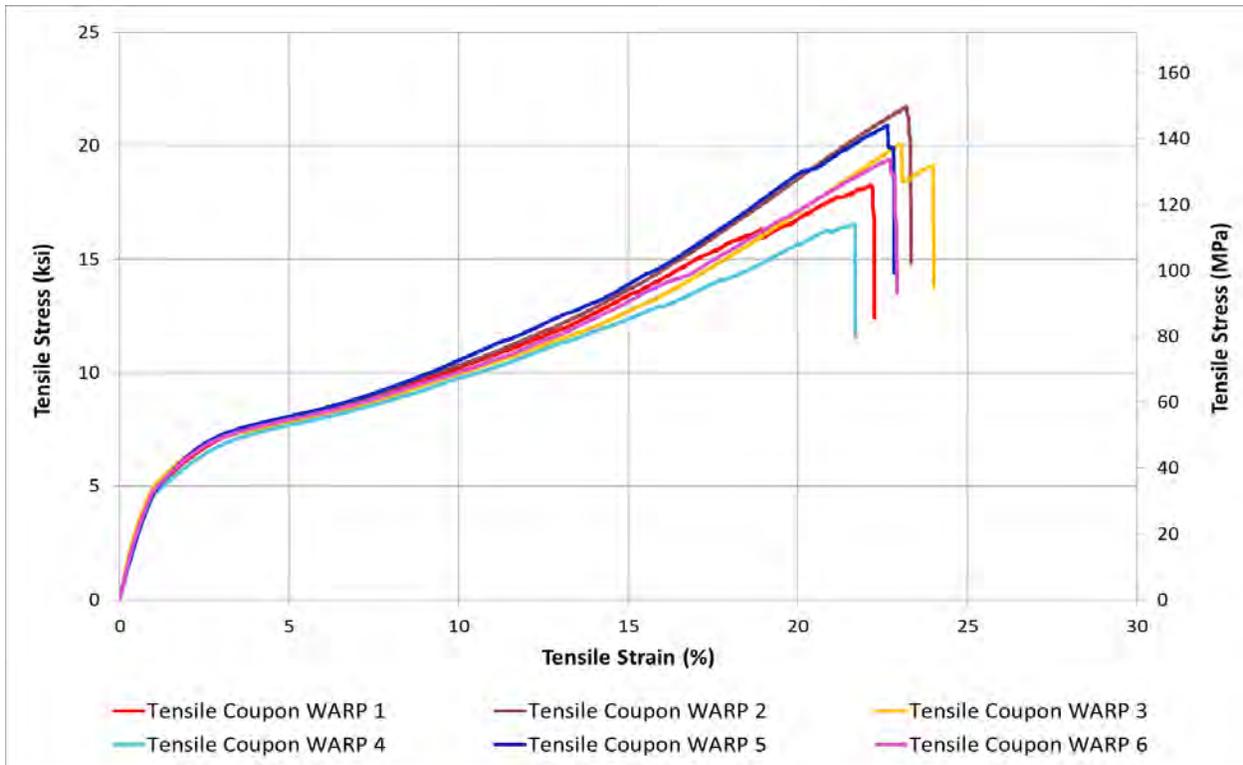
Figure 2.11 Tensile Stress vs Strain from CDCQ for the AP2 Warp Tensile Coupon Tests

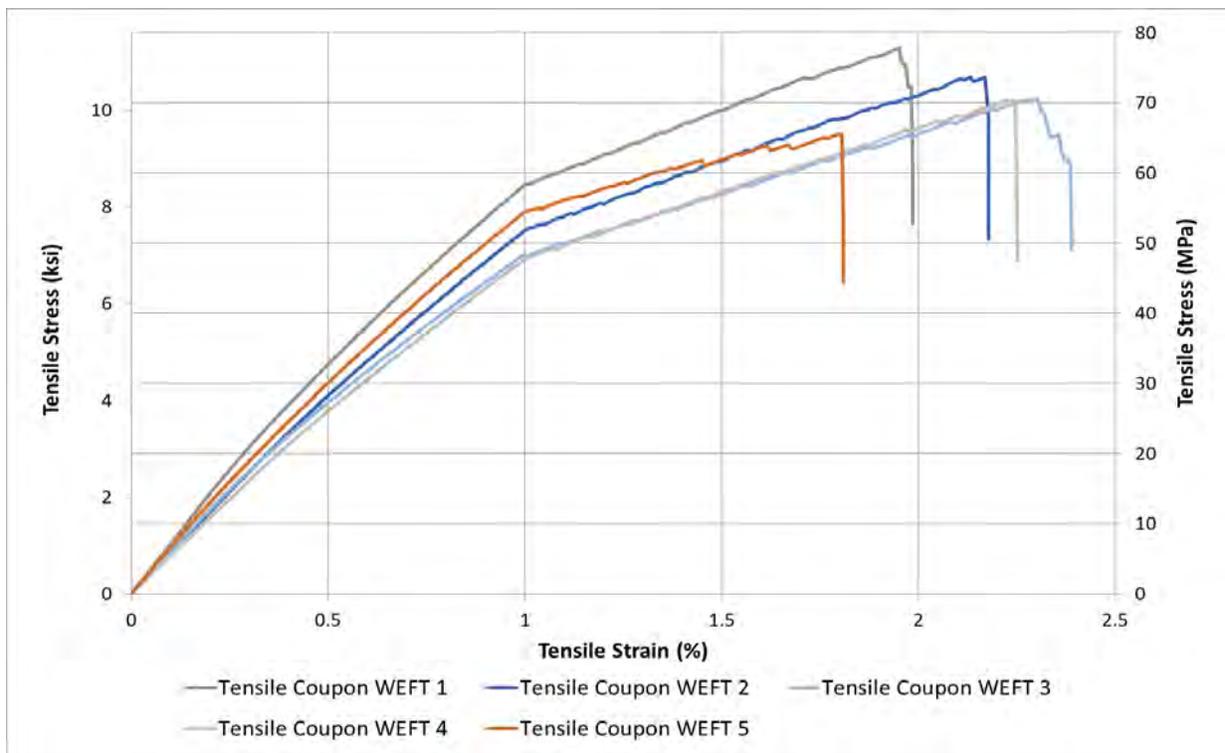
Figure 2.12 Tensile Stress vs Strain from CDCQ for the AP2 Weft Tensile Coupon Tests

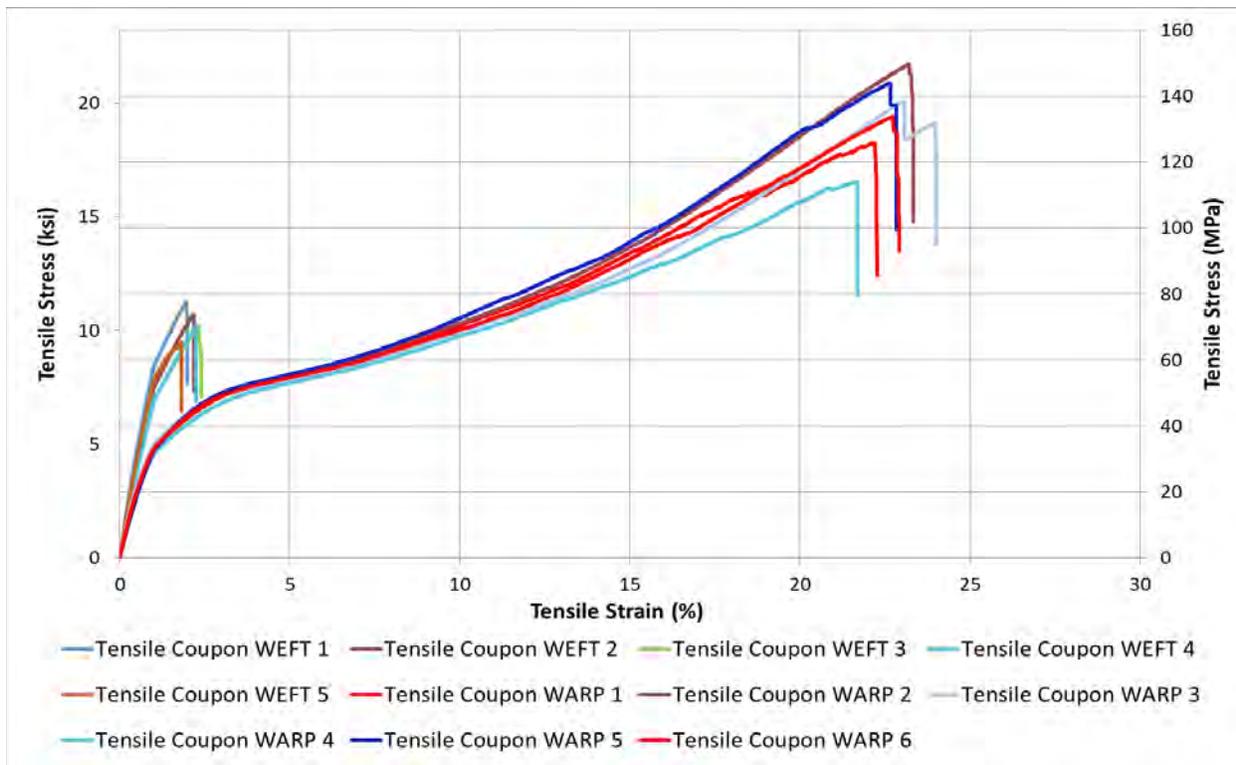
Figure 2.13 Tensile Stress vs Strain from CDCQ for AP2 Warp and Weft Tensile Coupon Tests

Figure 2.13 shows the tensile stress vs strain from CDCQ for all the specimens in the warp and weft directions. There is a significant difference in the maximum tensile strength and tensile strain at maximum stress for both directions. Like the AP1 specimens, there is marked departure from linearity for the AP2 specimens at tensile strains between 0.5 and 1.0%. The secant modulus in both the warp and weft directions of the AP2 specimens is larger than that in the same directions at the same strains for the AP1 specimens. At 0.5% strain, the secant modulus for AP2 is about 50% and 100% greater for AP1 in the warp and weft directions, respectively.

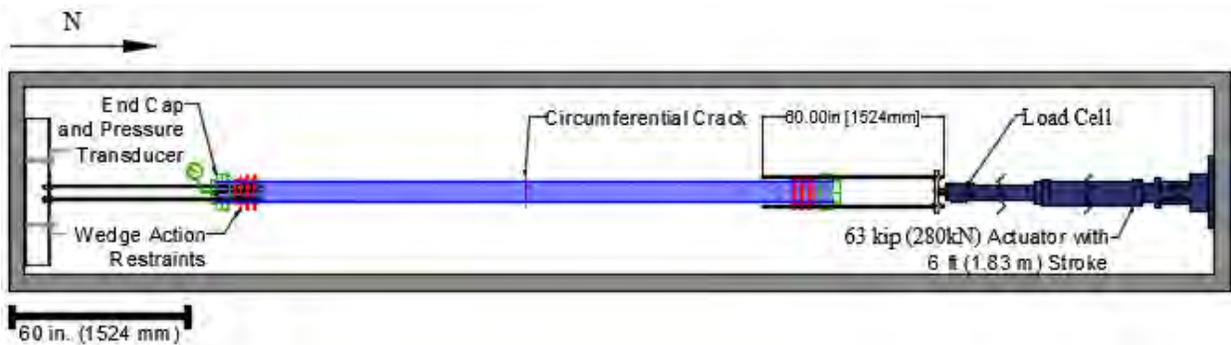
Figure 3.1. Plan View of a Direct Tension Test in the Large Load Frame

Figure 3.1 and Figure 3.2 show plan views of the axial tension test setup and equipment for large and small load frames. An actuator, load cell, and load frame were used to apply tensile load to the test specimen in each setup. The test specimens consisted of nominal 6 in. (152 mm) diameter DI and CI pipes lined with Aqua-Pipe that was installed by Sanexen. The specimen lengths were 8.5 ft (2.6 m) or 17 ft (5.2 m). Each specimen was fitted with end caps to allow for internal pressurization during loading. A photo of the test setup using the large load frame is shown in Figure 3.3, and a photo of the test setup using the small load frame is shown in Figure 3.4. Each test specimen consisted of two pipe sections of equal length on each side of a gap, representing a round crack.

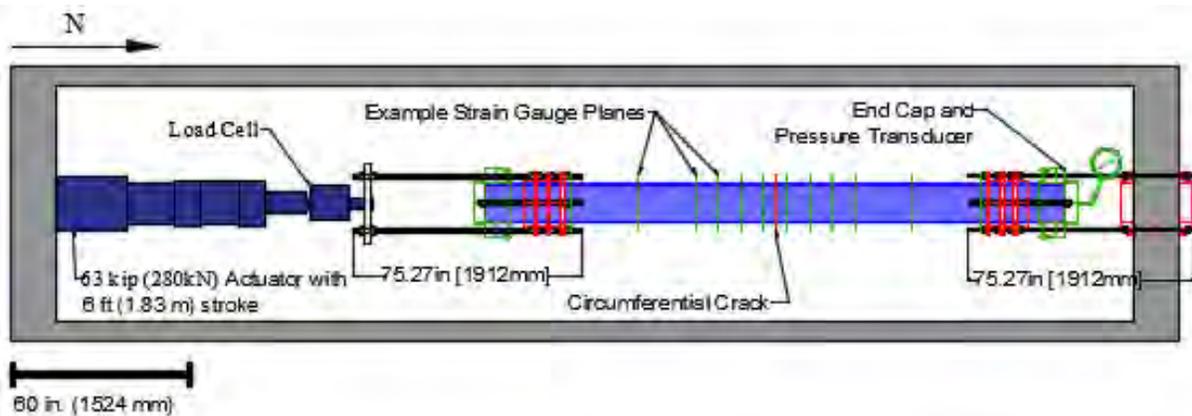
Figure 3.2. Plan View of a Direct Tension Test in the Small Load Frame

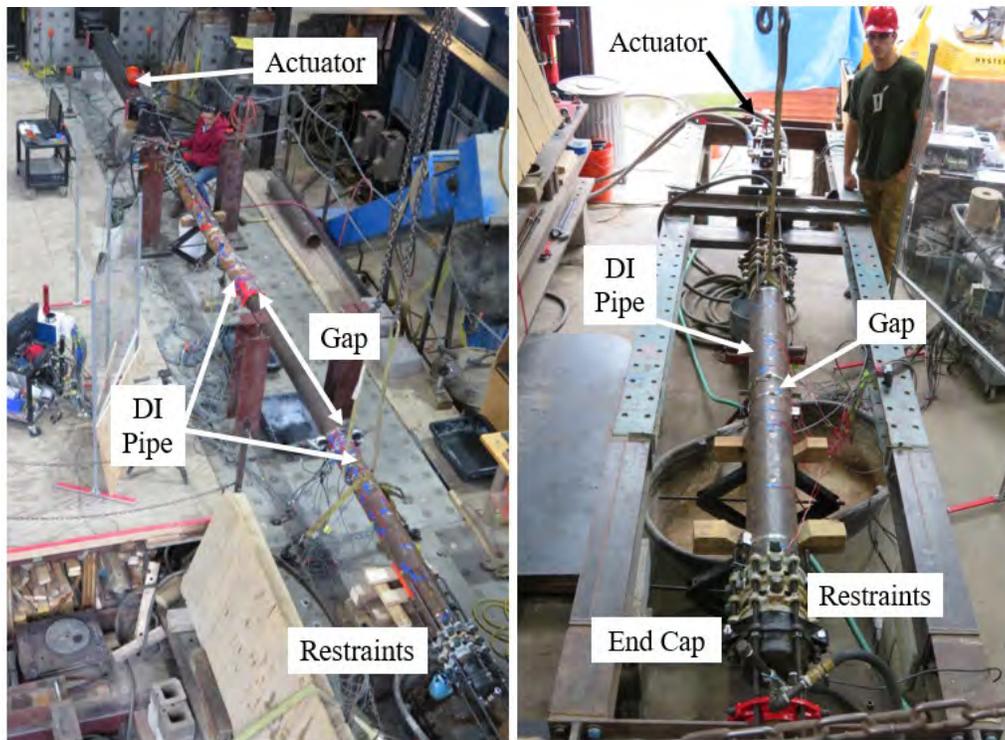
Figure 3.3. Large Load Frame (Facing North) Figure 3.4. Small Load Frame (Facing South)

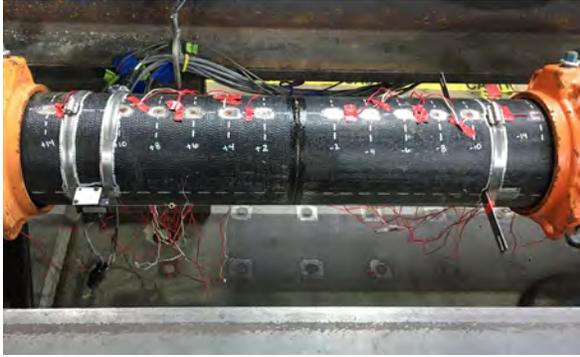
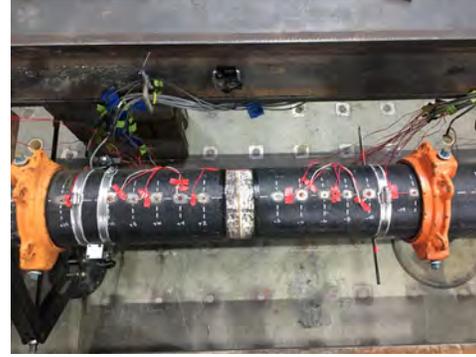
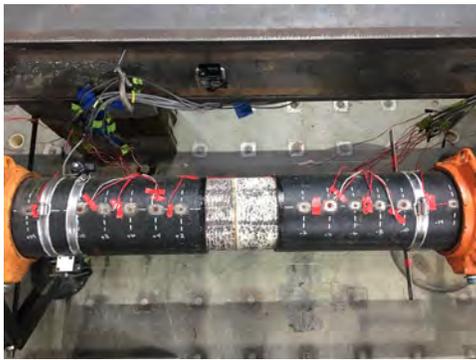
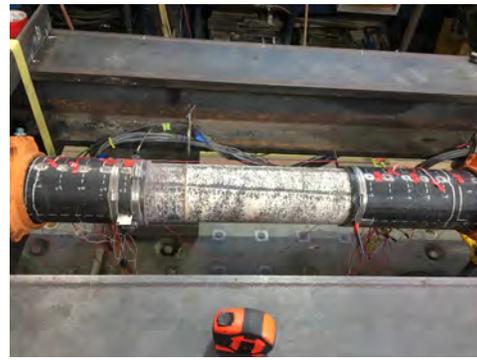
(a) View of DT1 Specimen in Load Frame Before Test Initiation

(b) View of Lining Exposed After First 6 in. (152 mm) of Actuator Displacement

(c) View of Lining Exposed After Second 6 in. (152 mm) of Actuator Displacement

(d) View of Lining Exposed After Completion of Actuator Displacement

Figure 3.5. Photos of the Center Gap at Various Levels of Displacement during DT1

Figure 3.5 (a) and (d) show photographs of the DT1 test pipe. Figure 3.5 (a) shows the pipe at the beginning of the test. Strain gages on the crown of the pipe and a string pot along the eastern springline of the pipe can be seen in the photo. Figure 3.5 (b) and (c) show the pipe after the first and second 6 in. (152 mm) of actuator displacement, respectively. Figure 3.5 (d) shows the maximum 12 in. (305 mm) opening of the center crack near the end of the test. At 12 in. (305 mm) of crack opening, the loading frame geometric limits were met, and the specimen was unloaded.

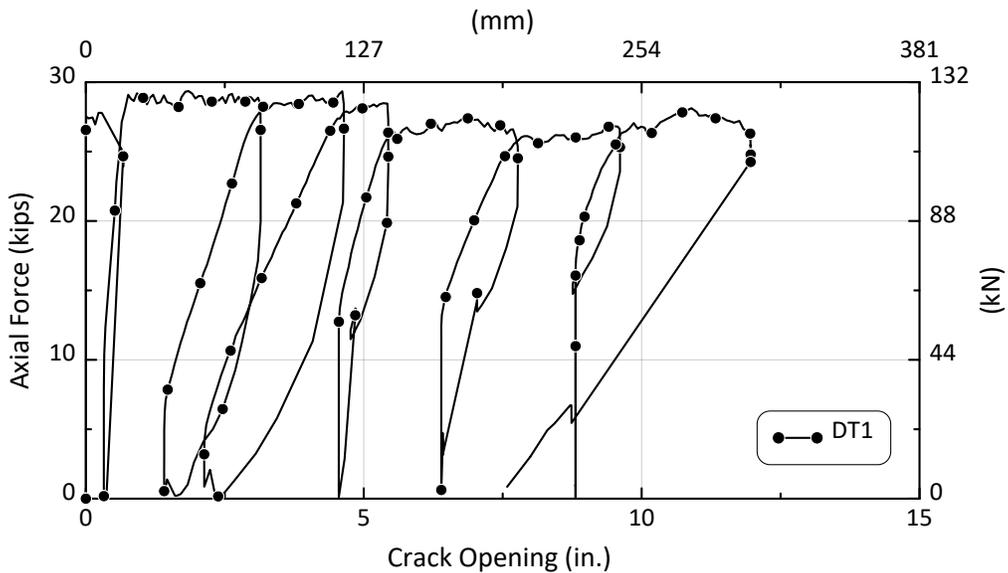
Figure 3.6. Axial Force versus Crack Opening for DT1

Figure 3.6 shows the axial force versus gap, or crack, opening. As displacement was applied, the axial load increased rapidly so that the slope of the plot appears to be a vertical line. After approximately 1 in. (25 mm) of crack opening, the test was paused, causing the first cyclic loading in the figure. After resuming the test, multiple load and reload cycles were applied until a maximum gap opening of 12 in. (305 mm) was achieved. Six unloading and loading cycles are

The maximum axial force recorded varied between 26 kips (116 kN) and 29 kips (129 kN). This force represents the debonding capacity of the lining, which is the force required to propagate a Type II fracture between the lining and inside surface of the pipe (Argyrou et al, 2018). The maximum debonding force varied roughly  $\pm 5\%$  along the pipe specimen, with an average of approximately 27.5 kips (122 kN).

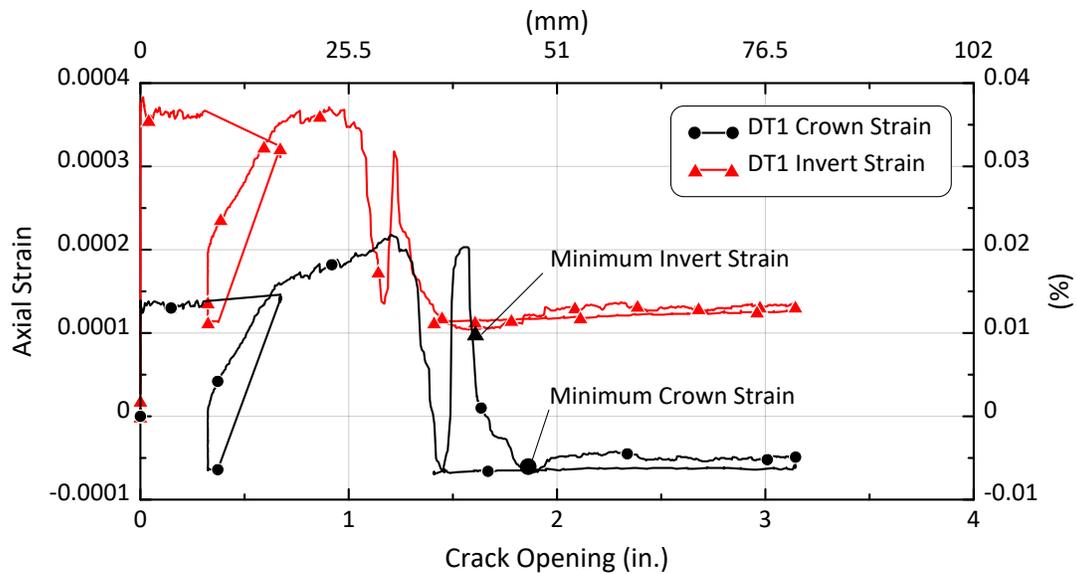
Figure 3.7. Longitudinal Strain at Strain Gage Station 6 versus Crack Opening for DT1 Specimen

Additional insight with respect to the debonding characteristics of the lining can be obtained from the strain gage readings. Figure 3.7 shows plots of the crown and invert strains measured by longitudinal strain gages, 6C and 6I, at 6 in. (152 mm) north of the pipe specimen center.

Each minimum reading indicates when debonding had fully propagated past the location of the gage. At approximately 1.7 in. (43 mm) of gap opening, the invert strain dropped to its minimum value, followed by the crown strain that dropped to its minimal value at 1.9 in. (48 mm) of gap opening. There is a lag of approximately 0.20 to 0.25 in. (5.1 to 6.4 mm) in crack opening between

the minimum readings. The same applies to the maximum strain readings (after which there is a perceptible decline). The maximum strain coincides with the crack opening at which debonding begins at the gage station.

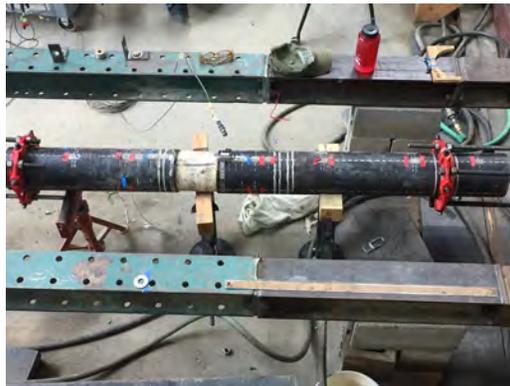
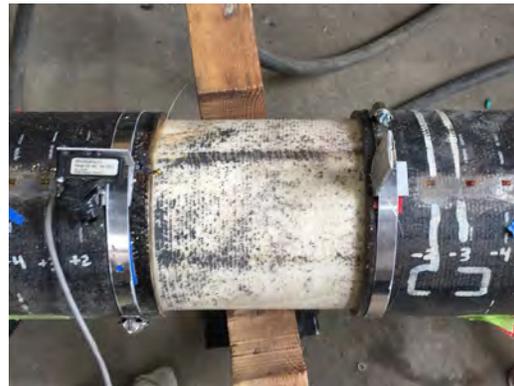
(a) View of DT2 Specimen in Load Frame

(b) View of Lining Exposed after DT2

Figure 3.8. Photos of the Center Gap at the End of DT2

Figure 3.8 (a) and (b) show photographs of the DT2 specimen after the lining fully debonded from the DI host pipe. Figure 3. (a) shows the specimen in the small load frame. A string pot on the crown of the crack opening and several strain gages are visible in Figure 3. (b).

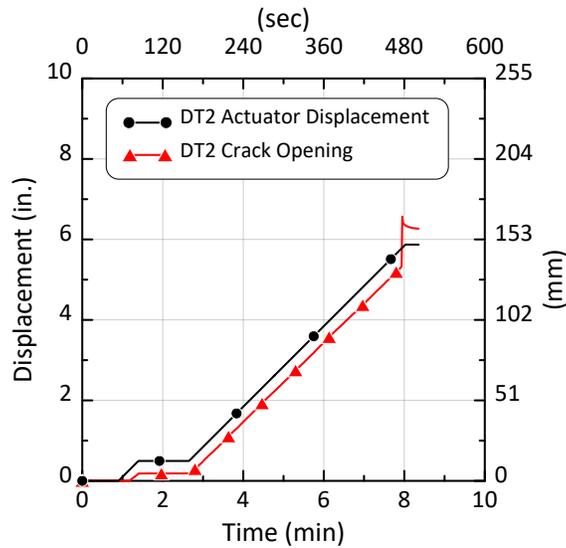
Figure 3.9. Actuator Displacement and Crack Opening versus Time for DT2 Specimen

The actuator displacement and crack opening versus time are shown in Figure 3.9. Actuator displacement is a direct measurement of the hydraulic piston movement. Crack opening represents the relative movement between the north and south pipe lengths. Only the south section of the pipe specimen debonded from the lining so the gap opening is equivalent to pipe movement along the south part of the lining. Crack opening was determined by averaging the displacements of the horizontal string pots, N-Pipe and S-Pipe, across the centerline. At approximately 1 minute, there was a slip of the retaining collars that resulted in an offset between the actuator displacement and gap opening. Further crack opening occurred in unison with the actuator displacement,

indicating no further slip of the restraining collars and no significant axial deformation of the DI pipe.

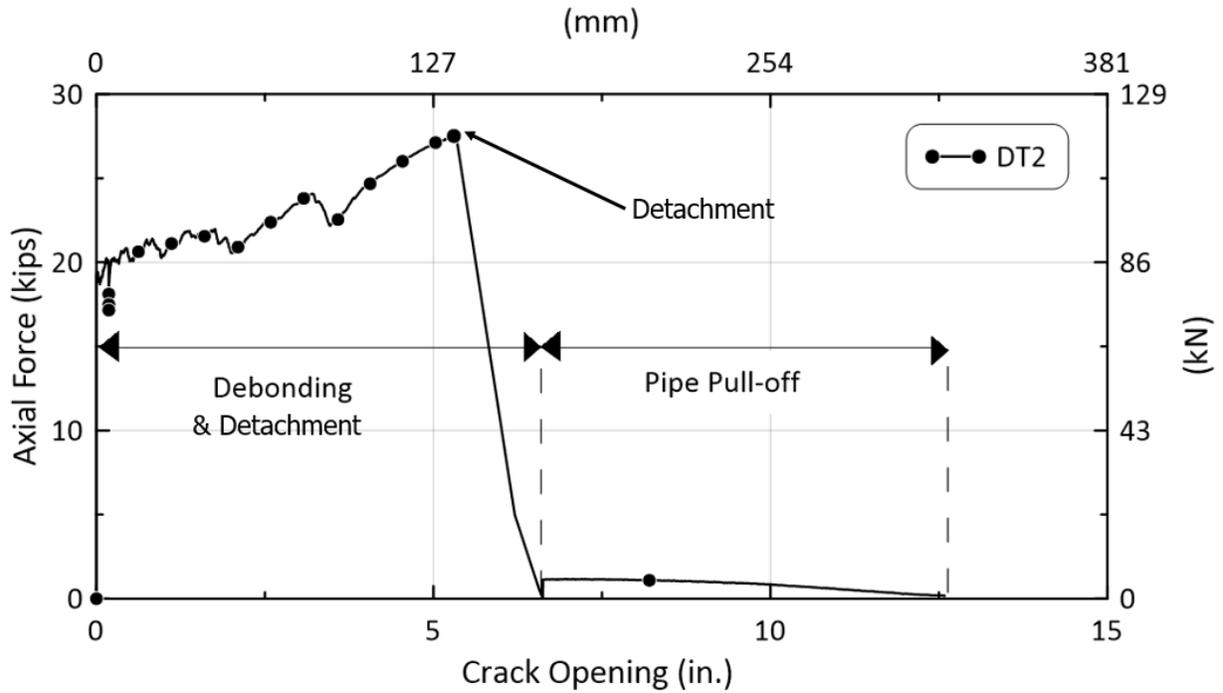
Figure 3.10. Axial Force versus Crack Opening for the DT2 Specimen

As described previously, the test consisted of propagating the debonding front along the entire south pipe section, followed by pulling the debonded side of the DI pipe off the Aqua-Pipe lining. After the maximum range of the string pot was exceeded, further crack opening was based on the actuator displacements. Figure 3.10 shows the axial force versus crack opening until 12.5 in. (318 mm) of crack opening. Both the debonding/detachment and pull-off phases of the test are identified. A maximum force of approximately 27 kips (120 kN) was reached at a corresponding crack opening of 5.5 in. (140 mm). At that point, there was lining detachment from the south end of the pipe with a corresponding rapid decrease in axial load. The test was paused before the second phase of loading.

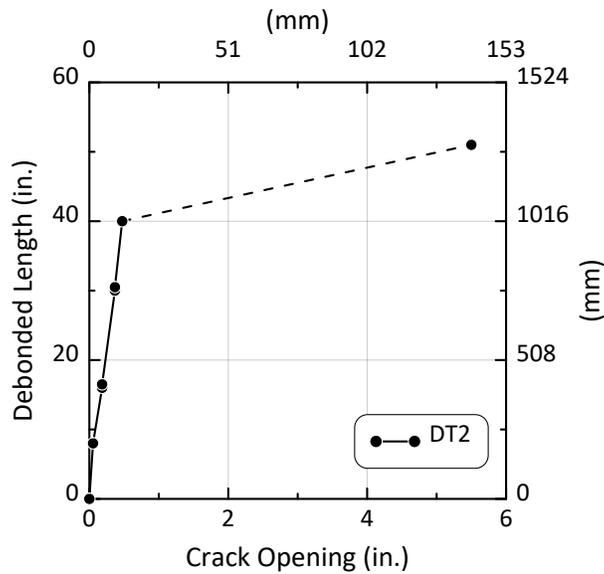
Figure 3.11. Location of Debonding Front versus Crack Opening of the DT2 Specimen

As shown in Figure 3.11, the debonding front propagated rapidly through the south section of pipe to 40 in. (1016 mm) at a crack opening of approximately 0.5 in. (13 mm); a ratio of roughly 80:1. All of the gap opening was in the southern direction. The increase in debonding length after 40 in. (1016 mm) is presented as a dashed line to indicate that there is uncertainty about the relationship between debonded length and crack opening from 40 to 51 in. (1016 to 1295 mm).

The debonded length versus crack opening was evaluated using strain gage data, as explained for DT2. The relatively low sampling rate (2 Hz) for this test makes it more difficult to interpret the data, so there is greater variability relative to the 50 Hz sampling rate used in DT2 (see Figure 3.11) when plotting debonded length versus crack opening.

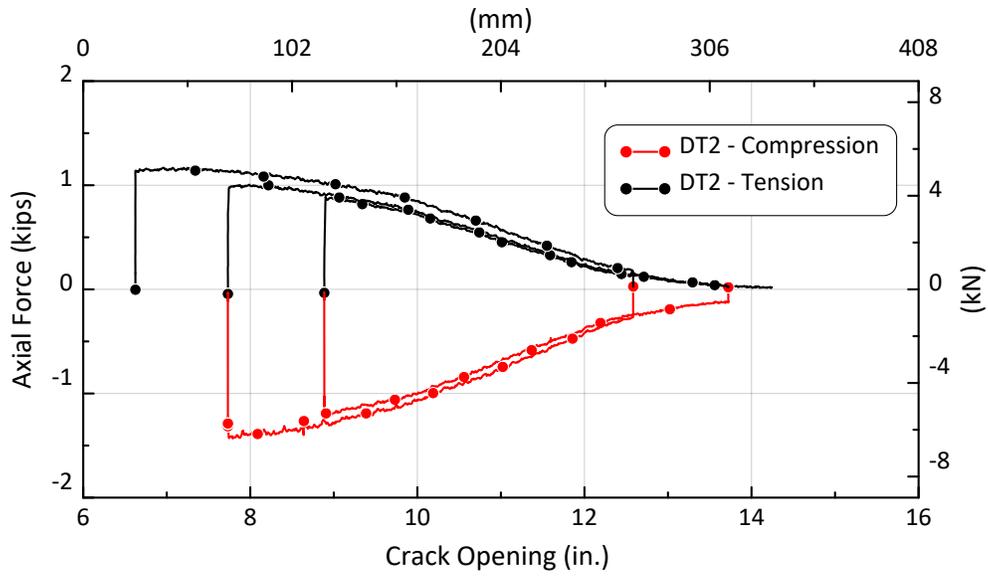
Figure 3.12. Axial Force versus Crack Opening during Pipe Pull-off for DT2

The second phase of the test consisted of pulling and pushing the DI pipe over the south section of the Aqua-Pipe lining. Figure 3.12 shows the first iteration of pulling the south section of pipe along the lining. The force increased to 1.5 kips (6.7 kN) rapidly and decreased to zero as the pipe moved towards the end of the lining. Figure 3.10 shows the axial force versus crack opening for the initial pipe pull-off, as well as two additional cycles of pushing and pulling the DI pipe along the lining. When the pipe was being pulled from the lining, it was in tension (positive force). The lining was in compression (negative force) while the pipe was pushed onto it. The axial force initially increased at the beginning of pipe pull off and decreased to zero. When the pipe was pushed back onto the lining, the force increased slowly from zero to the initial force necessary to pull the pipe off.

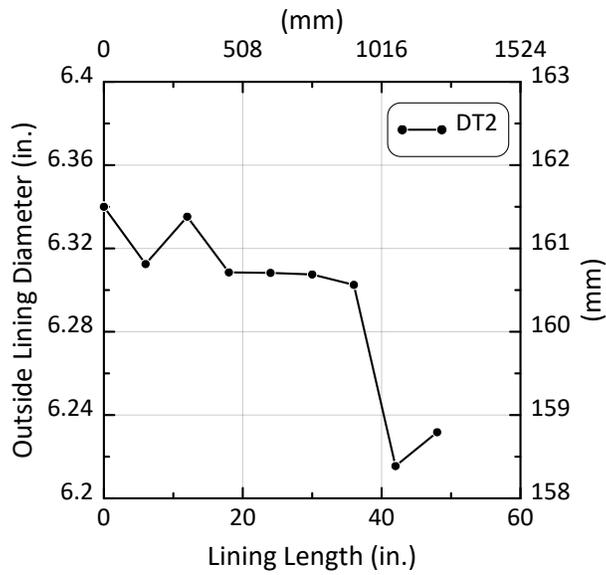
Figure 3.13. Average Outer Diameter of Lining along the South Section of the DT2 Specimen

Figure 3.13 shows the average outside lining diameter plotted with respect to distance along the south side of the lining that was exposed after the south section of the pipe was pulled from the lining. The diameter is measured from the center of the specimen at zero to near the south end of the lining at 48 in. (1219 mm).

Because the lining was cast and cured inside the pipe, the outside diameter of the lining is the inside diameter of the pipe. As the pipe was pulled along the lining, the larger end of the pipe was pulled across a lining diameter that decreased until a minimum diameter at about 42 in. (1067 mm) south of the initial center gap. Because the end of the pipe was displaced past a lining diameter lower than that of the pipe, contact between the inside diameter of the pipe and outside diameter of the lining was lost with a corresponding loss of shear resistance between the two surfaces. This geometric condition resulted in the reduction of axial load with increasing pipe lining movement

under tension as well as an increasing axial load with increasing pipe/lining movement under compression.

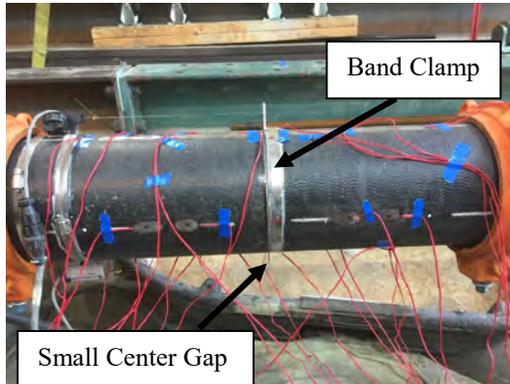
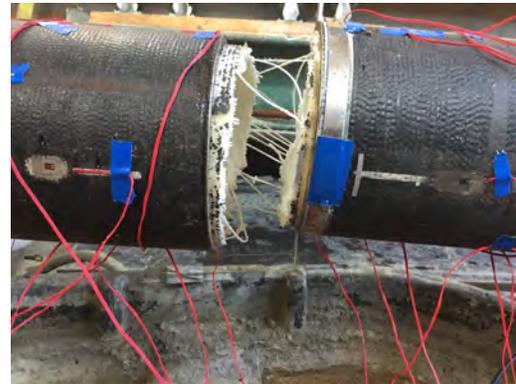
Figure 3.14. Photos of the Center Gap at the Beginning and End of DT3

Figure 3.14 (a) and (b) show photographs of the DT3 specimen before the start of the test and after the Aqua-Pipe lining failed. At approximately 2.0 in. (51 mm) of crack opening, the lining broke in tension rather than debonding along the length of the pipe. As the DI pipe was a new, clean specimen there was a relatively large amount of frictional resistance against debonding compared to the frictional resistance mobilized in field specimens.

a) Full View of Specimen in Load Frame

(b) View of Aqua-Pipe Failure

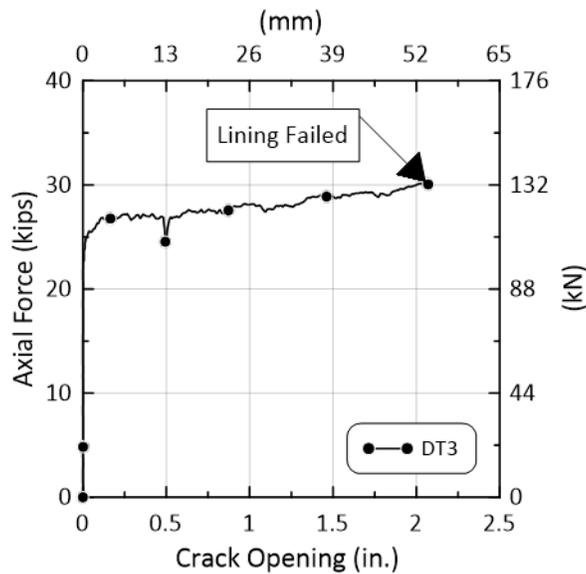
Figure 3.15. Axial Force versus Crack Opening for DT3

Figure 3.15 shows the axial force versus crack opening. The force increased until a maximum force of approximately 30 kips (133 kN) was reached and the Aqua-Pipe lining failed at approximately 2 in. (51 mm) of crack opening. The stress at failure in DT3 was 10.7 ksi (74 MPa). This failure stress agrees with the findings of the tensile coupon tests, which show an average failure stress in the warp direction of 10.9 ksi (75 MPa).

the maximum range of the string pot was exceeded, and further crack opening was measured by the actuator.

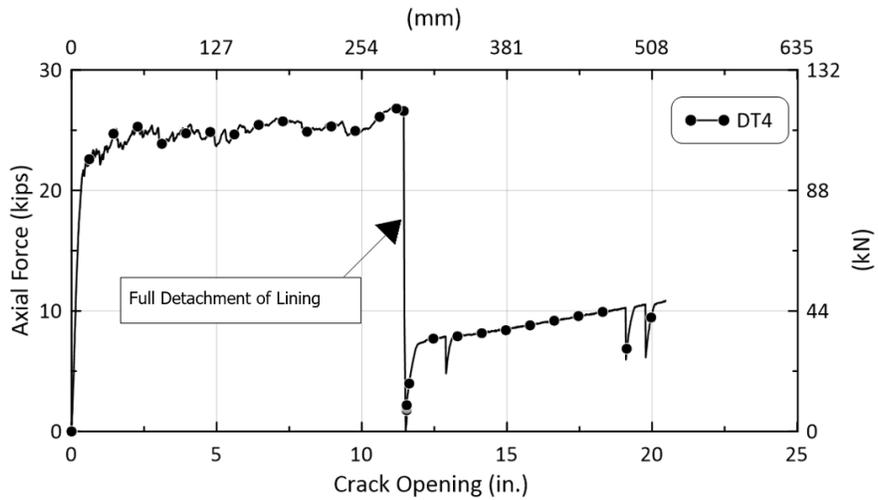
Figure 3.16. Axial Force versus Displacement for DT4 during Debonding

Figure 3.16 shows the axial force versus crack opening until 20 in. (508 mm) of movement. The gap opening was caused by displacement of the north pipe section relative to the lining. Thus, the gap opening is equivalent to the axial displacement of the north pipe.

The force increased rapidly followed by a relatively constant load until a peak load of 26.9 kips (120 kN). At about 12 in. (305 mm) of gap opening, the lining detached from the pipe south end, and the load dropped rapidly. With further crack opening the axial force began to increase.

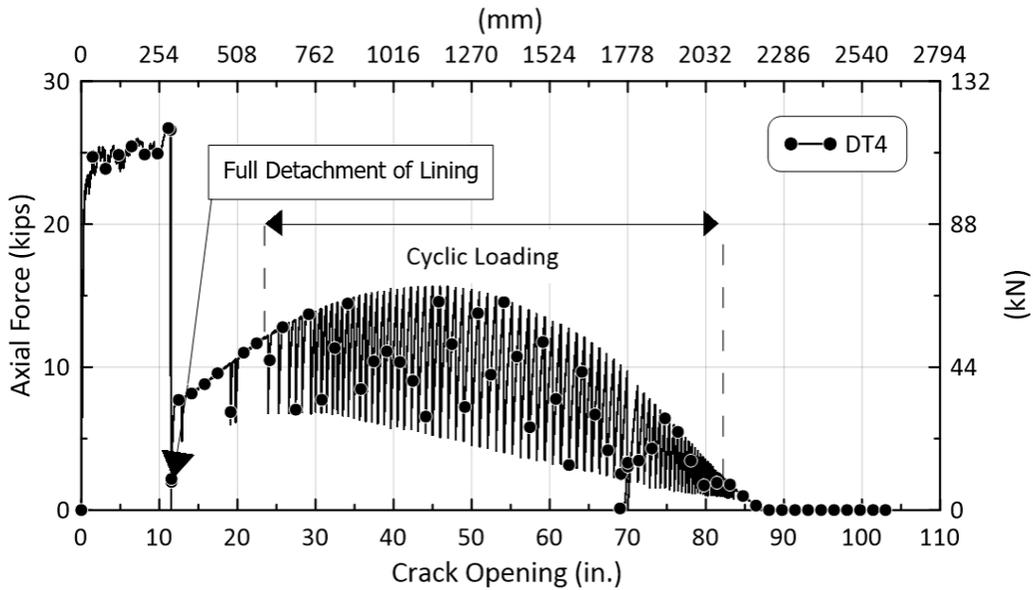
Figure 3.17. Axial Force versus Displacement for DT4 during the Full Test

Figure 3.17 shows the axial force versus crack opening until 103 in. (2616 mm) when the north pipe section was pulled completely from the lining. After the sudden drop in axial force at 12 in. (305 mm) of crack opening, the force increased steadily to a maximum force of 15.5 kips (69 kN) at about 48 in. (1219 mm) of crack opening. This increase in axial force was accompanied by a cyclic loading generated as the north section of the pipe was pulled along the lining. These cycles of axial force are shown in the force versus crack opening plot. The greatest difference between maximum and minimum load in a load cycle occurred when the maximum force of 15.5 kips (69 kN) was measured at 48 in. (1219 mm) of gap opening.
