# Performance Evaluation of Aqua-Pipe under Earthquake-Induced Ground Deformation

## Interim Report

Cornell University

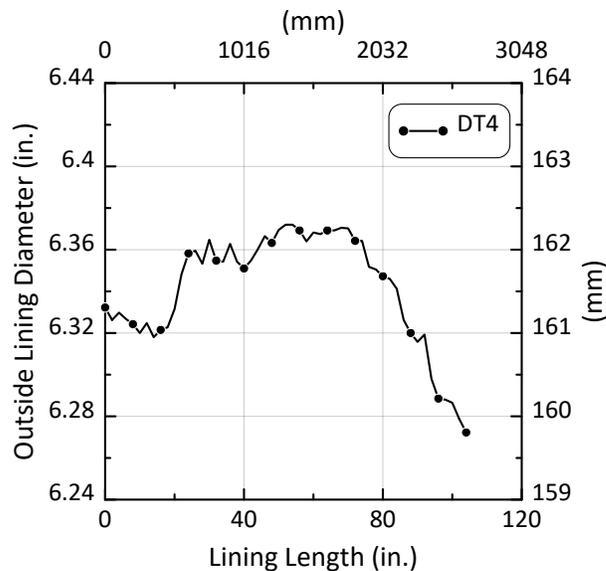
Figure 3.18. Average Outer Lining Diameter along the North Section of the DT4 Specimen

To understand the reason for the increase in cyclic as well as maximum axial force after debonding, the lining diameter was measured at various distances along the lining. Figure 3.18 shows the average outside lining diameter plotted with respect to distance along the north side of the lining that was exposed after the north section of the pipe was pulled from the lining. The diameter was

measured from the center of the specimen at 0 in. to the north end of the lining at 104 in. (2642 mm).

Because the lining was cast and cured inside the pipe, the outside lining diameter is the inside pipe diameter. As the pipe was pulled along the lining, the low-diameter end of the pipe was pulled across a lining diameter that increased until a maximum at about 48 in. (1219 mm).

Pulling a smaller diameter pipe along an increasingly larger diameter lining generated an axial load in the pipe that peaked at the location of the maximum lining diameter. After a pipe displacement along the pipe length of roughly 70 in. (1778 mm), corresponding to an opening of 70 in. (1778 mm), the lining diameter decreased rapidly, corresponding to rapidly decreasing axial force. When the end of the pipe was pulled along the lining past a lining diameter lower than that of the pipe, the axial force was rapidly approaching zero.

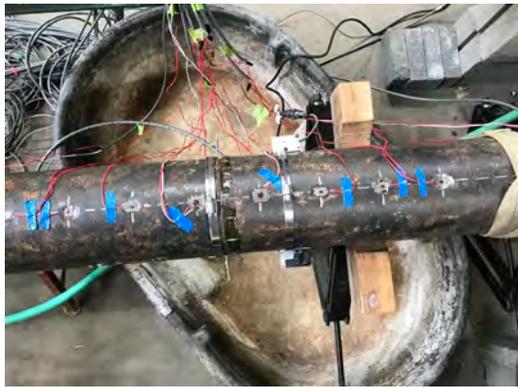
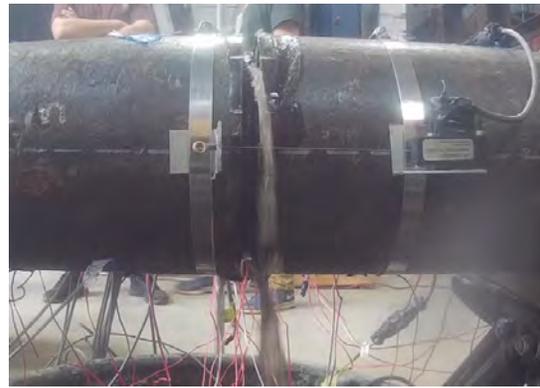
Figure 3.19. Photos of the Test Specimen before and during the First Stage of DT5

Figure 3.19. (a) and (b) show photographs of the DT5 test specimen. Figure 3. (a) shows the pipe at the beginning of the test. Strain gages on the crown of the pipe and string pots along the eastern and western springlines of the pipe can be seen in the photo. Figure 3. (b) shows the leaking that occurred after approximately 0.3 in. (7.6 mm) of crack opening. The leaking was initiated when the debonding front propagated to the south end of the pipe, breaking the end seal and causing water to flow longitudinally between the pipe and lining into the gap at the center of the specimen.

(a) View of Specimen in Load Frame before Test Initiation

(b) View of Specimen Leaking after 0.3 in. (8 mm) of Crack Opening

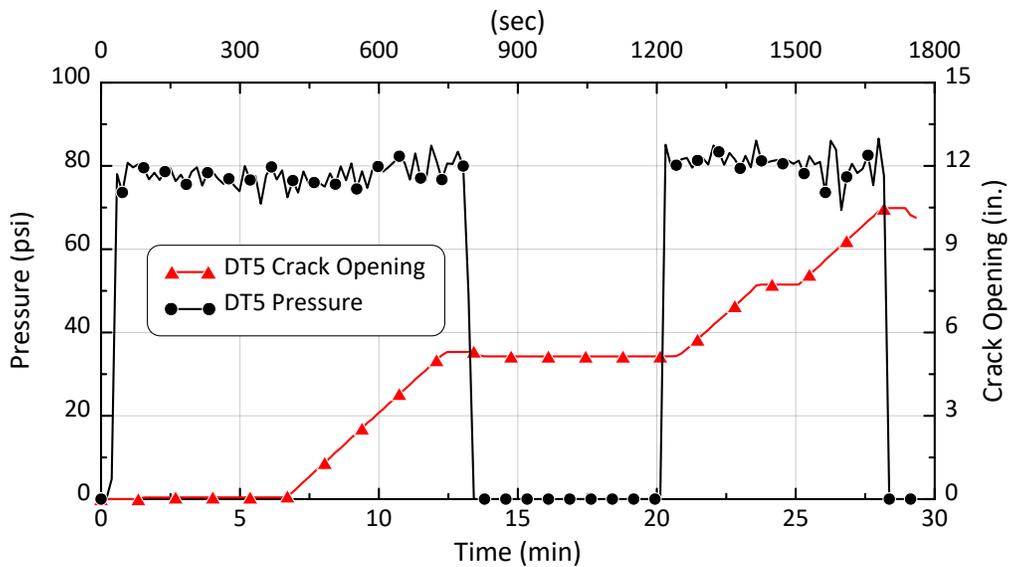
Figure 3.20. Pressure versus Time During the First Stage of DT5

Figure 3.20. shows both the internal pipe pressure and crack opening measured during the test plotted with respect to time. The test was paused from approximately 14 minutes to 20 minutes, during which time the pressure decreased to zero and the crack opening remained constant. At all other times, the pipe pressure was maintained at approximately 80 psi (551 kPa).

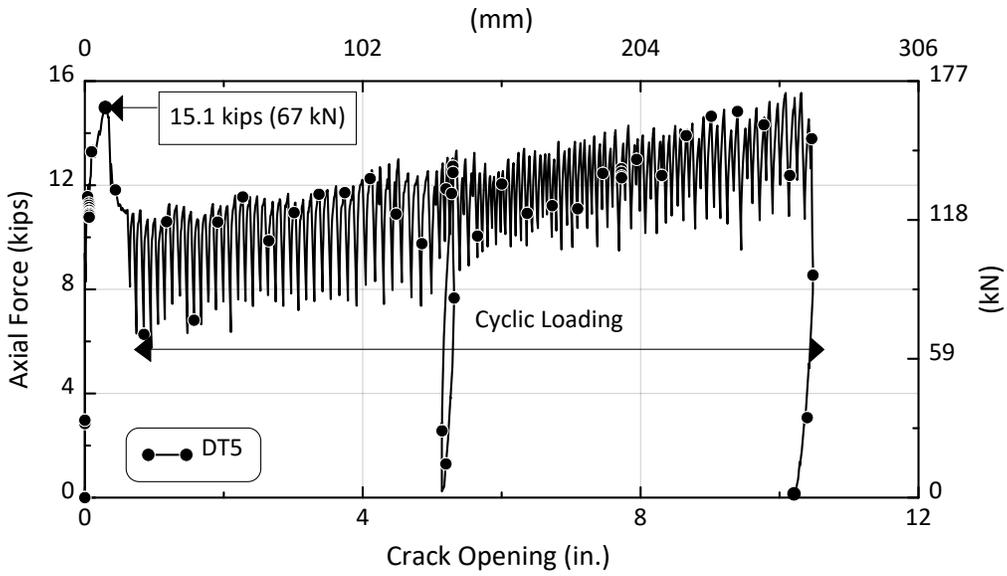
Figure 3.21. Axial Force versus Crack Opening During the First Stage of DT5

The gap opening was caused by displacement of the south pipe section relative to the lining. Thus, the gap opening is equivalent to the axial displacement of the south pipe. Figure 3.21. shows the axial force versus crack opening during debonding of the DI pipe from the Aqua-Pipe lining.

At 0.35 in. (9 mm) of crack opening and an axial force of 15.1 kips (67 kN), the pipe debonded to the south, causing a significant drop in axial force to 6 kips (26.6 kN).

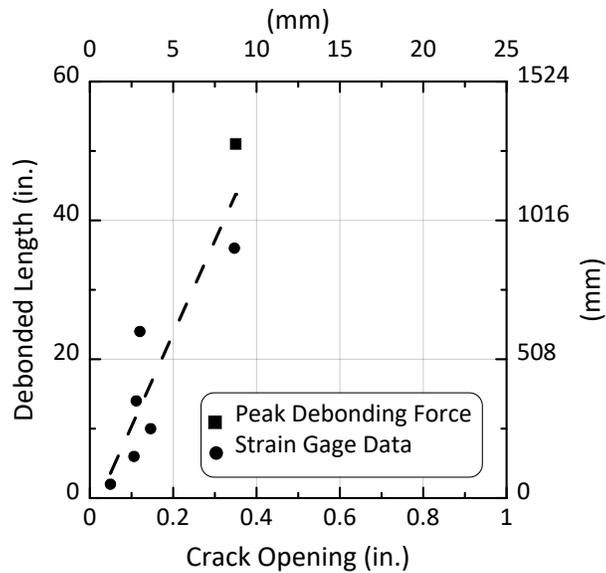
Figure 3.22. Debonding Front versus Crack Opening for DT5 Specimen

Figure 3.21. shows the debonded length estimated from the strain gage data plotted with respect to crack opening. The crack opening at the sudden drop in axial force in Figure 3.21 was correlated with the maximum debonding length of the pipe equal to 51 in. (1295 mm) and plotted in Figure 3.22. The data shows that the debonding front moved rapidly through the pipe at a crack opening of approximately 0.35 in. (8 mm).

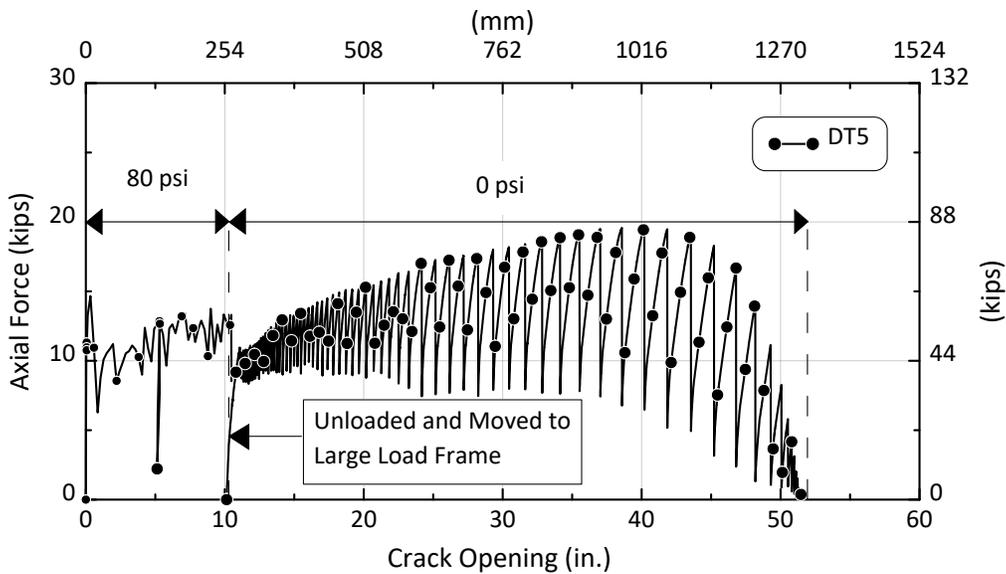
Figure 3.23. Axial Force versus Crack Opening for DT5 Specimen

Figure 3.23. shows the axial force versus crack opening throughout the entire test. The crack opening was measured using actuator displacement. After the sudden drop in axial force at 0.35 in. (9 mm) of crack opening, the force increased steadily to 13 kips (58 kN) at about 5 in. (127 mm) of crack opening. The test was interrupted at 11 in. (279 mm) of crack opening and the specimen was removed to the small load frame.

After the test resumed in the large load frame, the axial force quickly increased to 10 kips (44 kN) and continued to increase to a maximum of 19.5 kips (87 kN) at 40 in. (1016 mm) of crack opening. This increase in axial force was accompanied by cyclic loading generated as the north section of the pipe was pulled along the lining. These cycles of axial force are shown in the force versus crack opening plot. The greatest difference between maximum and minimum cyclic load occurred when a maximum force of 13.1 kips (58 kN) was measured at 40 in. (1016 mm) of gap opening.

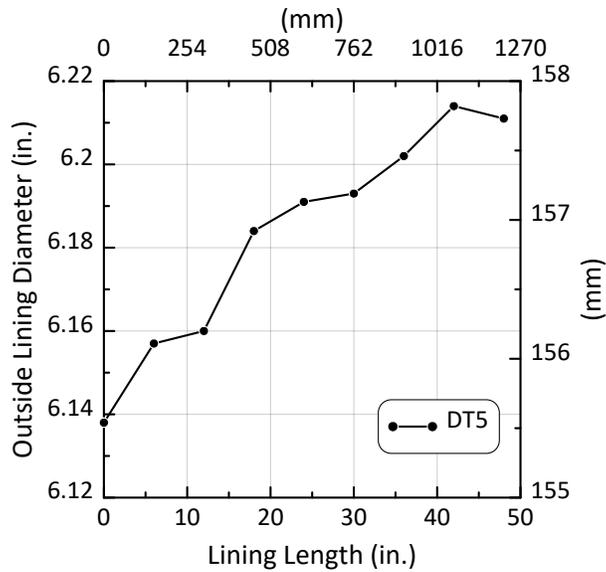
Figure 3.24. Average Outer Lining Diameter along the South Section of the DT5 Specimen

Figure 3.24. shows the average outside lining diameter plotted with respect to distance along the lining. The diameter was measured from the center of the specimen at zero to near the end of the lining at 48 in. (1219 mm). As the pipe was pulled along the lining, the smaller end of the pipe

was pulled across a lining diameter that increased until a maximum distance of 42 in. (1067 mm). Pulling a smaller diameter pipe along an increasingly larger diameter lining generated an axial load that peaked at the location of the maximum lining diameter. After a crack opening of 42 in. (1067 mm), the lining diameter decreased, corresponding to rapidly decreasing axial force.

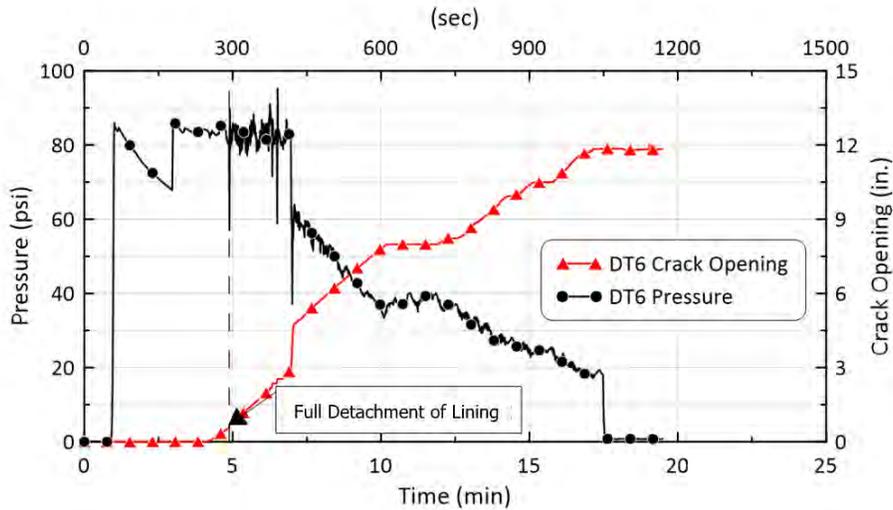
Figure 3.25. Internal Pressure versus Time for DT6 Specimen

There was substantial leaking from the beginning of the test. The leaking caused internal pressure to drop from 80 psi (551 kPa) to approximately 20 psi (138 kPa) after roughly 17 in. (432 mm)

Figure 3.25. shows the internal pressure throughout the test superimposed on the crack opening. Virtually all gap opening was caused by displacement of the north pipe section relative to the lining. Thus, the gap opening is equivalent to axial displacement of the north pipe. The pressure was maintained at approximately 80 psi (550 kPa) until approximately 5 minutes into the test. At that time, pressure decreased due to extensive leaking. The leaking was caused by loss of seal at the end of the specimen, and continued until the test was completed at approximately 17 in. (432 mm) of crack opening.

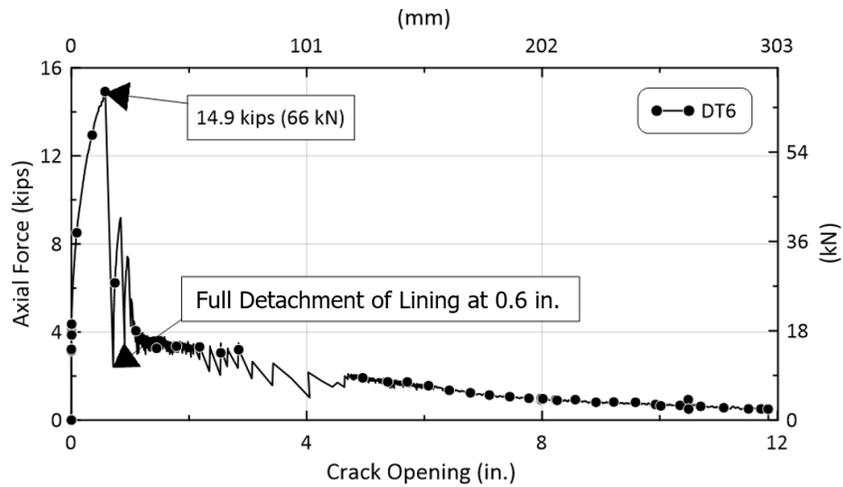
Figure 3.26. Axial Force versus Crack Opening for DT6 Specimen

Figure 3.26. shows the axial force versus crack opening. The maximum axial force was 14.9 kips (66 kN). The strain gage data were used to estimate how the debonded length increased with crack opening in a manner similar to that applied for DT2, DT4, and DT5. The strain gage data and pressure show full debonding along the north section of pipe at 0.6 in. (15 mm) of crack opening. As the Aqua-Pipe lining fully debonded from the DI pipe, the axial force decreased to approximately 3 kips (13 kN).

Figure 3.26. shows that, after detachment, the axial force continued to decrease with increasing crack opening. Following the procedures developed for DT2 and DT4 through DT6, the average

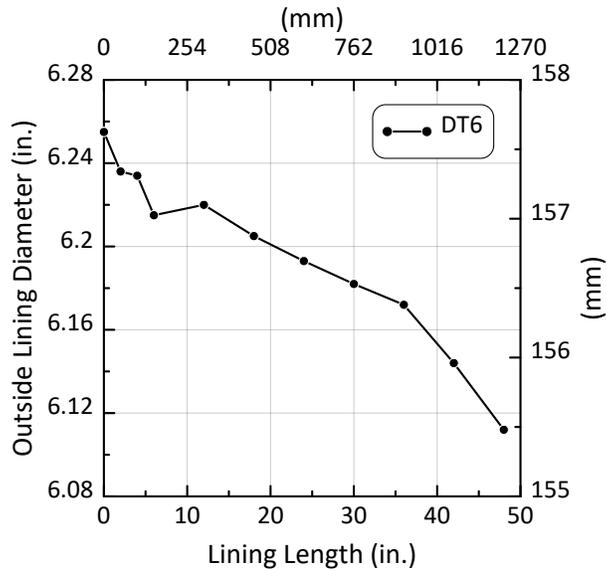
Figure 3.27. Average Outer Lining Diameter along the South Section of DT6

outside diameter of the lining was measured and plotted along the length of the lining. The diameter was measured from the center of the test specimen at zero to near the end of the lining at 48 in. (1219 mm). As can be observed in Figure 3.27., the lining diameter decreases in the direction that the north pipe section was displaced across the test specimen. Thus, a larger pipe section diameter was pulled across a progressively smaller lining diameter, resulting in decreasing axial load similar to the response of DT2.

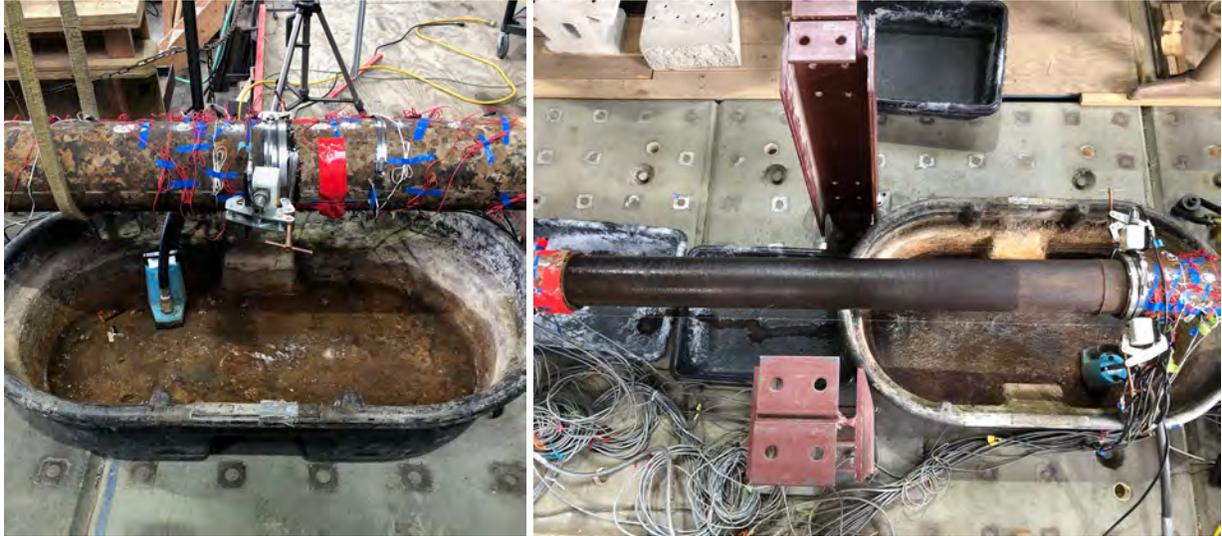
Figure 3.28. DT7 Test Specimen before and after Direct Tension Test

Figure 3.28. (a) and (b) show photographs of the DT7 test specimen. The test specimen has visible rust and pitting typical of a field specimen. Figure 3.28. (a) shows the pipe at the beginning of the test. Figure 3.28. (b) shows the specimen at the end of the test, including displacement in both the north and south directions from the initial crack location. During this test, the Aqua-Pipe lining debonded completely to the north, and then the north CI pipe was pulled over the Aqua-Pipe lining to remove it from the lining.

(a) Specimen in Load Frame before Test      (b) Specimen at the End of Direct Tension Test

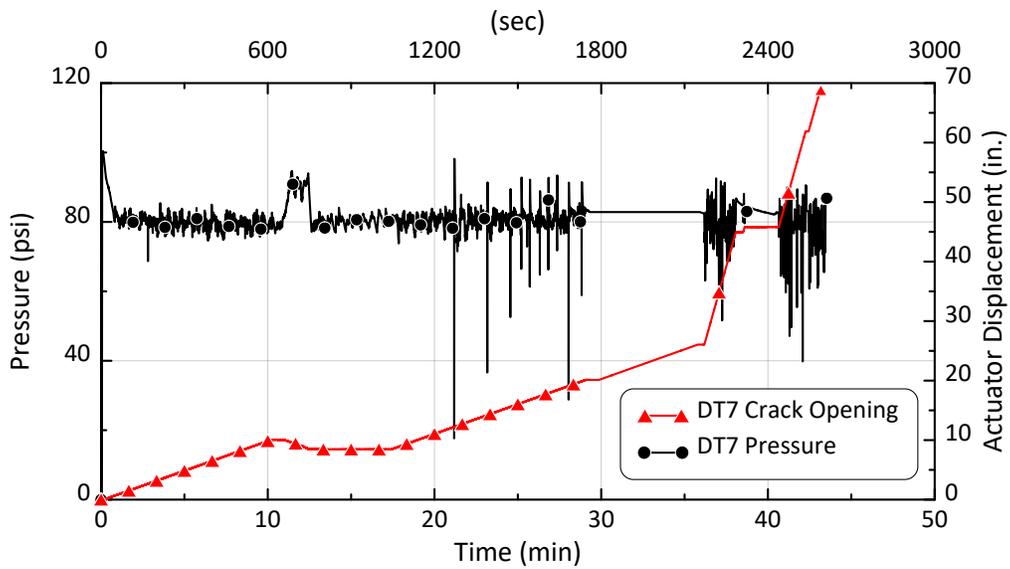
Figure 3.29. Pressure and Actuator Displacement versus Time for DT7

Figure 3.29. shows a plot of internal pipe pressure versus actuator displacement. Throughout the test, the pipe pressure was maintained with some fluctuation at 80 psi (551 kPa). This test differed from DT5 and DT6 where the pipe was pulled from the lining under diminished or near zero pressure. In DT7, axial movement of the pipe relative to the lining occurred under 80 psi (551 kPa) for the entire test.

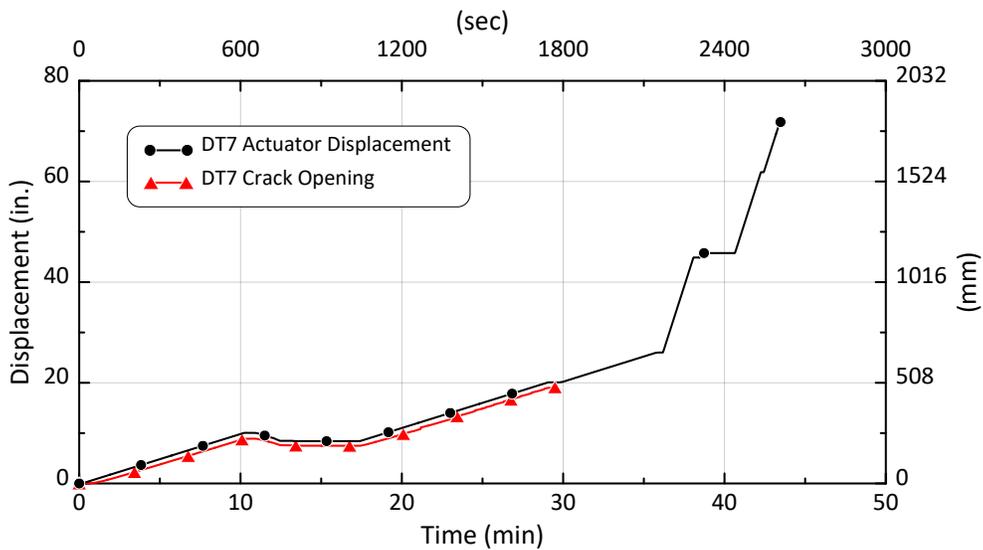
Figure 3.30. Actuator Displacement and Crack Opening versus Time for DT7

Figure 3.30. shows the actuator displacement and crack opening versus time. They recorded similar displacements until 30 minutes into the test, at which point the string pots reached their maximum travel. During the test, most of the crack opening developed as a result of the north section of the pipe debonding from the lining. Some debonding, however, occurred in the south

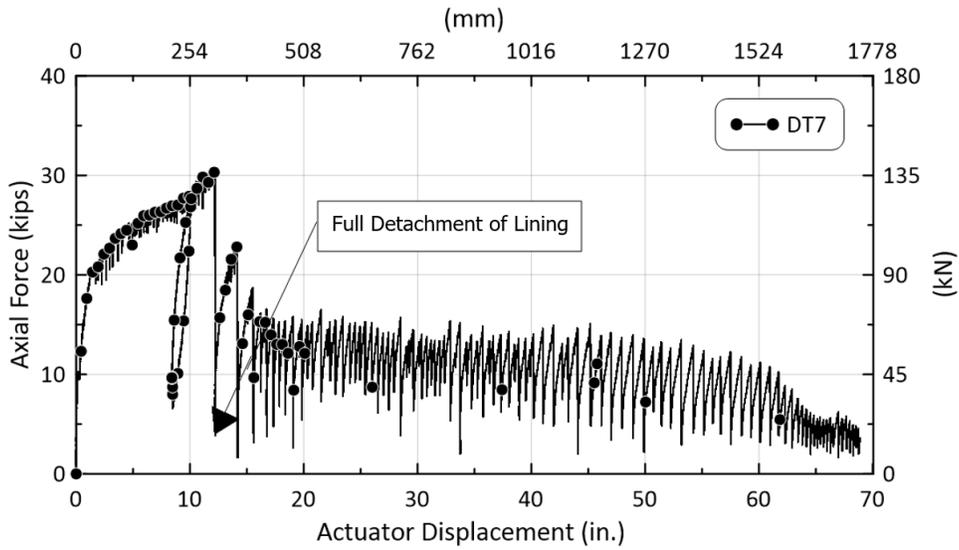
Figure 3.31. Axial Force versus Actuator Displacement for DT7

Figure 3.31. shows the axial force versus actuator displacement. The north pipe section debonded from the lining. At approximately 12 in. (305 mm) of actuator displacement, the lining detached from the end of the north pipe. The force rapidly decreased to 6.5 kips (30 kN), as shown in the figure. At full debonding of the north pipe section, the north and south pipes had been pulled 9.3 in. (236 mm) and 2.7 in. (69 mm), respectively, from the lining.

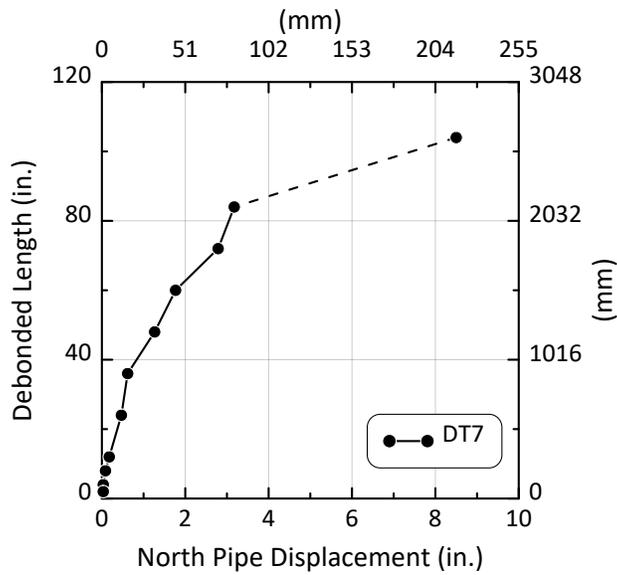
Figure 3.32. Debonding Length versus North Pipe Displacement for DT7

pipe section displacement from the actuator displacement. As shown in Figure 3.32., the debonding front propagated rapidly through the north section of pipe to 84 in. (2134 mm) at a north pipe displacement of 3.2 in. (81 mm). The increase in debonding length after 84 in. (2134 mm) is

presented as a dashed line to indicate that there is uncertainty about the relationship between debonded length and north pipe section displacement from 84 to 104 in. (2134 to 2642 mm).

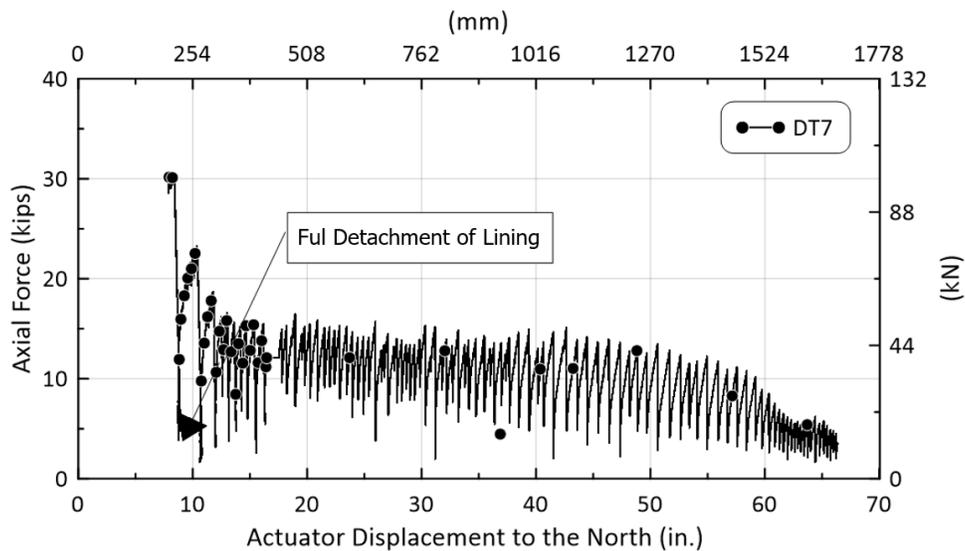
Figure 3.33. Axial Force versus North Pipe Displacement after Debonding for DT7

The actuator displacement was corrected to provide only the axial movement of the north pipe section after completion of debonding. Figure 3.33. is a plot of the axial force with respect to displacement of the north section of pipe after debonding occurred. After debonding there was no additional south pipe displacement and the maximum axial force remained around 14 kips (62 kN) until approximately 41 in. (1041 mm) of north pipe displacement. Then the maximum axial force decreased until a north pipe displacement of 66 in. (1676 mm).

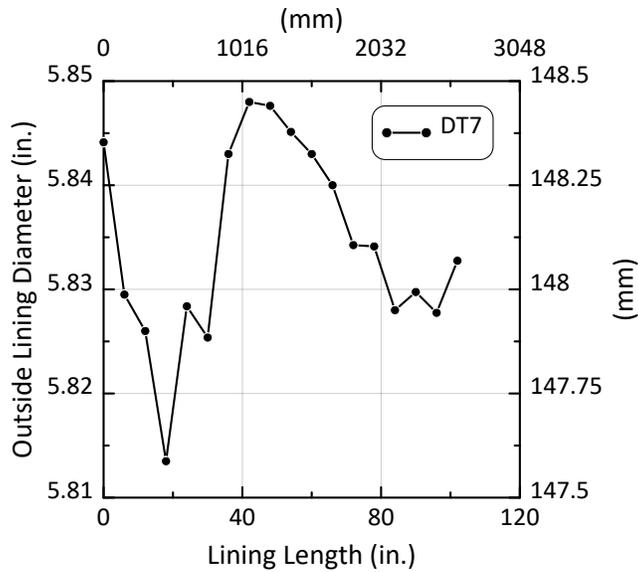
Figure 3.34. Average Diameter versus North Pipe Section Length for the DT7 Specimen

Following the procedures developed for DT2, DT4, DT5, and DT6, the average outside diameter of the lining was measured and plotted along the length of the lining as shown in Figure 3.34. The diameter was measured from the center of the test specimen at zero to near the end of the lining at 102 in. (2591 mm). At approximately 42 in. (1067 mm) from the center, the lining diameter peaks and begins to decrease. After a pipe displacement of 42 in. (1067 mm), a larger pipe diameter section moved over a lining with progressively smaller diameters. This agrees with the decrease in axial force after 41 in. (1041 mm) of north pipe displacement seen in Figure 3.31.

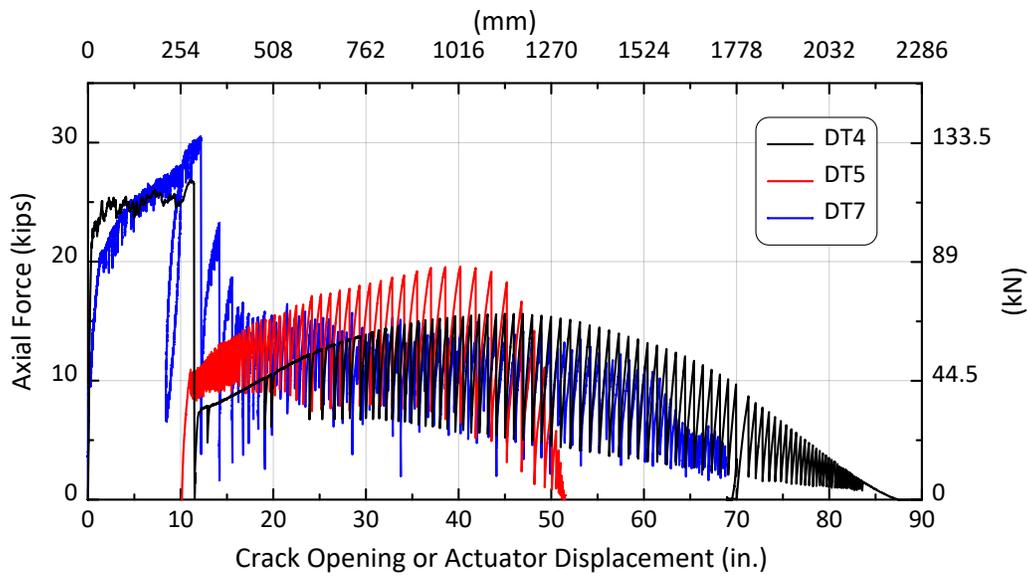
Figure 3.35. Axial Force versus Crack Opening or Actuator Displacement for DT4, DT5, and DT7

Figure 3.35. compares the axial force versus displacement plots of DT4, DT5, and DT7. Increasing axial loads were accompanied by tension-induced reductions in lining diameter that caused the lining to lurch forward until firm contact with the pipe was reinstated. Subsequent axial movement was accompanied by increased axial load until the next load cycle was initiated. During each load cycle, there was an audible pop or boom that accompanied the abrupt relative displacement between the lining and the pipe.

The test results show a complex interaction involving the pipe and lining geometry, friction between the lining and pipe, and internal pressure. After debonding, DT4 and DT5 were performed at zero internal pressure. The highest maximum force after debonding was recorded in DT5. A larger change in pipe and lining diameter over distance was measured in DT5 than in DT4. DT7

was performed with the smallest change in pipe and lining diameter over distance. Although DT7 was performed under a pressure of 80 psi (551 kPa), it nonetheless shows the lowest axial load after debonding, which is apparently related to a smaller change of diameter over distance compared with that of the DT4 and DT5 specimens.

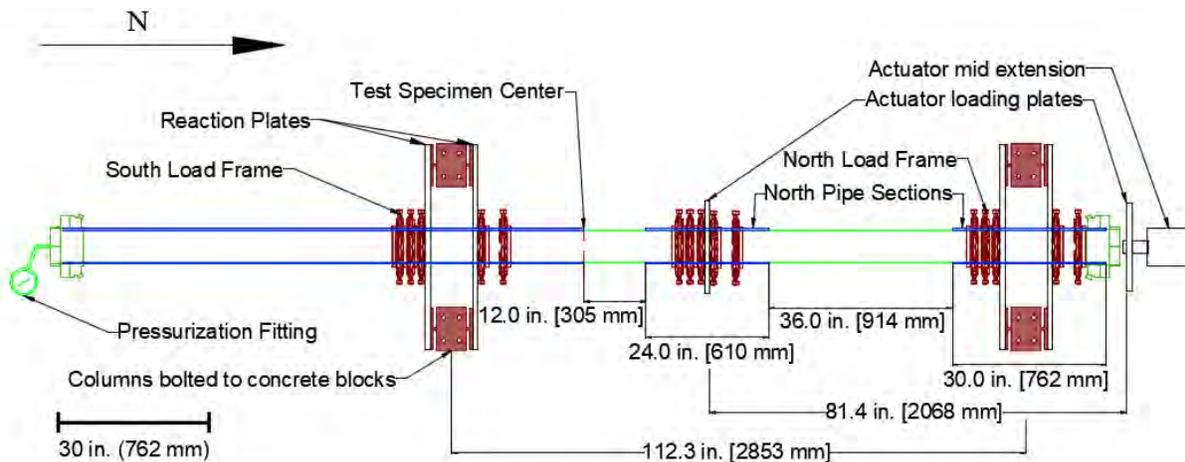
Figure 4.1. Plan View of Friction Test Setup

A plan view of the friction test setup is presented in Figure 4.1., and photographs of the setup are provided in Figure 4.2. and Figure 4.3. Two load frames, consisting of steel plates attached to steel columns bolted to concrete bearing blocks, were separated by 112.3 in. (2853 mm) center to center. The load frames supported and anchored the test pipes and Aqua-Pipe lining. Figure 4.2. shows the test setup with the north and south load frames. Due to the high cyclic loads experienced during friction tests at relatively high internal lining pressure, the north and south load frames were stiffened and strengthened by inclined chains that were tensioned to resist axial loads developed on the 24-in. (610 mm)-long section of pipe as it was pulled in a northward direction along the lining.

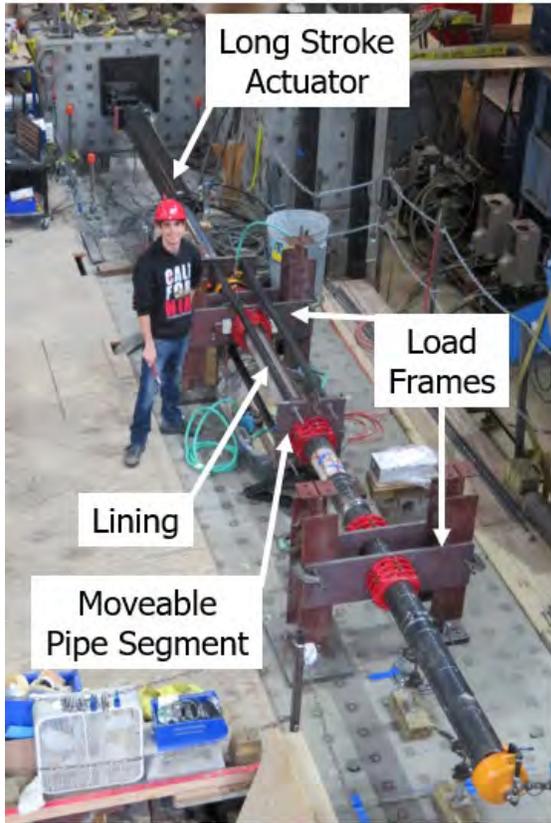
Figure 4.2. Photograph of Friction Test Setup (Facing North)

The friction tests were performed after DT4 was completed. To set up for testing, the north section of pipe was pulled from the Aqua-Pipe lining. The 102-in. (2591 mm)-long south section of the DT4 pipe and lining was fixed to the south load frame by means of restraining collars clamped to the pipes on either side of the load frame. This arrangement is shown in the left side of Figure 4.1. The north load frame is located on the right (north) side of Figure 4.1. A 30-in. (762 mm)-long section of pipe and lining was fixed to the north load frame by restraining collars as shown in Figure 4.1. A 24-in. (610 mm)-long section of pipe was pulled from the south side of the exposed lining to the north load frame by means of steel rods connected to the restraining collars that were, in turn, attached to the mobile length of steel pipe. The steel rods were attached to the long stroke actuator on the north side of the north load frame. Although the full actuator and steel rods are not shown in Figure 4.1., they can be seen in Figure 4.2 .and Figure 4.3.

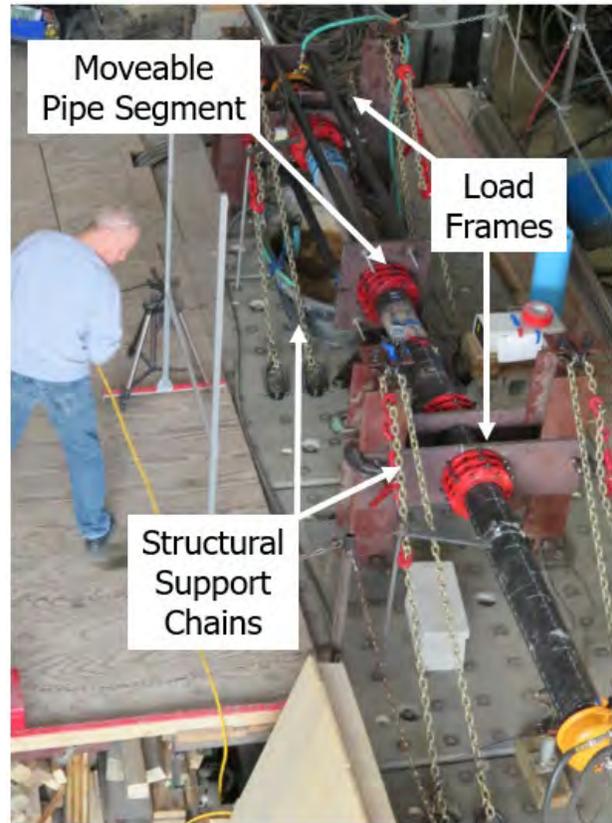
Figure 4.3. Photograph of Friction Test Setup with Structural Support Chains (Facing North)

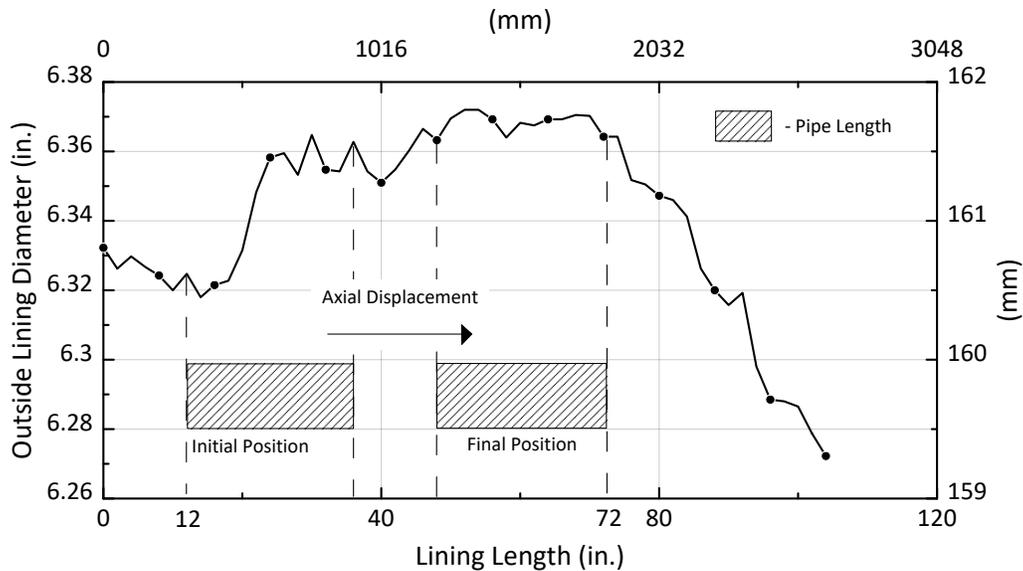
Figure 4.4. DT4 Specimen Outside Lining Diameter versus Lining Length

Each friction test was performed from an initial position where the leading side of the 24-in. (610 mm)-long section of pipe was located 36 in. (914 mm) north of the DT4 specimen center. The pipe was then pulled along the lining 36 in. (914 mm) until contact with the north section of pipe. The moveable pipe section was then reset by pushing it under zero lining pressure back to its initial position. Figure 4.4. shows the movement of the 24-in. (610 mm)-long pipe section on the plot of the DT4 lining diameter versus distance along the lining. As the pipe was pulled in the northward direction, it moved onto a lining that increased in diameter from 6.318 in. (160.5 mm) to 6.372 in. (161.9 mm) as shown in the figure.

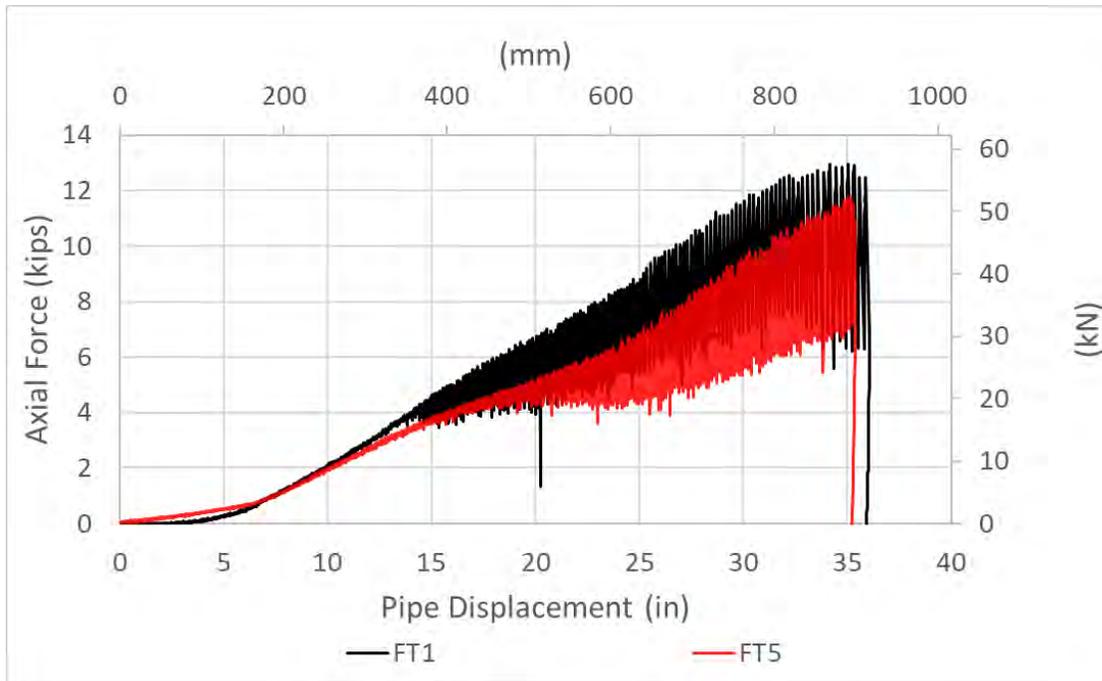
Figure 4.5. Axial Force versus Pipe Displacement for the Initial Friction Test (FT1) and a Subsequent Friction Test (FT5)

Figure 4.5 presents the results of two friction tests performed under zero internal lining pressure. The axial force versus pipe displacement are shown side by side for the first friction test (FT1) and a subsequent test (FT5) performed after intervening tests. The two tests were performed under identical conditions at a displacement rate of 1 in. (25 mm) per minute. Similar to the results of DT4 and DT5, during which a section of pipe was pulled along a lining of increasing diameter, the same cyclic loading phenomenon was observed with an audible pop or boom during each cycle. The loading cycles are shown in the figure.

The reason for the higher force in FT1 is related to the roughness of the outside surface of the lining, which was more pronounced in the first test compared with subsequent tests.

To estimate the coefficient of friction representative of the initial roughness between the lining and new DI pipe, the results of FT1 and FT5 were used (see Figure 4.5). As described in Section 4 Friction Tests, these tests were performed for Aqua-Pipe lining in contact with new DI pipe. The reason for the higher axial force in FT1 is related to the increased roughness of the outside lining surface during the initial test. Both FT1 and FT5 were performed under identical conditions of zero pressure, displacement rate, displacement, and pipe/lining geometry. Assuming that the main factor contributing to the different forces was friction, one can use the ratio of the axial loads above 10 in. (252 mm) axial movement in these two tests to estimate the coefficient of friction for the FT1 lining with initially high roughness. The weighted average ratio of axial force in FT1 with respect to FT2 at identical displacements is approximately 1.25. Multiplying this ratio by  $f = 0.61$  for smooth surface conditions provides an estimate of  $f = 0.76$  for lining/pipe surfaces that are rough and irregular.

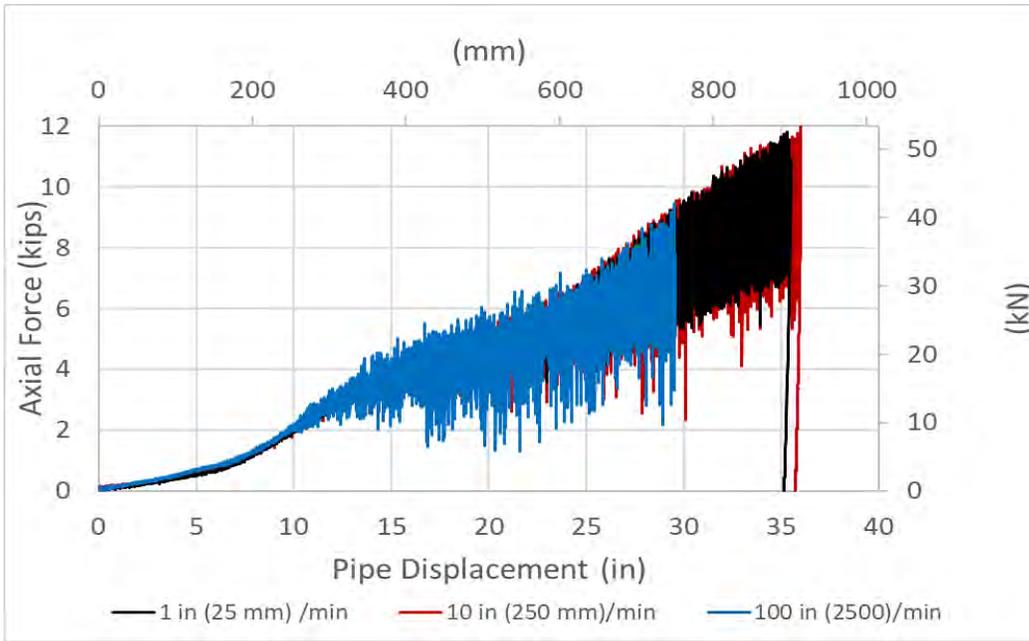
Figure 4.6. Comparison of Axial Force versus Pipe Displacement Response at Zero Pressure for Different Loading Rates

Figure 4.6 compares the axial load versus pipe displacement plots for three friction tests at zero lining pressure and three different rates of displacements of 1 in. (25 mm) per minute, 10 in. (250 mm) per minute, and 100 in. (2500 mm) per minute. The results of the three tests are nearly identical. For each test, both the maximum force and cyclic loading range follow closely the same load versus displacement relationship.

To filter dynamic effects, the load rate database of Figure 4.6 was evaluated using ten and twenty point moving averages of the data. Figure 4.7 provides a comparison of the twenty point moving average axial force versus the pipe displacement response at zero pressure for different loading rates. The results in this figure are similar to those for the ten point moving averages.

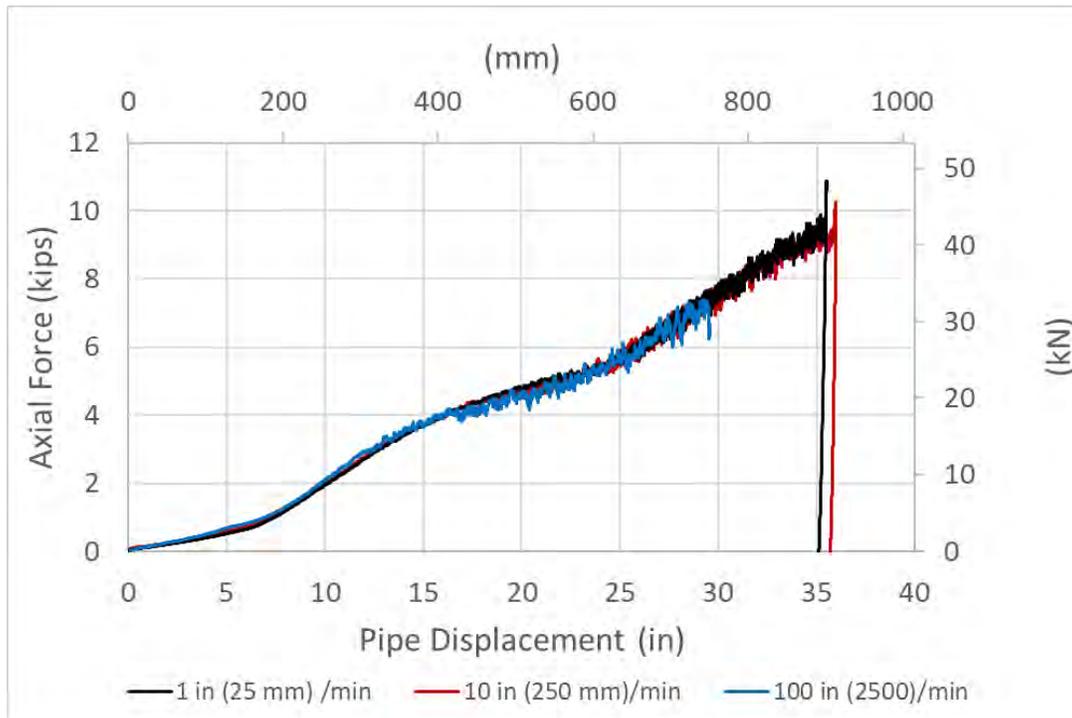
Figure 4.7 Comparison of Twenty Point Moving Average Axial Force versus Pipe Displacement Response at Zero Pressure for Different Loading Rates

These results show that axial load versus displacement performances is not influenced by the loading rate. The load response remains unchanged over two orders of magnitude in displacement rate. Showing the independence of load response to the rate of loading displacement eliminates an

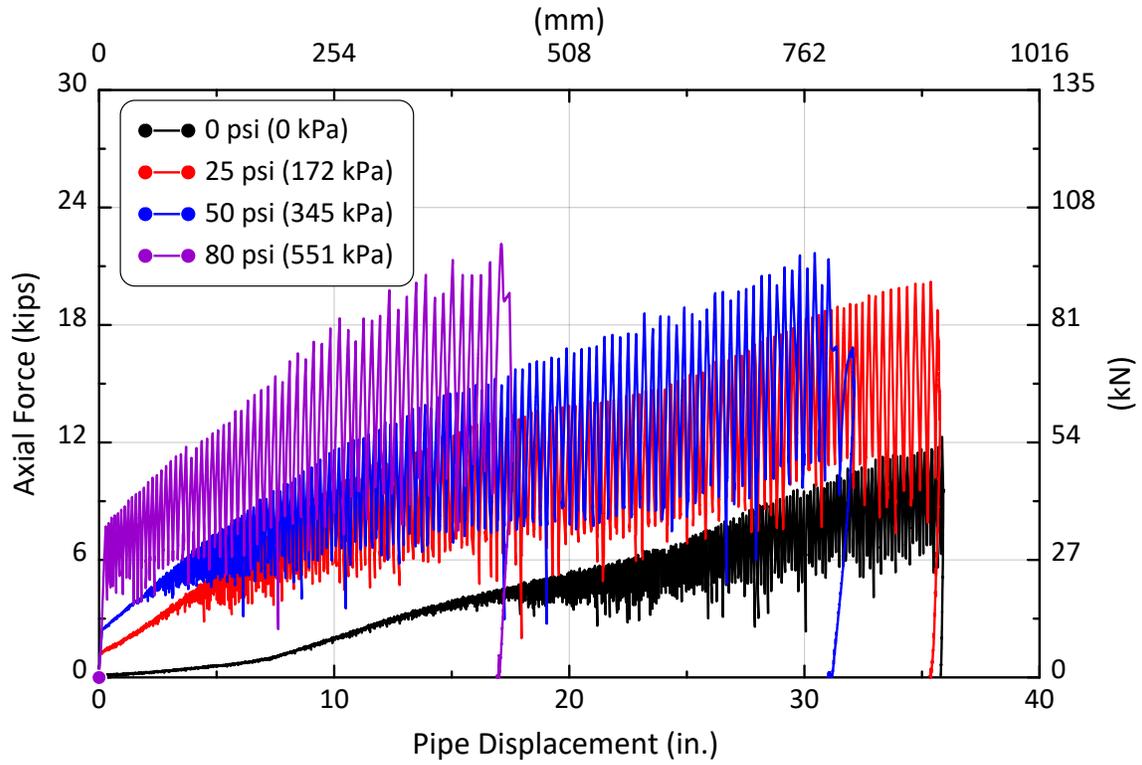
Figure 4.8. Load versus Pipe Displacement Response at Different Lining Pressures and Constant Load Rate

Figure 4.8. presents the load versus pipe displacement plots at a constant loading rate of 10 in. (250 mm) per minute for nominal lining pressures of 0 psi, 25 psi (172 kPa), 50 psi (345 kPa), and 80 psi (551 kPa). There is a marked increase in axial force with increasing internal pressure at all levels of displacement.

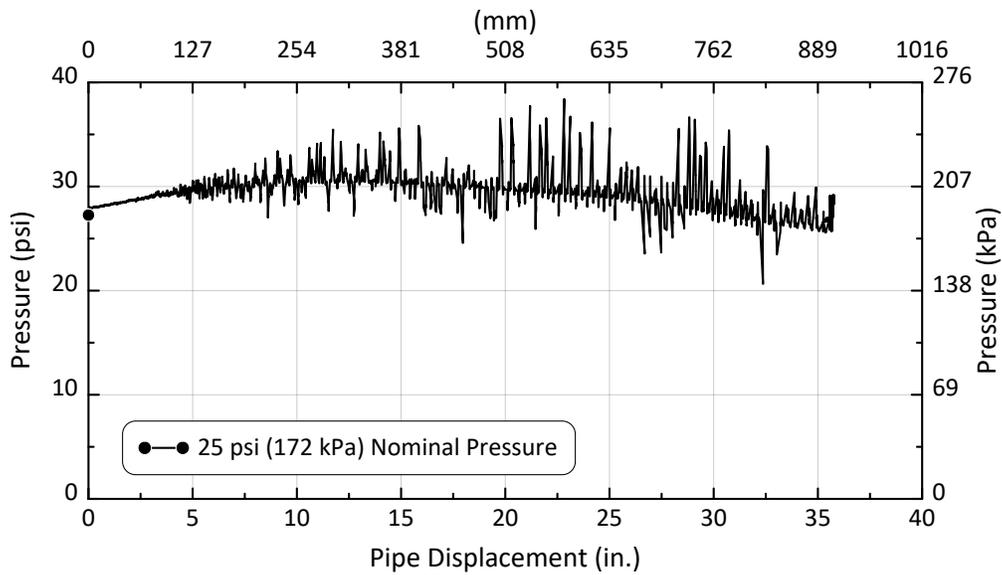
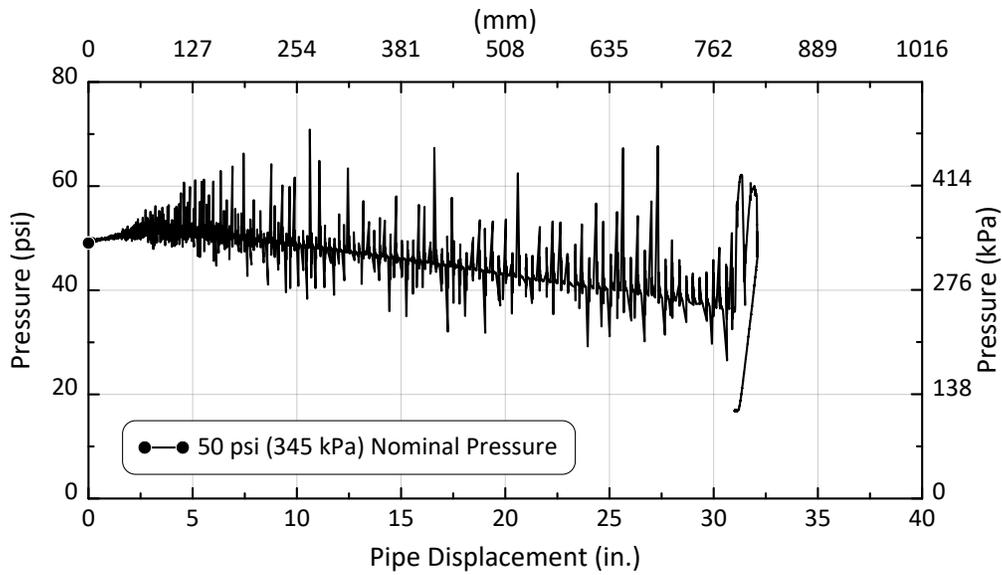
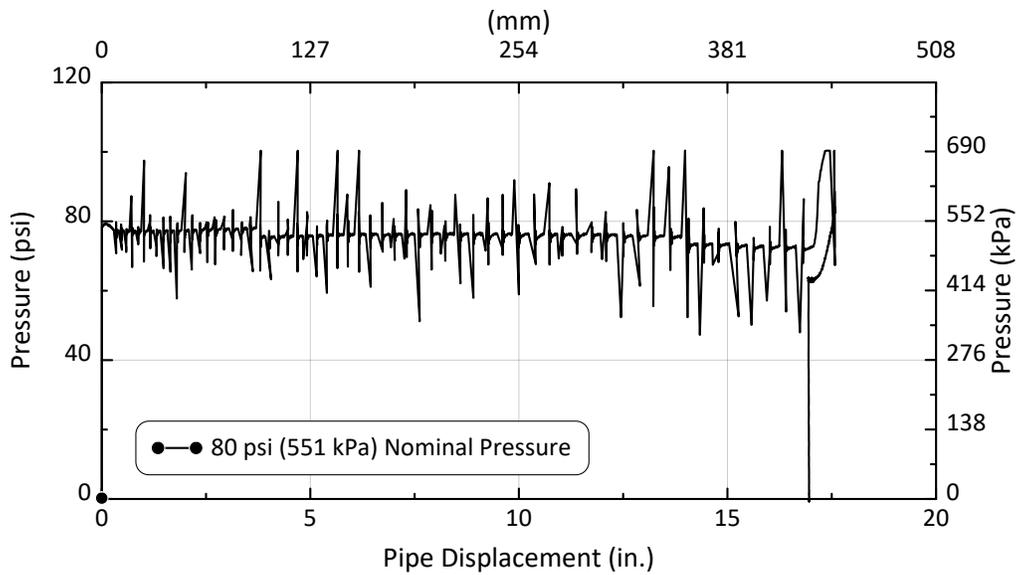
Figure 4.9. Lining Pressure versus Pipe Displacement for Nominal 25 psi (172 kPa) Pressure

Figure 4.10. Lining Pressure versus Pipe Displacement for Nominal 50 psi (345 kPa) Pressure

Figure 4.11. Lining Pressure versus Pipe Displacement for Nominal 80 psi (551 kPa) Pressure

To explore further the relationship between axial load and lining pressure, the pressures measured in each test are plotted with respect to pipe displacement in Figure 4.9. through Figure 4.11. Because of the cyclic loading and associated rapid changes in axial movement, it was difficult to maintain constant pressure. The trend in average pressures is plotted for each test, from which the pressure at any displacement can be identified and used to evaluate the relationship between peak axial load and internal lining pressure.

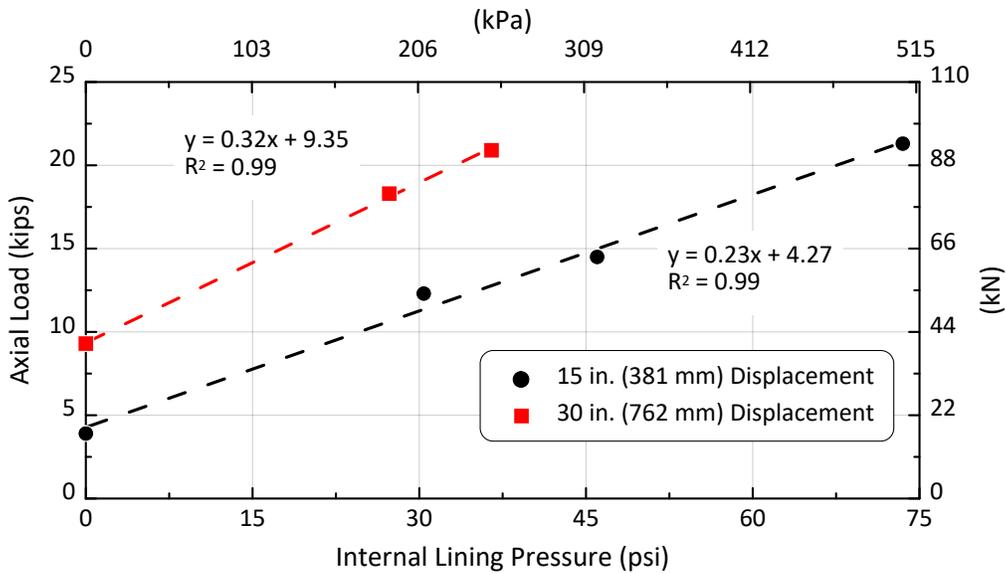
Figure 4.12. Axial Load versus Internal Lining Pressure for Different Pipe Displacements

Figure 4.12 shows the peak axial load at 15 in. (381 mm) and 30 in. (762 mm) of pipe displacement plotted with respect to the internal lining pressure, both of which can be taken from Figure 4.9 through Figure 4.11. Given that the friction conditions and variation in lining diameter remain unchanged, the peak axial load at a given displacement should increase in direct proportion to the internal lining pressure at the same displacement. This is indeed the case.

Figure 4.12 shows a linear relationship between axial load and lining pressure with similar slopes at two different levels of displacement. The linear regression analyses show very high levels of  $R^2$ , which provides statistical support for the linear relationships.

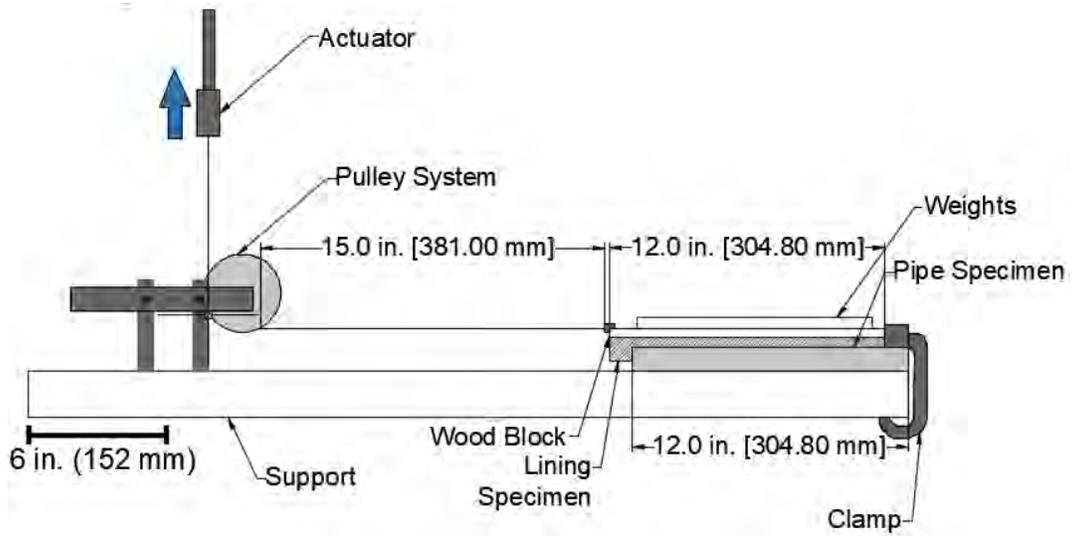
Figure 5.1. Schematic of Direct Shear Test Setup

The direct shear tests were performed on an MTS 858 Bionix Test System. Figure 5.1 shows a schematic of the direct shear test setup including an actuator, pulley system, and test specimen. Figure 5.2 shows a photo of the setup with a weight of 25 lb (0.11 kN) applied across the sliding surface. The hydraulic actuator had a stroke of 6 in. (152 mm) and a capacity of 5.5 kips (24.5 kN). The load cell had a capacity of 2.2 kips (9.8 kN).
