# Performance Evaluation of Aqua-Pipe under Earthquake-Induced Ground Deformation

## Interim Report

Cornell University

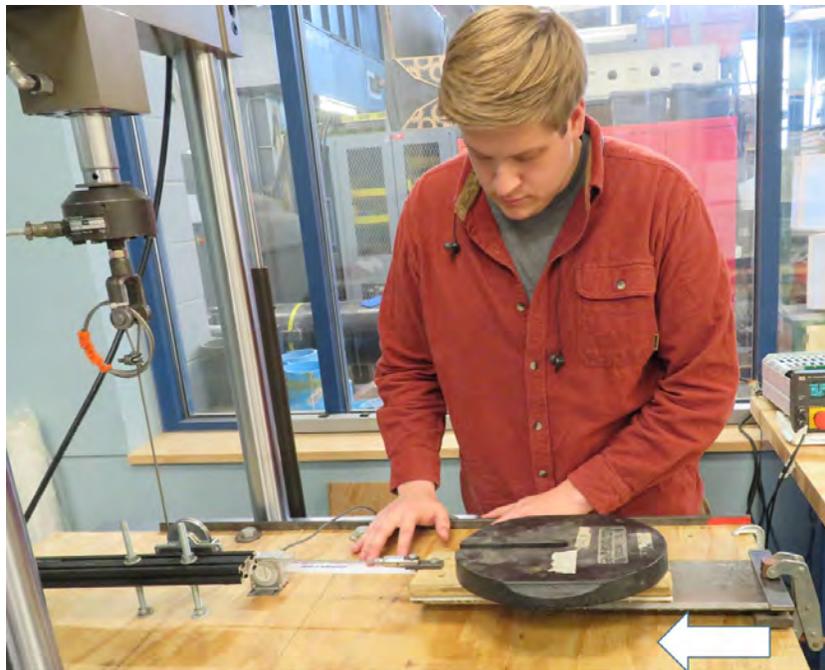
Figure 5.2. Photo of Aqua-Pipe Direct Shear Test Setup

The direct shear tests were performed on an MTS 858 Bionix Test System. Figure 5.1 shows a schematic of the direct shear test setup including an actuator, pulley system, and test specimen. Figure 5.2 shows a photo of the setup with a weight of 25 lb (0.11 kN) applied across the sliding surface. The hydraulic actuator had a stroke of 6 in. (152 mm) and a capacity of 5.5 kips (24.5 kN). The load cell had a capacity of 2.2 kips (9.8 kN).

Pipe specimens from DT1 and DT5 were used to create test specimens for the direct shear tests. A 45-degree section of the 6 in. (152 mm) diameter lined pipe was cut as shown in Figure 5.3 (a). The section was cut so that the lining was in contact with the interior pipe surface at the location where it was cured in place during installation. The lining was then separated from the host pipe as shown in Figure 5.3 (b). The lining specimen was fixed to a wooden insert that was used to convey weights of various magnitude across the lining/pipe interface, as illustrated in Figure 5.2.

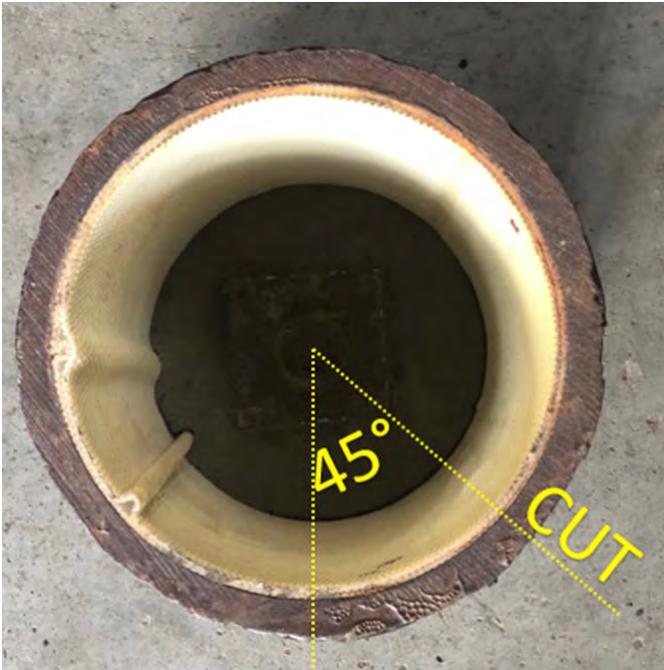
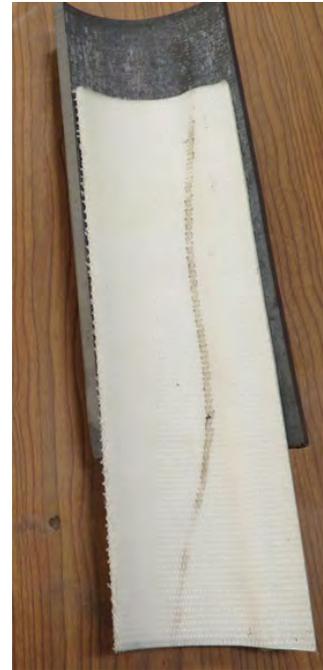
(a) Specimen before It Was Cut and the Lining and Host Pipe Separated

(b) View of Aqua-Pipe Lining and Pipe Specimen after Being Cut and Prepared

Figure 5.3. Photos of Aqua-Pipe Direct Shear Test Specimen

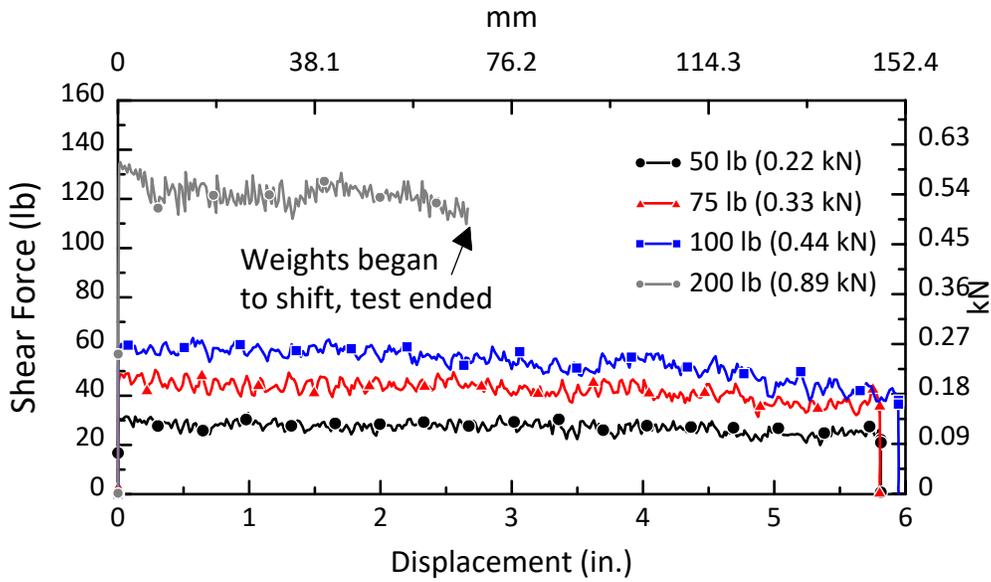
Figure 5.4. Shear Force versus Displacement for Direct Shear Tests Using New DI Pipe from DT1

Figure 5.4 and Figure 5.5 show the shear force versus displacement for the new DI pipe and field CI pipe specimens, respectively, for weights of 50 lb (0.22 kN), 75 lb (0.33 kN), 100 lb (0.44 kN), and 200 lb (0.89 kN). The weights were converted to normal force following the procedure described in Appendix A. There was an overall downward trend in the shear force as the lining slid along the host pipe, reducing the contact between the lining and pipe surface.

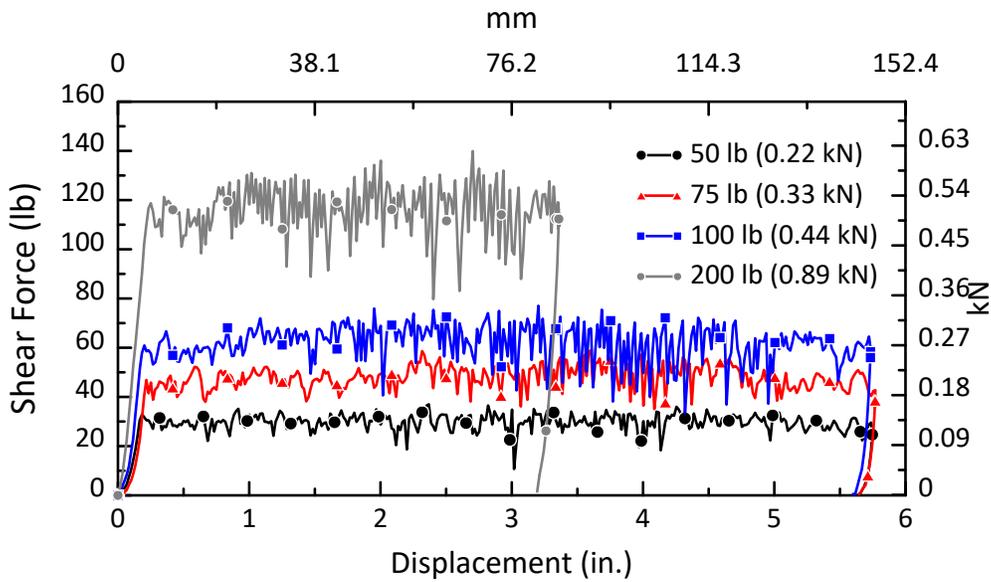
Figure 5.5. Shear Force versus Displacement for Direct Shear Tests Using Field CI Pipe from DT5

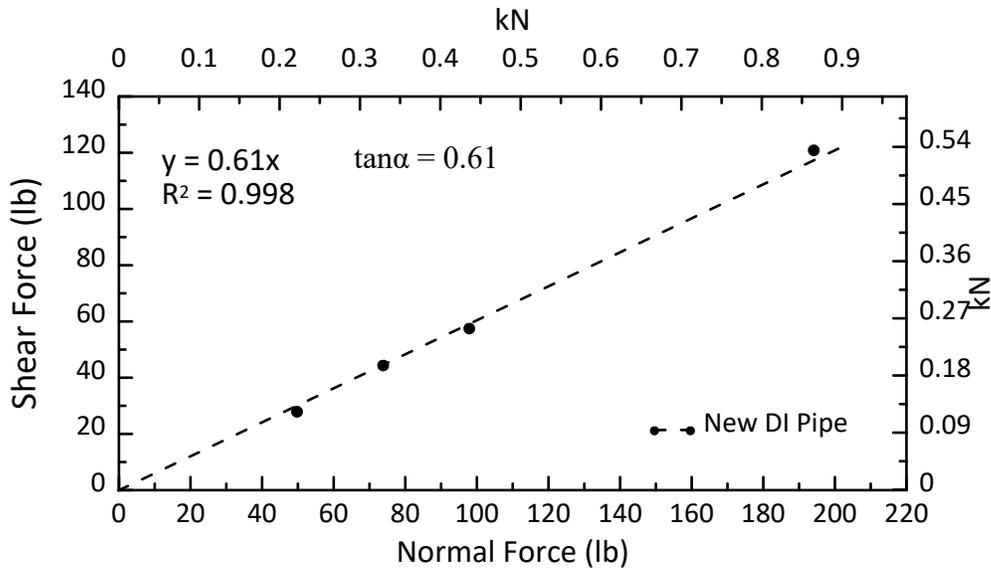
Figure 5.6. Shear Force versus Normal Force for Direct Shear Tests Using New DI Pipe from DT1

The shear force was plotted with respect to the normal force to determine the friction coefficient for each type of surface. Figure 5.6 and Figure 5.7 show linear regressions through zero of shear force versus normal force for the new DI pipe and old CI pipe specimens, respectively. The friction coefficient is the ratio of shear force to normal force, so the slope of these plots represents the friction coefficient. The friction coefficient for the lining and both the new DI pipe and field CI pipe was 0.61. Performing the direct shear tests involved repeated displacements of the lining

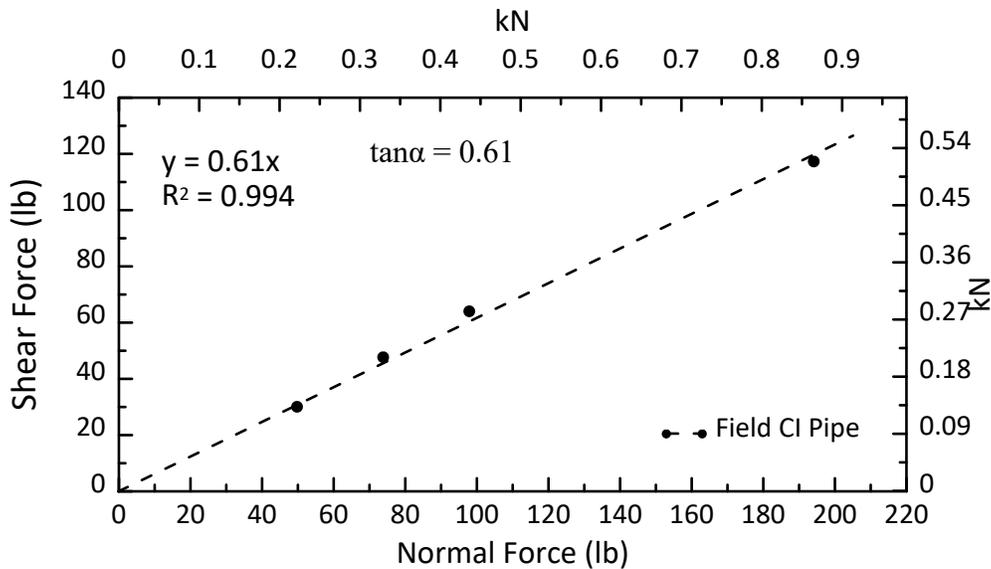
Figure 5.7. Shear Force versus Normal Force for Direct Shear Tests Using Field CI Pipe from DT5

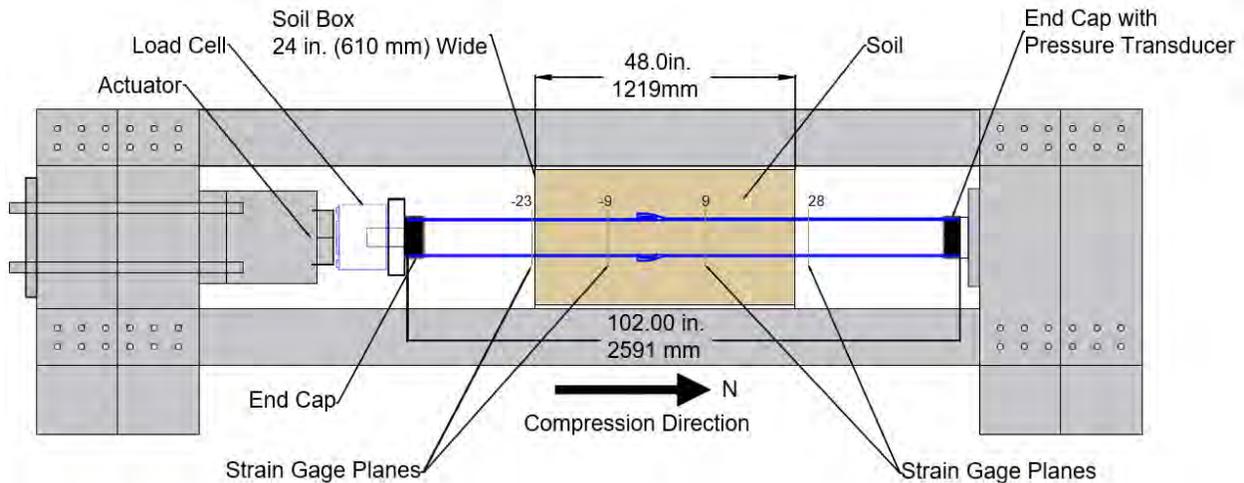
Figure 6.1. Plan View of Direct Compression Test Set Up

A plan view of the direct compression test setup is presented in Figure 6.1. Figure 6.2 and Figure 6.4 show the test specimen, load frame, and box for encapsulating the CI joint in soil to simulate underground confinement in the field. As mentioned above, jointed pipe specimens were extracted from the field by EBMUD and LADWP crews with Cornell guidance. Figure 6.3 shows the extraction of a CI jointed pipe specimen by EBMUD personnel. Field sampling, shipping, and handling were performed with great care to avoid disturbance. Each specimen was exposed in an open trench, then removed and transported with a strongback, consisting of a stiff timber section strapped to the test specimen.

As shown in Figure 6.1 and illustrated in Figure 6.2 and Figure 6.4, a plywood box, centered on the CI joint, was lowered onto the floor so that it encapsulated the center part of the specimen. The plywood was 0.75 in. (19 mm) thick. The exterior plan dimensions of the box were 48 in. (1219 mm) long and 24 in. (610 mm) wide. Soil was placed in the box so that there was 18 in. (457 mm) of soil beneath the invert of the pipe and 32 in. (810 mm) between the crown of the pipe and ground surface. A plastic sheet was placed between the box and floor to seal the base.

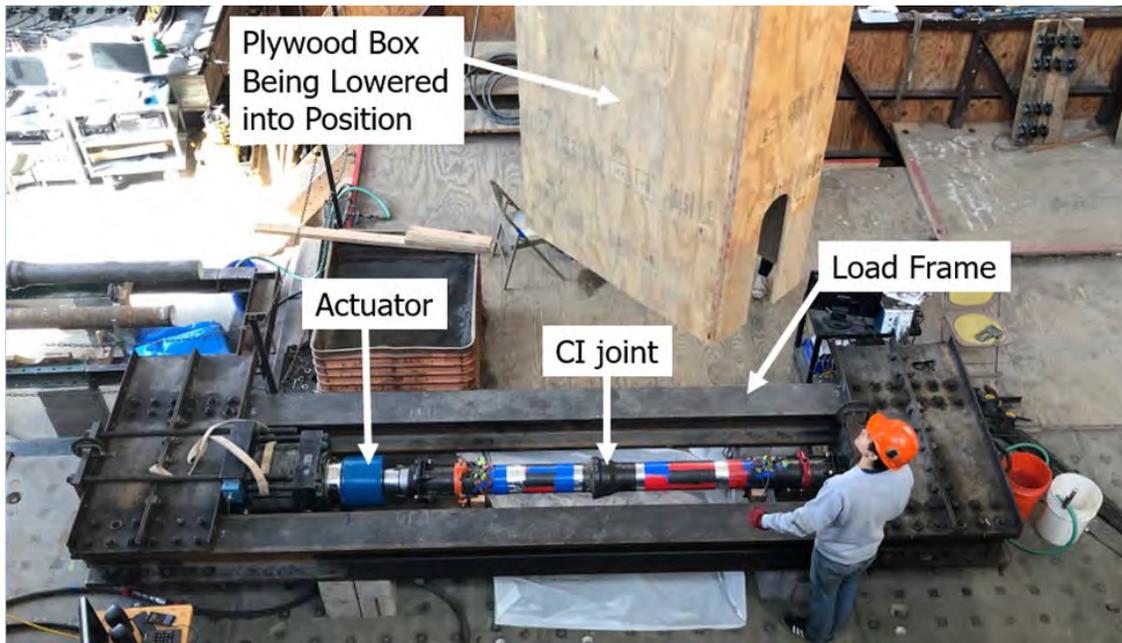
Figure 6.2. Direct Compression Jointed Pipe Specimen in Load Frame

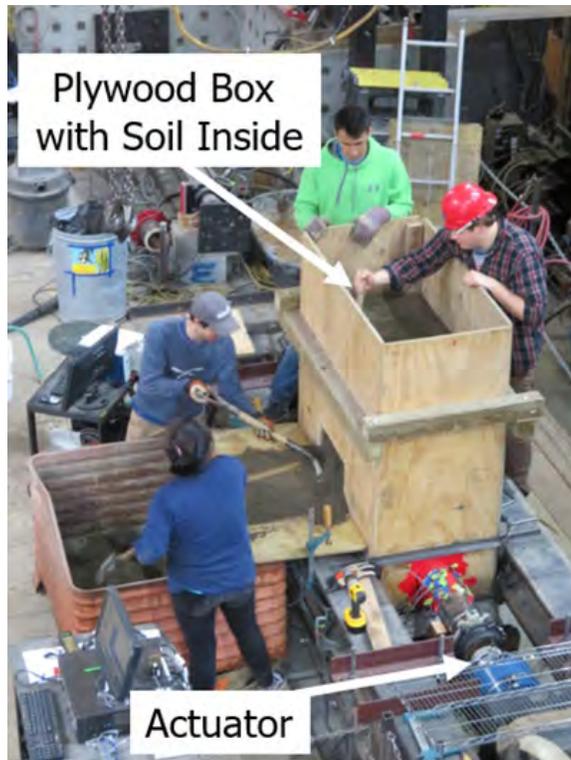
Figure 6.4. Soil Box Used in Direct Compression Tests

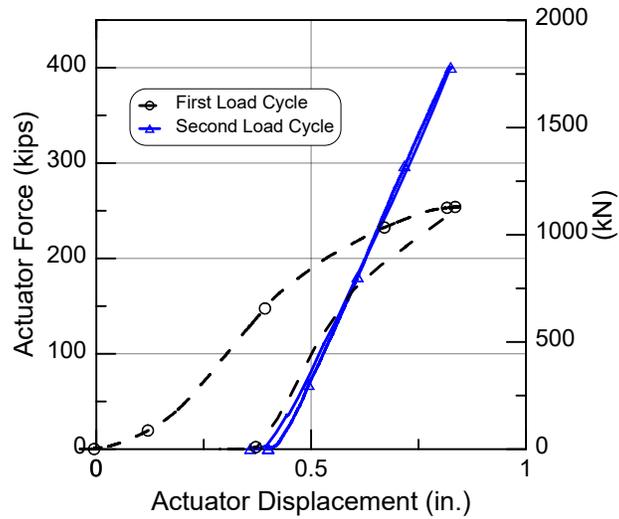
Figure 6.5. DC1 Axial Force versus Displacement

Figure 6.5 presents a plot of the actuator force (axial compressive force on pipe) versus actuator displacement (axial displacement) for the DC1 specimen provided by EBMUD. The test was performed in two load cycles. During the first load cycle there was a partial blockage in the load cell that prevented an accurate measurement of axial load. The axial displacement, however, is accurate, and shows irrecoverable deformation of approximately 0.4 in. (10 mm). This deformation is the displacement of the spigot into the bell until there was solid contact between the spigot and back of the bell.

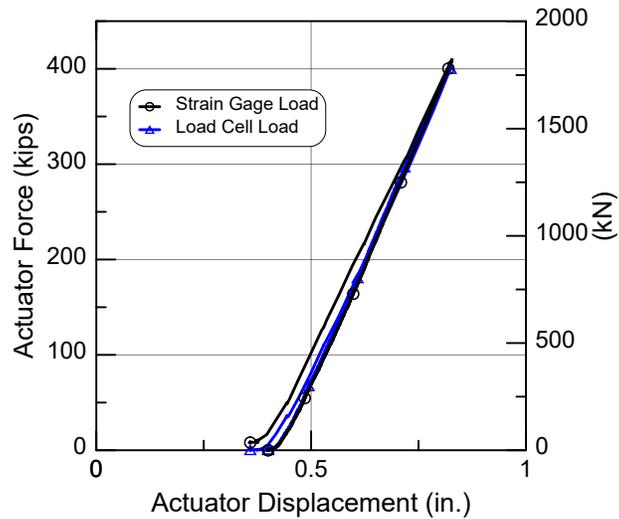
Figure 6.6. Comparison of Axial Force versus Displacement with Load Cell and Strain Gage Measurements

Figure 6.6 compares the axial load versus displacement measured by both the load cell and strain gages. The axial force,  $F_A$ , was evaluated from the strain gages using the relationship  $F_A = \epsilon_A EA$ , for which  $\epsilon_A$  is the measured axial strain,  $E$  is the Young's modulus of elasticity (17500 ksi) determined from tensile coupon tests performed on samples of the CI pipe, and  $A$  is the transverse cross-sectional area of the pipe (4.27 in<sup>2</sup>). There is excellent agreement between the load versus displacement plots from the two different measurement methods.

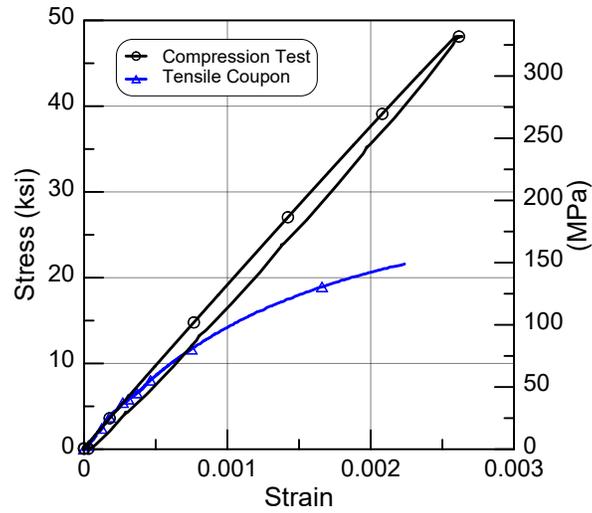
Figure 6.7. Comparison of CI Stress versus Strain Relationship from Tensile Coupon and Direct Compression Tests

The linear force versus displacement relationship and strain gage measurements at different locations around the pipe circumference indicate that the axial load was applied through concentric contact between the spigot and back of the bell. Under these circumstances the axial stress calculated as  $F_A/A$  can be plotted relative to the average axial strain to estimate the CI compressive stress versus strain relationship. This relationship is compared in Figure 6.7 with the stress versus strain relationship determined from tensile coupon tests on CI specimens cut from the test pipe. The initial Young's modulus for tension and compression are in close agreement. As expected, the compressive stress versus strain relationship remains linear to a much higher stress level than that in tension. The results from this test provide a rare opportunity to compare high quality test measurements for CI pipe in tension and compression. The resulting comparison is consistent with properties and performance of CI pipe summarized by Taki and O'Rourke (1983).

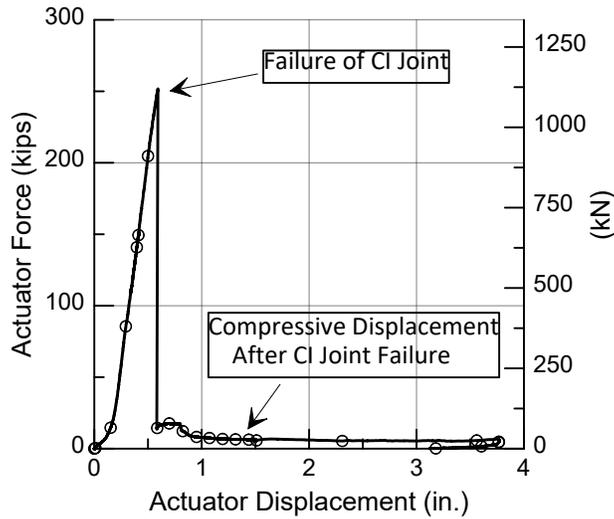
Figure 6.8. DC2 Axial Force versus Displacement Plot

The second compression test was performed on a specimen provided by EBMUD. Figure 6.8 presents a plot of the actuator force versus displacement. At about 0.10 in. (2.5 mm) of displacement, when the spigot made firm contact with the back of the bell, there was a rapid linear rise in force versus displacement to 0.59 in. (15 mm) and a load of 252 kips (1120 kN), when the CI bell fractured.

There was an immediate drop in axial load as shown in the figure. The test was paused at 1.5 in. (38 mm) of axial displacement and then continued to a total displacement of 3.8 in. (97 mm). The displacement rate was increased from 0.1 in./min. (0.25 mm/min.) to 1.0 in./min (10 mm/min.) when the test was resumed after failure of the CI bell.

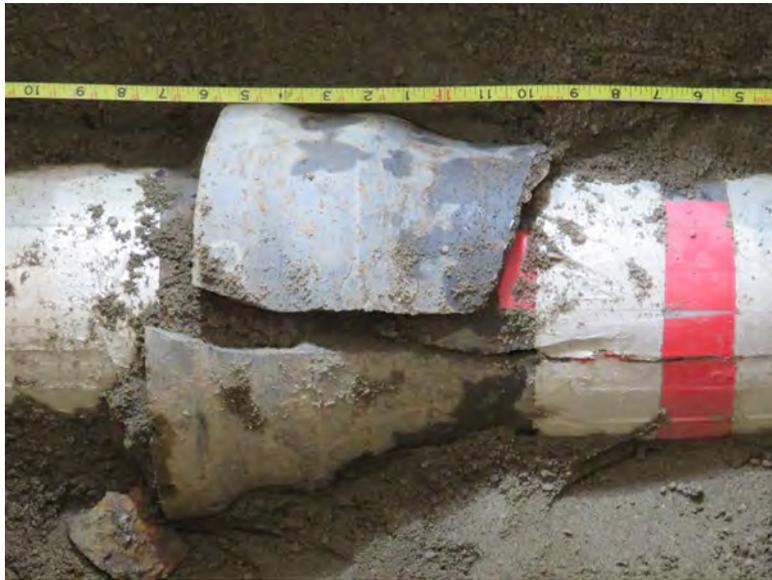
Figure 6.9. DC2 Fractured CI Bell

Soil was excavated to expose the joint. A photo of the fractured bell is provided in Figure 6.9. Portions of the fractured bell were removed from the joint to observe the lining. A close-up photo of the deformed and wrinkled lining is presented in Figure 6.10.

The test specimen was pressurized in the condition shown in Figure 6.9 and Figure 6.10 at 80 psi (552 kPa). Drips of water were observed at two locations along the wrinkled lining. A very low leakage rate of 95 mL/min. (3.2 fl. oz./min.) was measured.

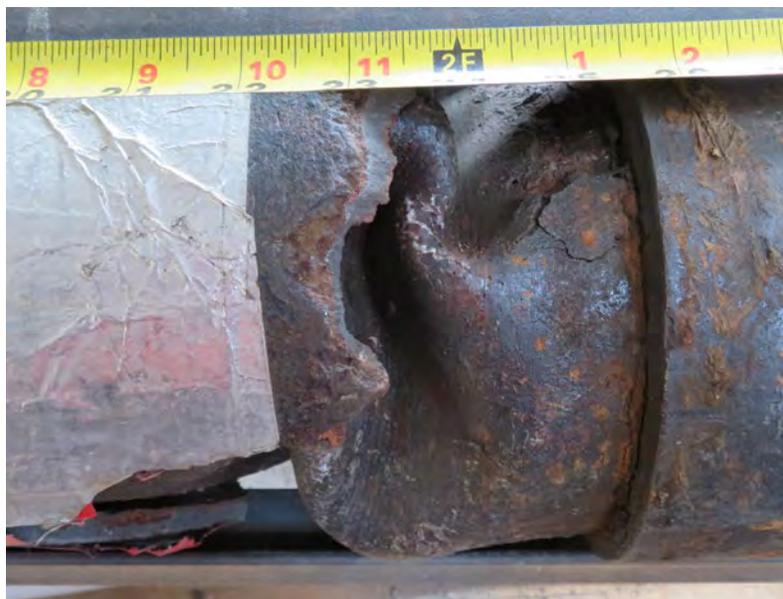
Figure 6.10. DC2 Deformed and Buckled Lining

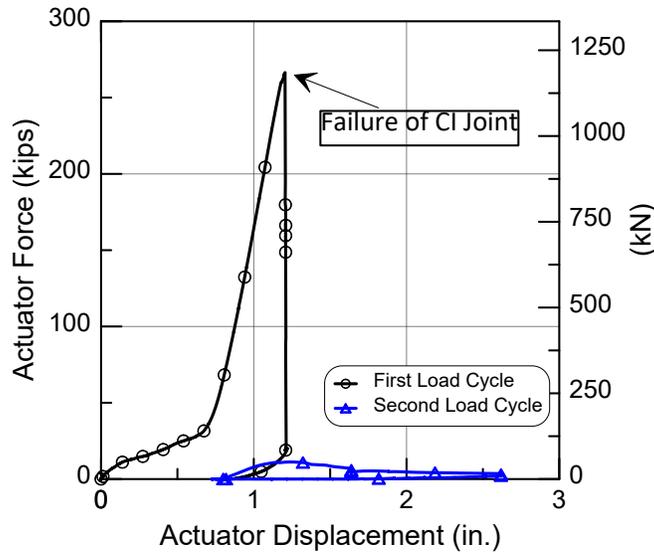
Figure 6.11. DC3 Axial Force versus Displacement Plot

The third compression test was performed on a test specimen provided by LADWP with a cement caulked joint. Figure 6.11 presents a plot of the actuator force versus axial displacement. There is a noticeable change in slope of the force versus displacement plot at about 0.7 in. (18 mm), when the spigot made firm contact with the back of the bell. The pipe barrel north of the joint failed at a

The test was paused, and the actuator was retracted, leaving a residual displacement of approximately 0.8 in. (20 mm), as shown in Figure 6.11. No leakage was detected. The pipe specimen was excavated, and the soil box was removed. The specimen was again loaded during a second load cycle with until a total axial displacement of 2.7 in. (6.86 cm). The water pressure during this second cycle was increased from 10 psi to 80 psi (69 to 552 kPa), and the displacement

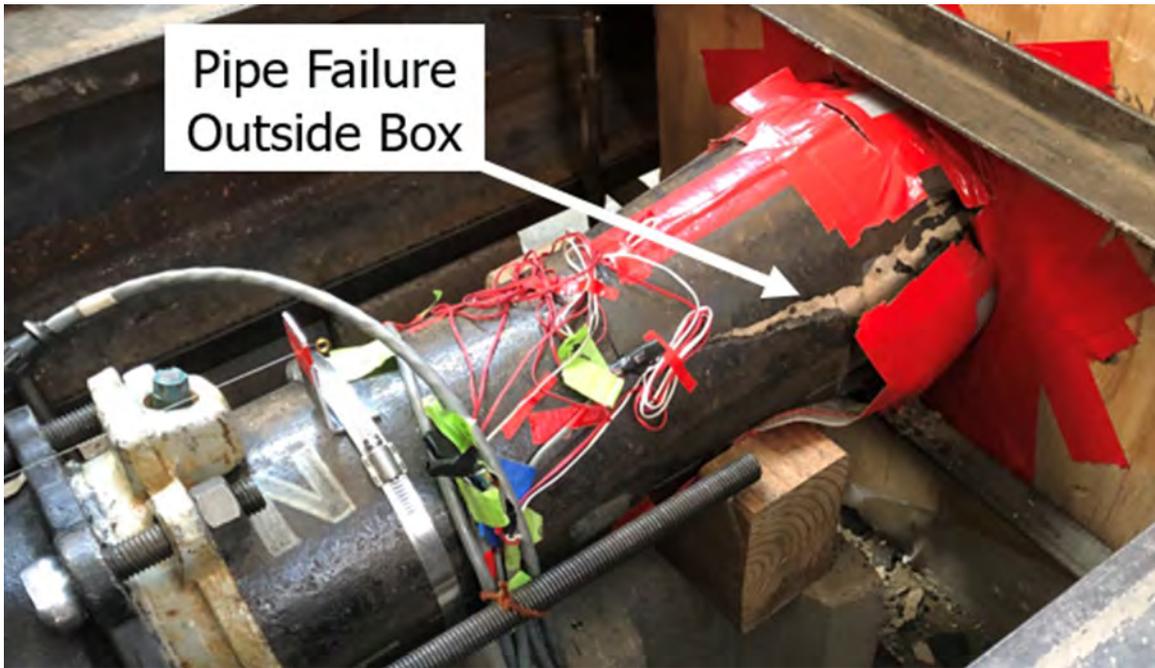
Figure 6.12. DC 3 Fractured Test Pipe Specimen

load of 267 kips (1190 kN) and 1.20 in. (61 mm) of axial displacement. The failure occurred outside of the soil box at a location of corrosion pitting. Figure 6.12 is a photograph of the failed pipe barrel outside of the soil box. Because a cement caulked joint is much stronger and stiffer than a lead caulked joint, the failure occurred at a location of relative weakness close to, but apart from, the relatively strong cement caulked joint.

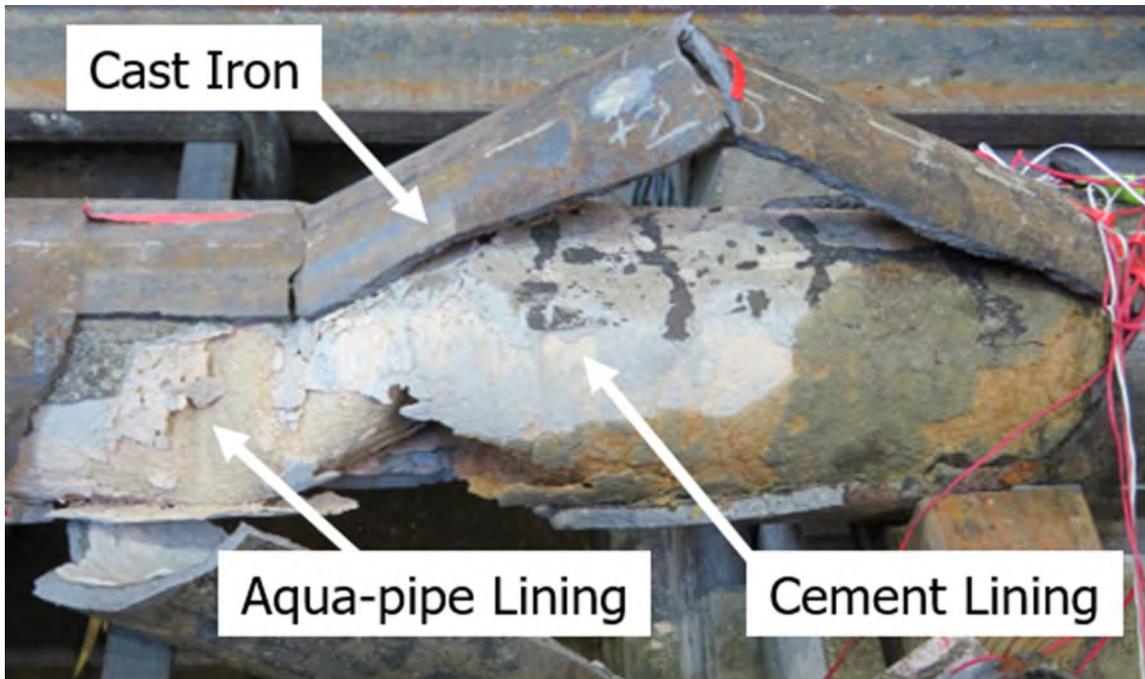
Figure 6.13. DC3 Fractured Test Pipe Specimen View of Deformed Aqua-Pipe Lining and Cement Lining

rate was increased from 0.1 in./min. (0.25 mm/min.) to 1.0 in./min (10 mm/min.) Again, no leakage was detected. Figure 6.13 is a photograph of the fractured CI pipe barrel, underlying cement lining, and deformed Aqua-Pipe lining.

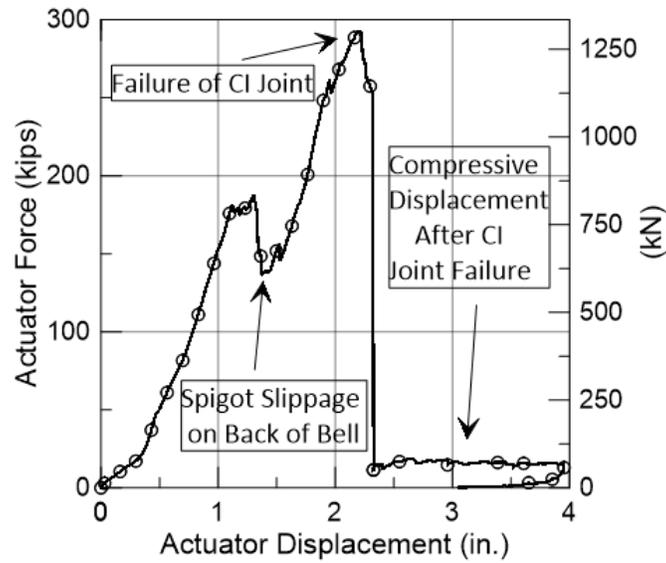
Figure 6.14. DC3 Axial Force versus Displacement Plot

The fourth compression test was performed on a test specimen provided by LADWP with rubber gasket and lead caulked joint. Figure 6.14 presents a plot of the actuator force versus axial displacement. There is a noticeable change in slope of the force versus displacement plot at about 0.25 in. (6 mm), when the spigot made firm contact with the back of the bell. As depicted on the plot, the spigot slipped on the back of the bell at 1.32 in. (3.35 cm) of displacement, corresponding to an axial load of 181 kips (804 kN). After a reduction in load of approximately 40 kips (178 kN), the load increased again to a maximum 291 kips (1293 kN) at an actuator displacement of 2.22 in. (5.6 mm) when the cast iron bell fractured. The load then decreased rapidly, and remained in a range of approximately 10 to 15 kips (44.5 to 67.8 kN) until 4 in. (102 mm) of axial displacement, when the test was terminated.

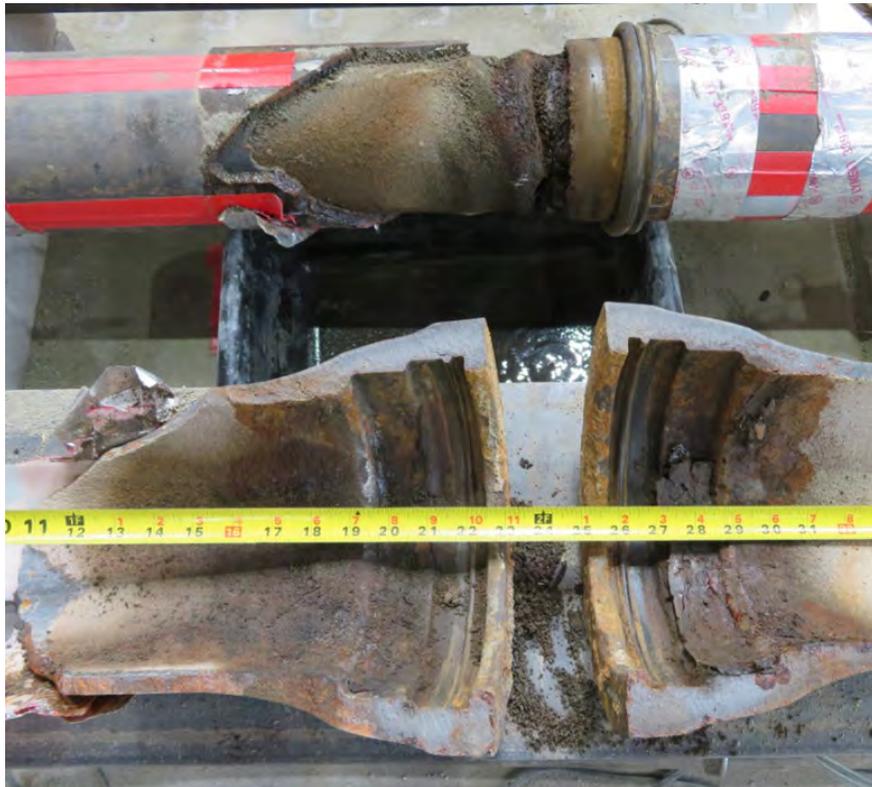
Figure 6.15. DC 4 Fractured CI Bell and Deformed Aqua-Pipe Lining

As previously mentioned, DC 4 was performed continuously under 80 psi (552 kPa). At the end of the test, leakage was measured at a very low level of 10 mL/min. (0.34 fl. oz./min.). Figure 6.15 is a photograph of the failed joint and deformed lining. In the figure the broken halves of the bell

have been removed from the pipe, exposing the wrinkled lining. The broken halves of the bell, with inside surfaces in view, are positioned just below the fractured pipe and deformed lining.

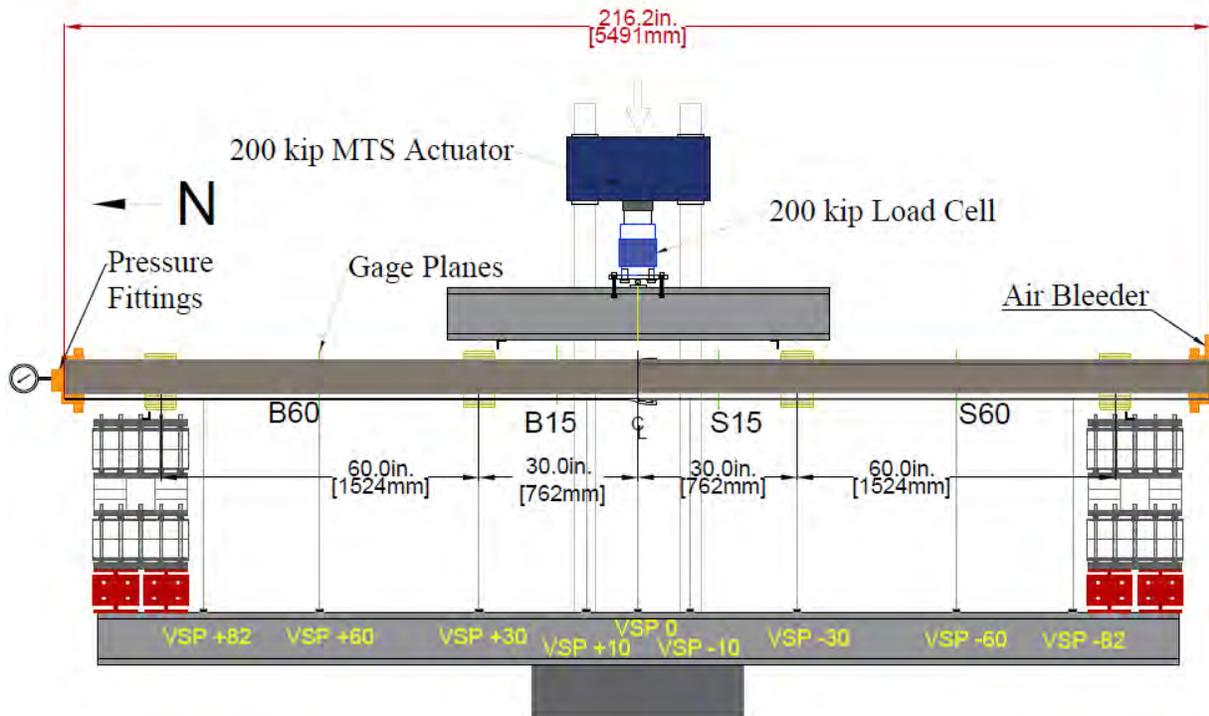
A schematic for the instrumentation used in the test is shown in Figure 7.1 The vertical load was applied to the pipeline by a 200-kip (4.45 kN) actuator through a 200-kip (4.45 kN) load cell. Vertical displacements were measured through string pots positioned horizontally along the pipeline. The vertical string pots (VSPs) were established both north (+) and south (-) of the center joint. The locations of the string pots with respect to the center are shown according to distance in in. (25.4 mm) in the figure.

Figure 7.1. Schematic of Instrumentation for AP1 LADWP Bending Test

A schematic for the instrumentation used in the test is the same as shown in Figure 7.1, and the equipment is the same as described above under 7.5.1. Figure 7.2 presents a photograph that is representative of the test set-up. The description, location, and instruments with abbreviations are identical to those listed in Table 7.2

A schematic for the instrumentation used in the test is identical to Figure 7.1. The equipment is the same as described above under 7.5.1. Figure 7.2 presents a photograph that is representative of the test set-up. The description, location, and instruments with abbreviations are provided in Table 7.3, which is similar to Table 7.2 with the exception that the invert and crown axial strain gages were not provided in AP2 DI Joint. In addition, the center VSP was moved slightly to obtain better vertical displacement of the joint.

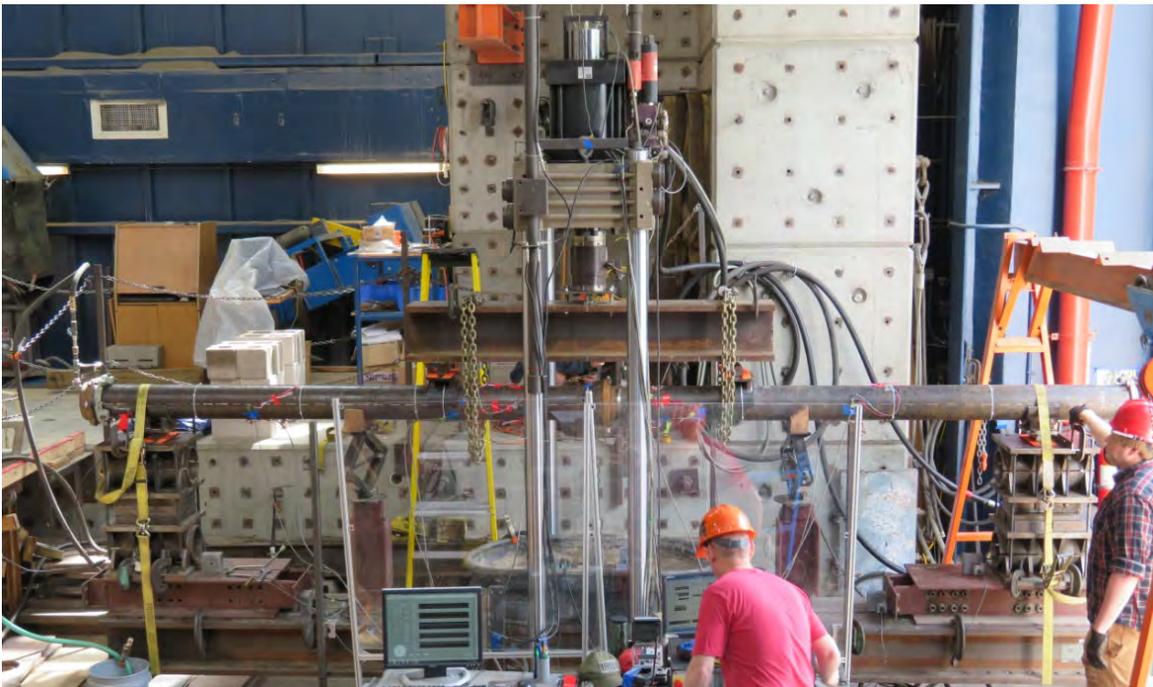
Figure 7.2 presents a photograph of the test set-up depicted in Figure 7.1. The photo was taken just before load was applied through the spreader. The pipeline is still in a horizontal position. The test

Figure 7.2. Photo of Bending Specimen

pipeline, MTS actuator, load cell, load spreader beam, load contacts and supports can be seen clearly in the figure, which is representative of all tests.

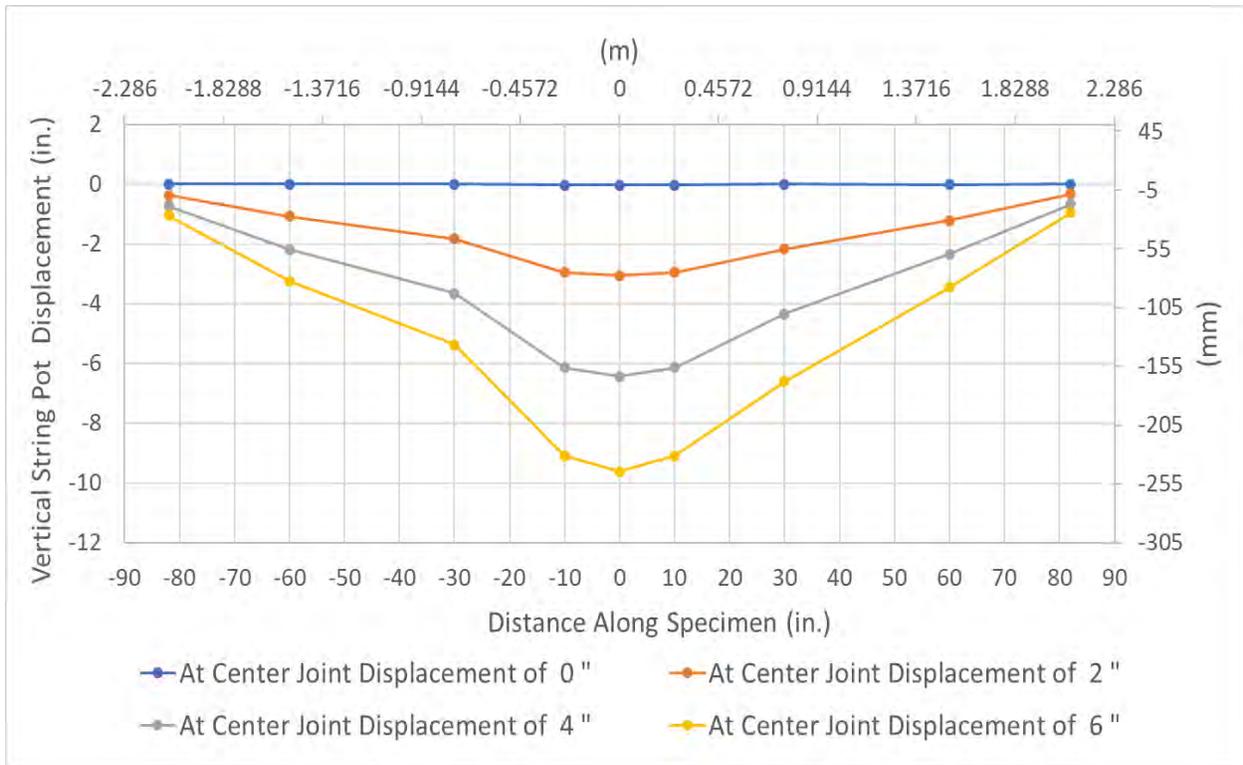
Figure 7.3 presents the VSP measurements along the test pipeline. The spigot and bell side VSP measurements indicate that there is good agreement between vertical movement measurements at equal distances from the center point of the test. The continuous progression of these displacements is a further indication that the assumption of rigid body motion can be used to evaluate rotations. Such estimates of rotation are close to the rotation from the HSPs provided by Equation 7.3.

Figure 7.3. Vertical Displacements for API LADWP with Various Center Joint Movements

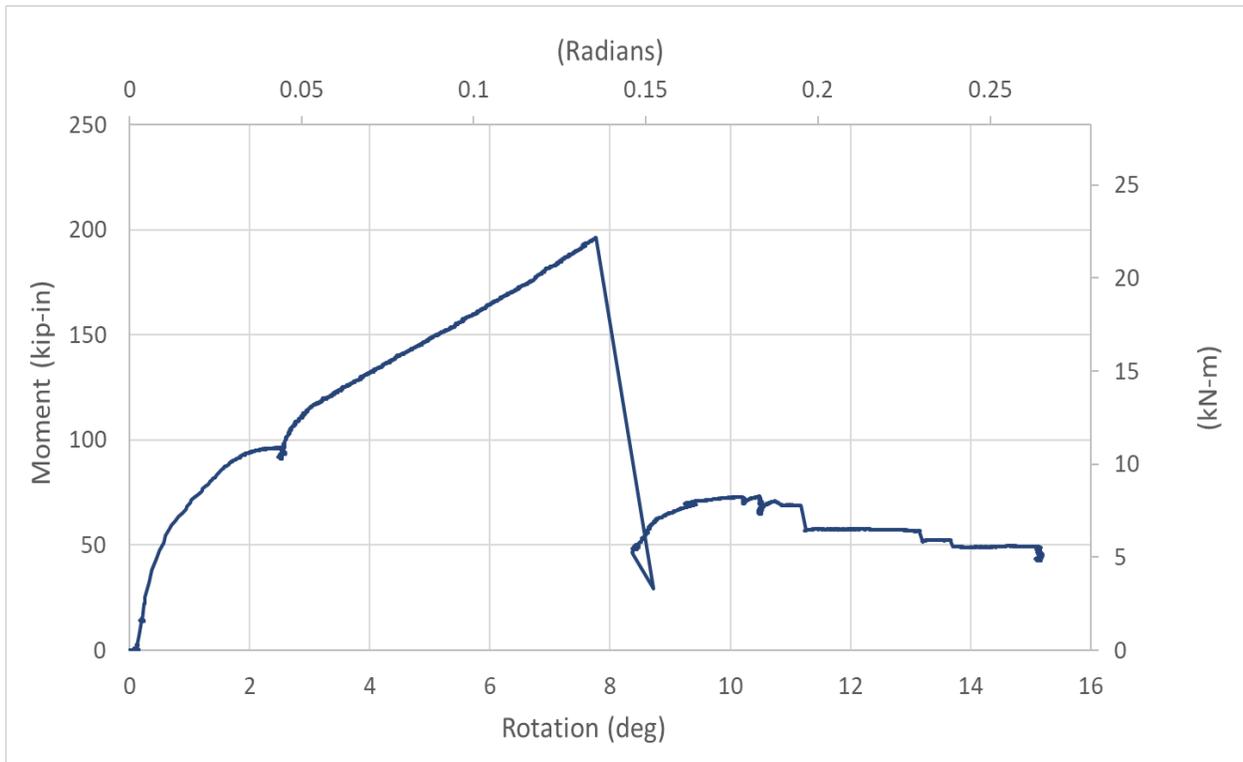
Figure 7.4 presents the moment vs rotation relationship for AP1 LADWP. The maximum moment of nearly 200 (kip-in.) (22610 kN-mm) occurred at approximately 8° of rotation when the CI joint fractured at its crown. The actuator travel was re-set and the vertical loading commenced again at about 8° rotation. The test was taken to a total of 15° rotation when it was terminated due to concerns for personnel safety. No leakage or significant reduction in average water pressure of 78.3 psi (540 kPa) were observed.

Figure 7.4. Moment versus Rotation Relationship for API LADWP

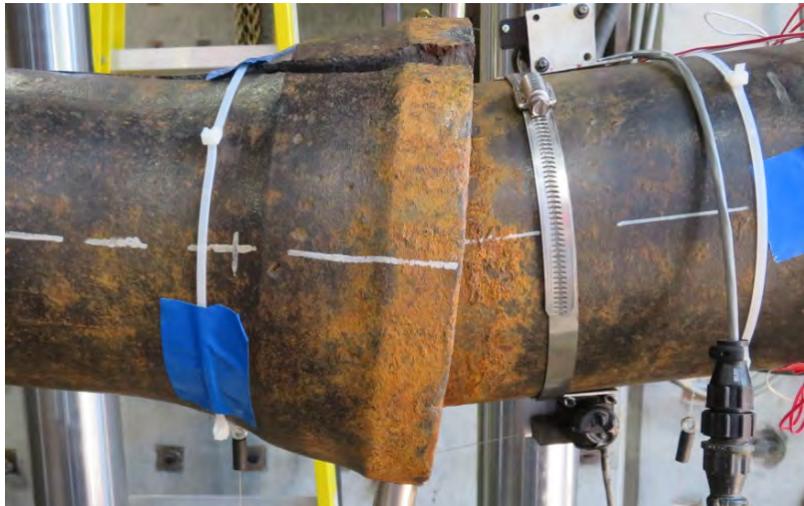
Figure 7.5 provides a photo of the failed CI pipe joint. The fracture at the top, or crown, of the bell can be seen clearly. As stated previously, the bell fracture did not coincide with leakage or loss of water pressure. Although the pipeline failed at the joint, the lining did not fail, but continued to hold full internal pressure.

Figure 7.5. Photo of CI Bell Fracture at Crown

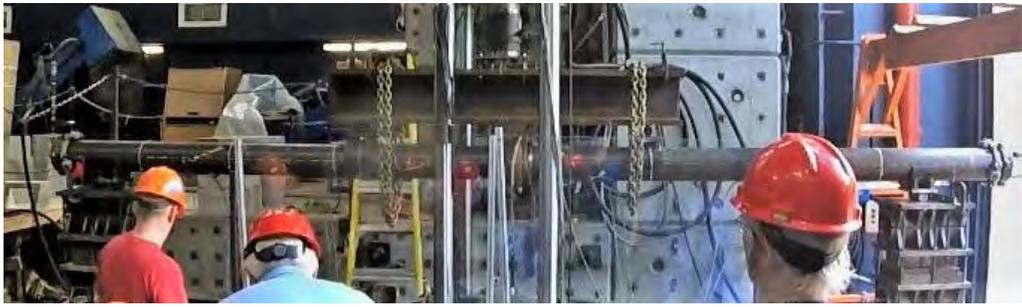
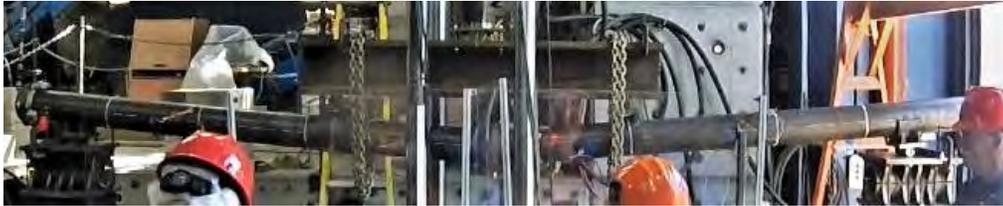
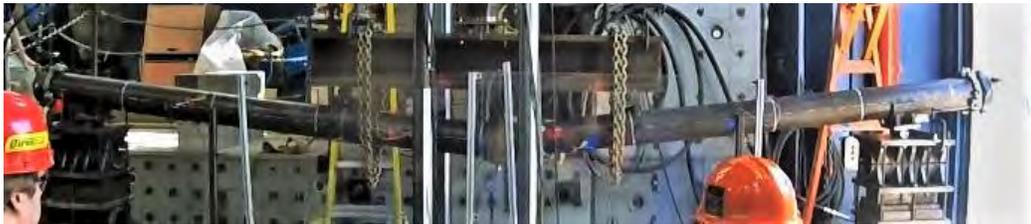
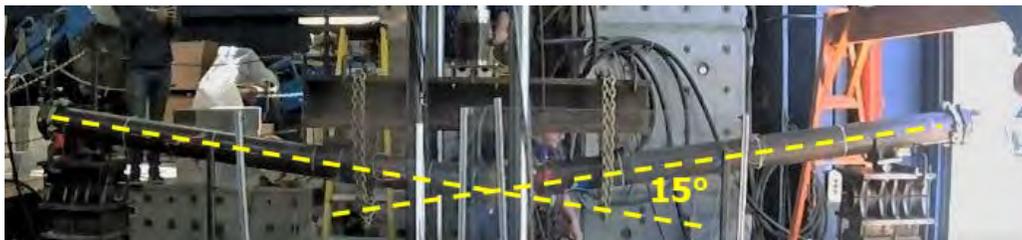
Figures 7.6 a, b, c, and d show photos of the initial position of the test specimen as well as its position at intermediate displacements and the final displacement at which there was rotation of 15°. This sequence of photos shows graphically the ability of a CI pipeline lined with AP1 to accommodate vertical displacements and joint rotations without leakage or failure. The maximum rotation of 15° is shown in Figure 7.6 d.

a) Initial Position

b) Approximately 5° Rotation

c) Approximately 10° Rotation

d) 15° Rotation

Figure 7.6. AP1 LADWP at Four Levels of Rotation, or Deflection

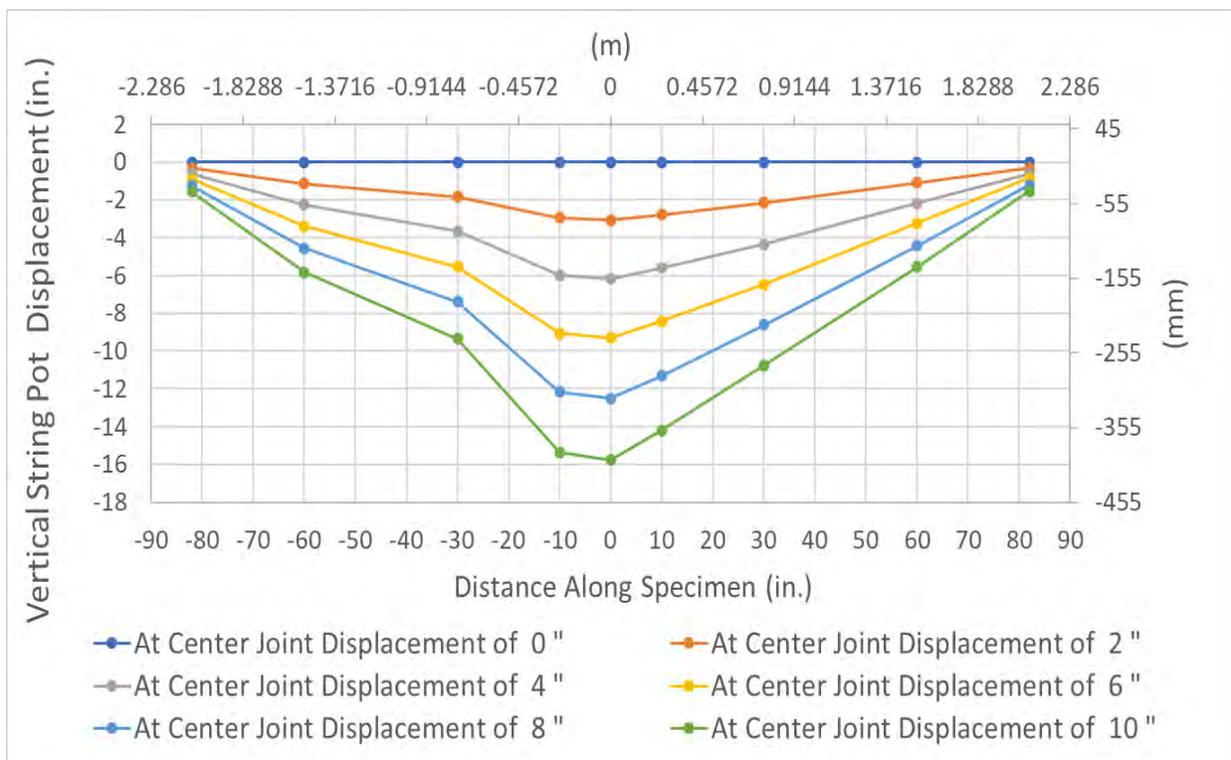
Figure 7.7. Vertical Displacements for AP1 DI Joint with Various Center Joint Movements

Figure 7.3 presents the VSP measurements along the test pipeline. Again, the spigot and bell side VSP measurements indicate that there is good agreement between vertical movement measurements at equal distances from the center point of the test. The displacement pattern shows

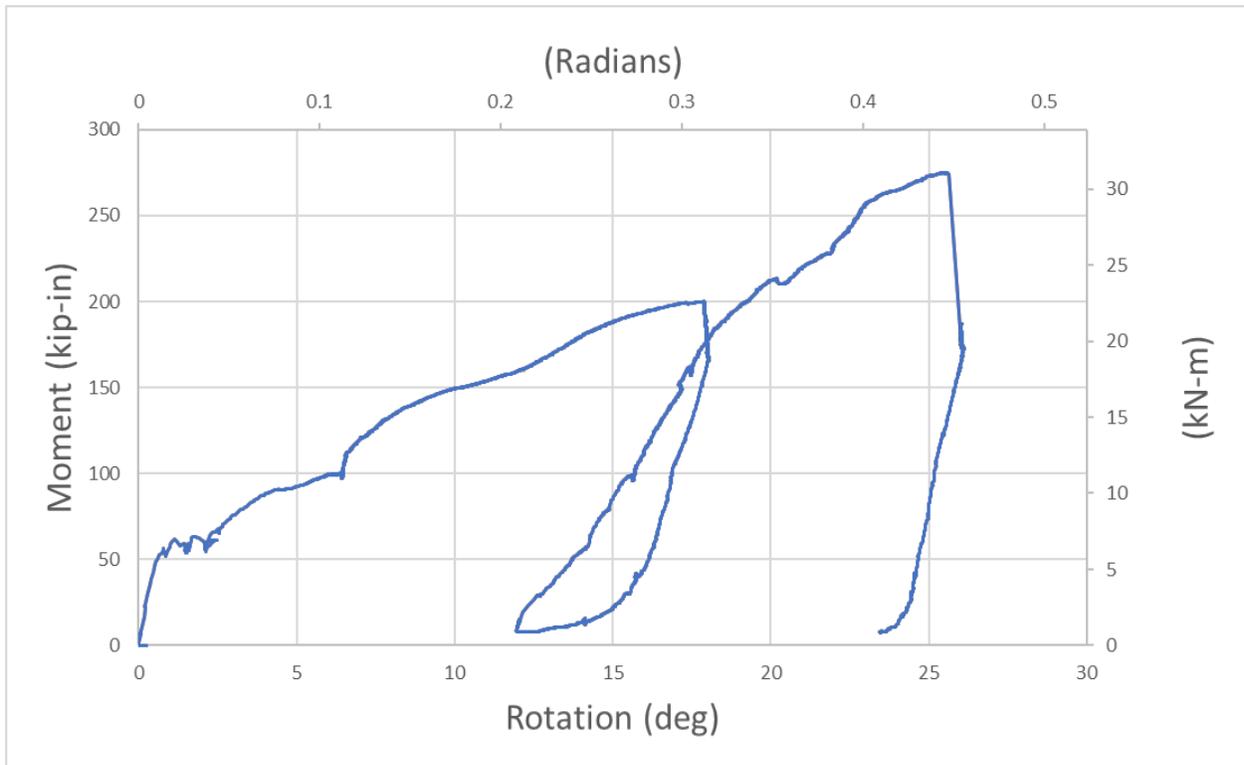
Figure 7.8 presents the moment vs rotation relationship for AP1 DI Joint. A moment of nearly 200 (kip-in.) (22610 kN-mm) occurred at approximately 18° of rotation, after which the actuator travel was re-set and the vertical loading re-started. The maximum moment of approximately 275 (kip-in.) (31090 kN-mm) occurred at approximately 25.6° of total rotation, when the test was terminated due to concerns for personnel safety. No leakage or significant reduction in the average water pressure 80.9 psi (558 kPa) were observed.

Figure 7.8. Moment vs Rotation Relationship for AP1 DI Joint

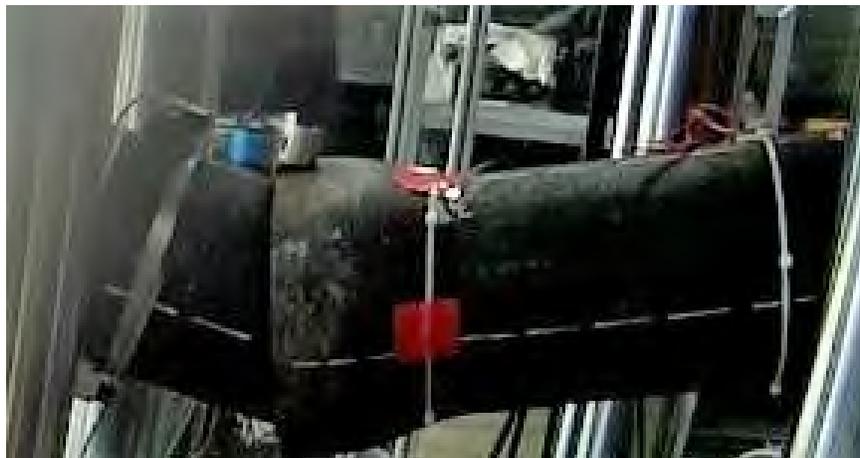
Figure 7.9 provides a photo of the DI pipe joint. Neither the pipeline nor joint failed. There was no failure of the lining, which continued to hold full internal pressure.

Figure 7.9. Maximum DI Joint Rotation
