# Performance Evaluation of Aqua-Pipe under Earthquake-Induced Ground Deformation

## Interim Report

Cornell University

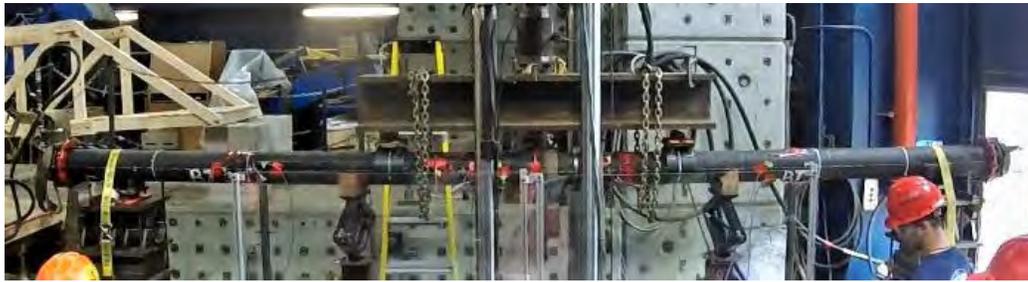
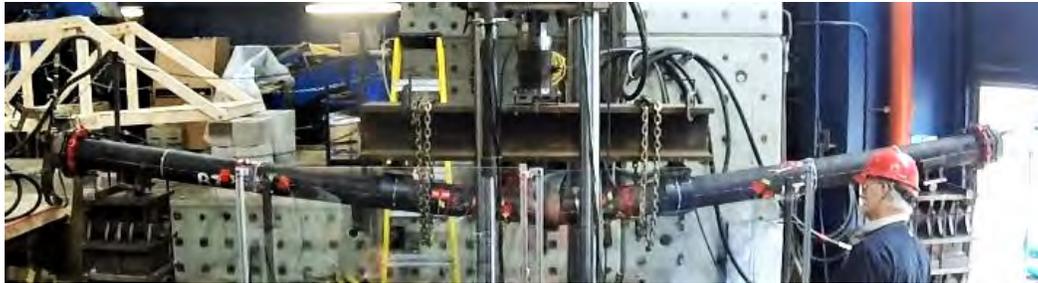
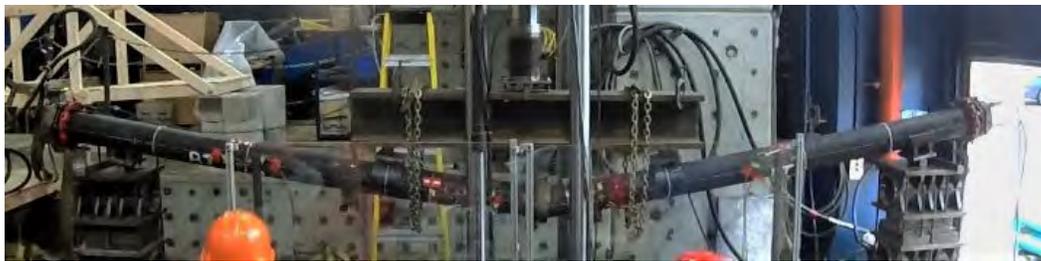
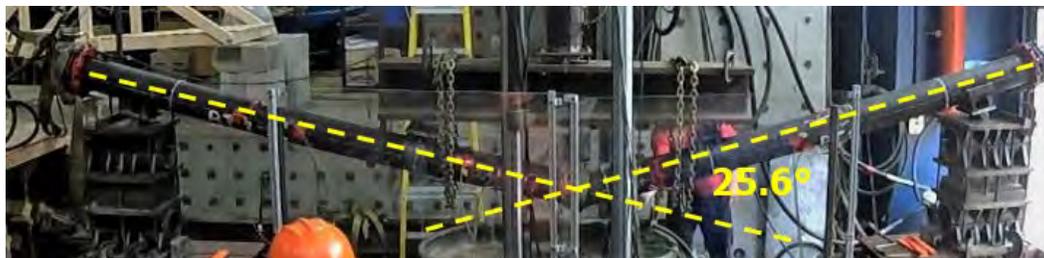
Figures 7.10 a, b, c, and d show photos of the initial position of the test specimen as well as its position at intermediate displacements and the final displacement at which there was rotation of 25.6°. This sequence of photos shows graphically the ability of a DI pipeline lined with AP1 to accommodate vertical displacements and joint rotations without leakage or failure. The maximum rotation of 25.6° is shown in Figure 7.6 d.

a) Initial Position

b) Approximately 8° Rotation

c) Approximately 16° Rotation

d) 25.6° Rotation

Figure 7.10. AP1 DI Joint at Four Levels of Rotation, or Deflection

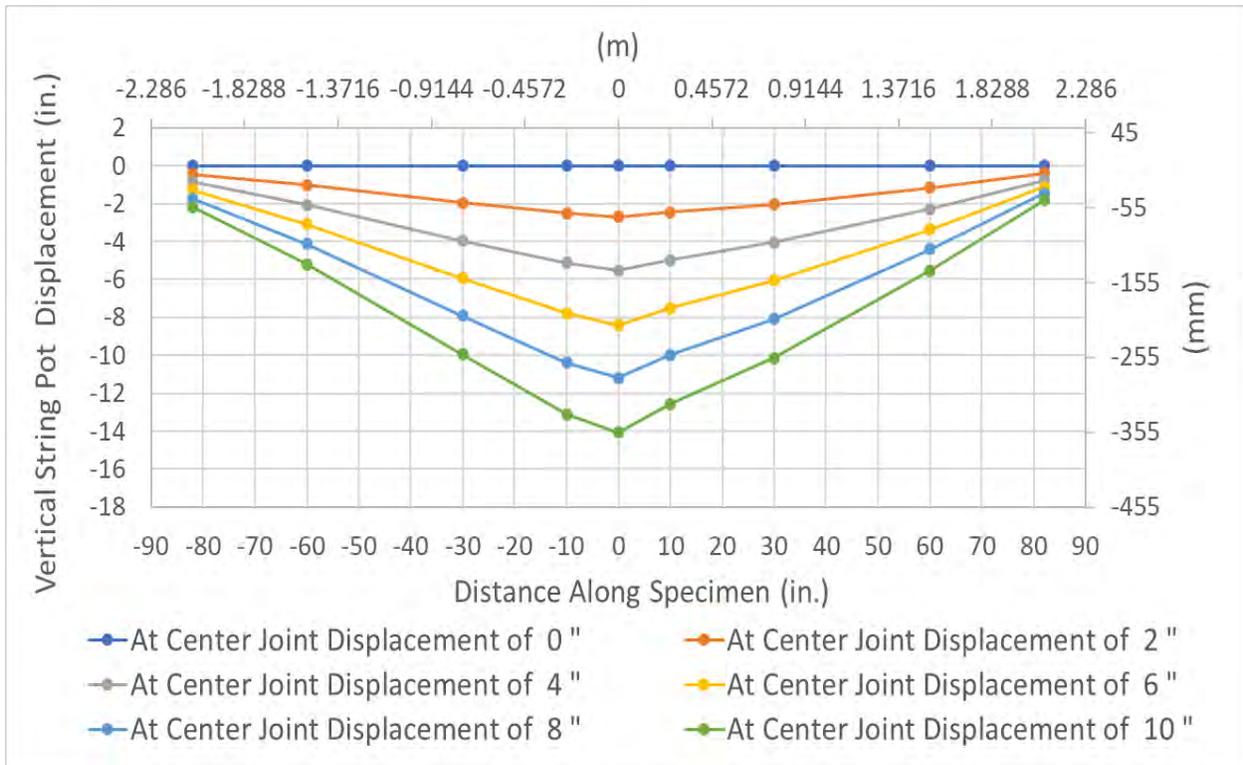
Figure 7.11 presents the VSP measurements along the test pipeline. Again, the spigot and bell side VSP measurements indicate that there is good agreement between vertical movement measurements at equal distances from the center point of the test. The displacement pattern shows that rigid body motion can be used to estimate rotations, which are close to the rotation from the HSPs provided by Equation 7.3.

Figure 7.11. Vertical Displacements for AP2 DI Joint with Various Center Joint Movements

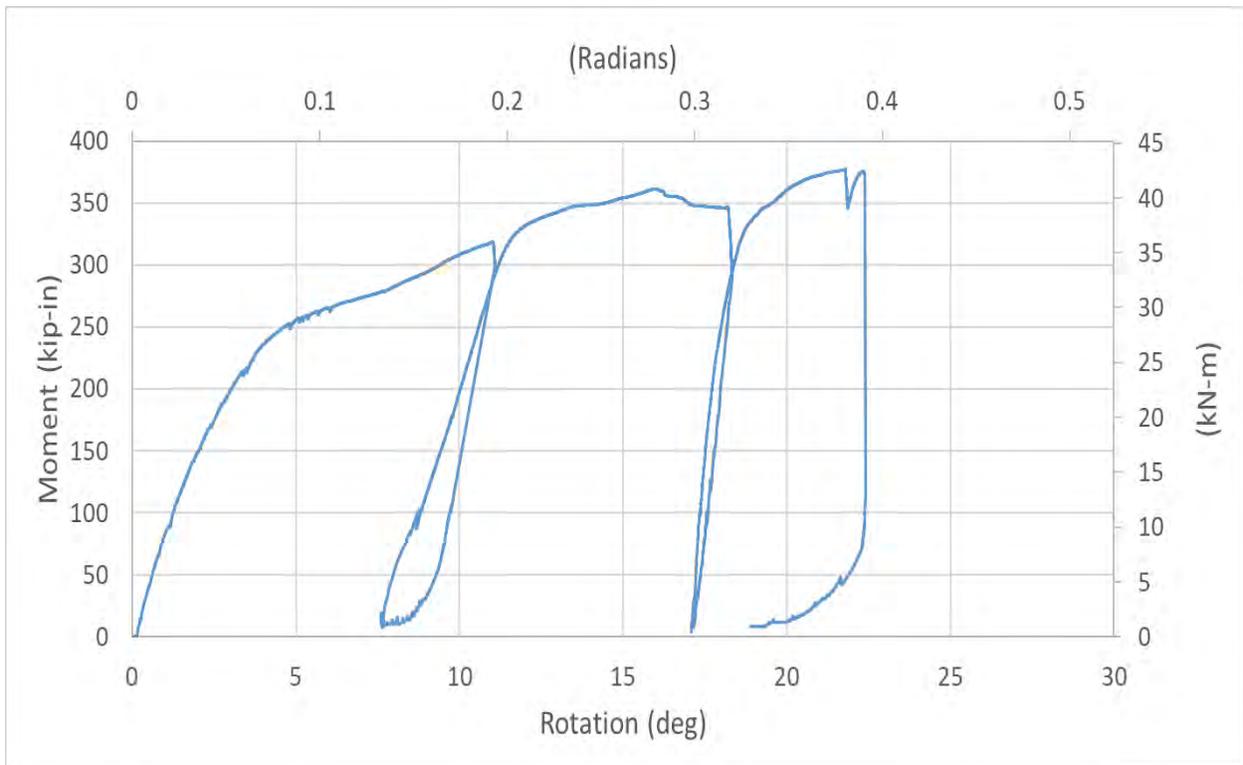
Figure 7.12 presents the moment vs rotation relationship for AP2 DI Joint. Three cycles of moment and rotation were undertaken as shown by the loops in the figure. A moment of nearly 320 (kip-in.) (36180 kN-mm) occurred at approximately 12° of rotation, after which the actuator travel was re-set and the vertical loading re-started. Then a moment of about 350 (kip-in.) (39570 kN-mm) was applied to approximately 18° of rotation, after which the actuator travel was again re-set and the vertical loading re-started. The maximum moment of approximately 375 (kip-in.) (42390 kN-mm) occurred at approximately 22.4° of total rotation, when the pipe barrel fractured. The test then was terminated due to concerns for personnel safety. No leakage or significant reduction in the water pressure of 82.7 psi (570 kPa) were observed.

Figure 7.12. Moment versus Rotation Relationship for AP2 DI Joint

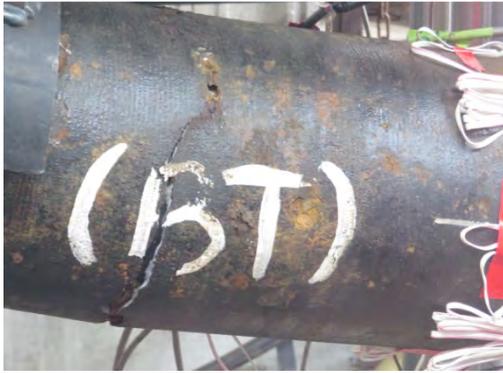
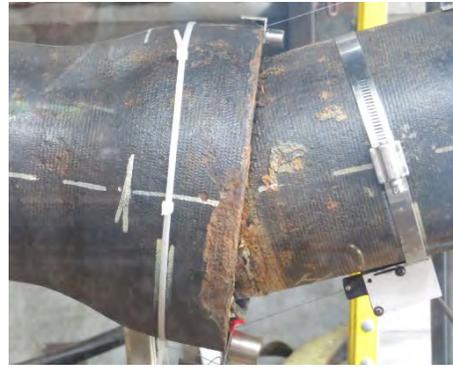
Figure 7.13 a) presents a photo of the DI pipe joint where failure occurred by fracturing through corrosion pits on the pipe barrel north of the joint. Figure 7.13 b) presents a photo of the DI pipe

a) Corroded Pipe Barrel

b) Corroded Pipe Joint

Figure 7.13. Corrosion in Test Pipeline

joint with corrosion between the centerline and invert of the joint. Upon unloading to a rotation of about  $19^\circ$  the pipeline started to leak by dripping at the joint under water pressure of about 82.5 psi (567 kPa).

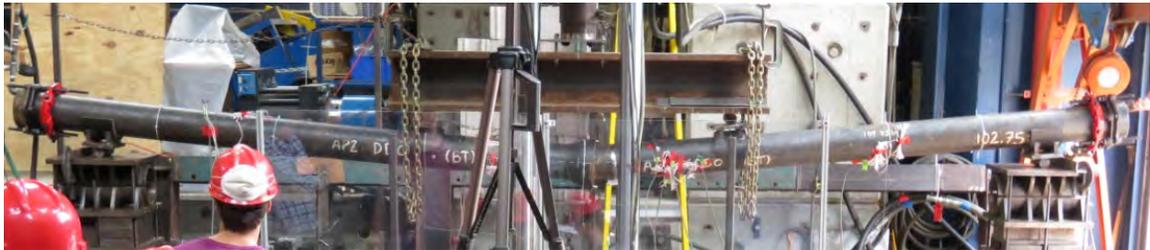
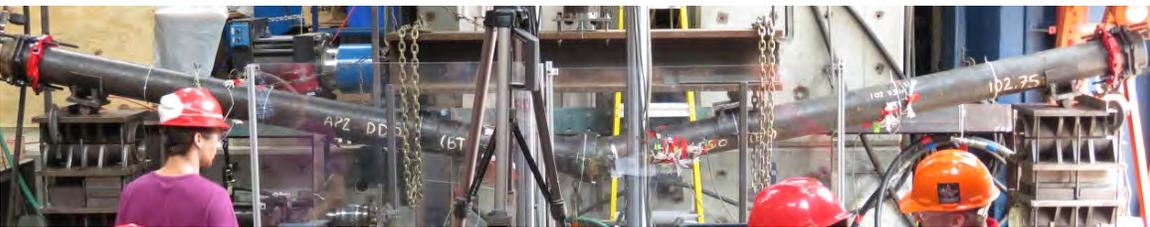
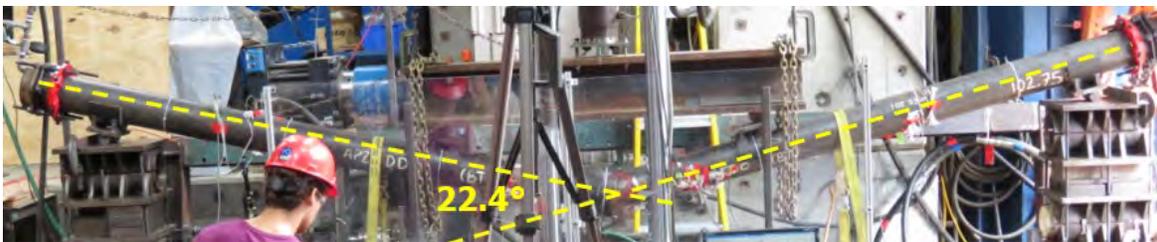
Figures 7.14 a, b, c, and d show photos of the initial position of the test specimen as well as its position at intermediate displacements and the final displacement at which there was rotation of  $22.4^\circ$ . This sequence of photos shows graphically the ability of a DI pipeline lined with AP2 to accommodate vertical displacements and joint rotations without leakage or failure. The maximum rotation of  $22.4^\circ$  is shown in Figure 7.14 d.

b) Approximately 7° Rotation

c) Approximately 14° Rotation

d) 22.4° Rotation

Figure 7.14. AP2 DI Joint at Four Levels of Rotation, or Deflection

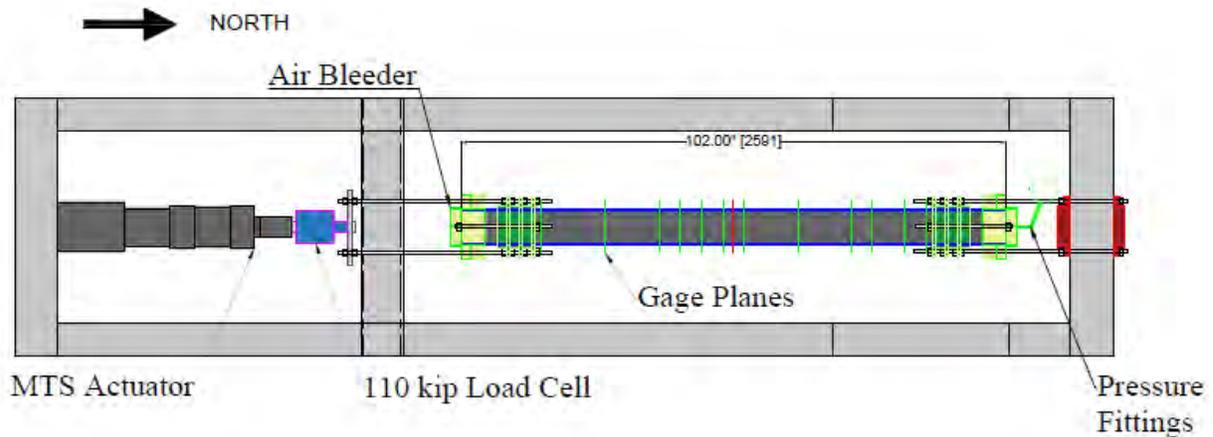
The plan view of the axial tension test setup and equipment for the small load frame used for these tests is provided in Figure 3.2 and photo in Figure 3.4. An actuator, load cell, and load frame were used to apply tensile load to the test specimen in each setup. Each specimen was fitted with end caps to allow for internal pressurization during loading. A photo of the test setup using the small load frame is shown in 3.2. Each test specimen consisted of two pipe sections of equal length on each side of a gap, about 0.25 in. (6 mm) wide, representing a round crack. In the small load frame setup, an actuator and load cell were installed at the south end of the load frame to apply and measure tensile force, respectively. The load cell had a capacity of 110 kips (489 kN).

Figure 8.1. Plan View of a Direct Tension Test in the Small Load Frame

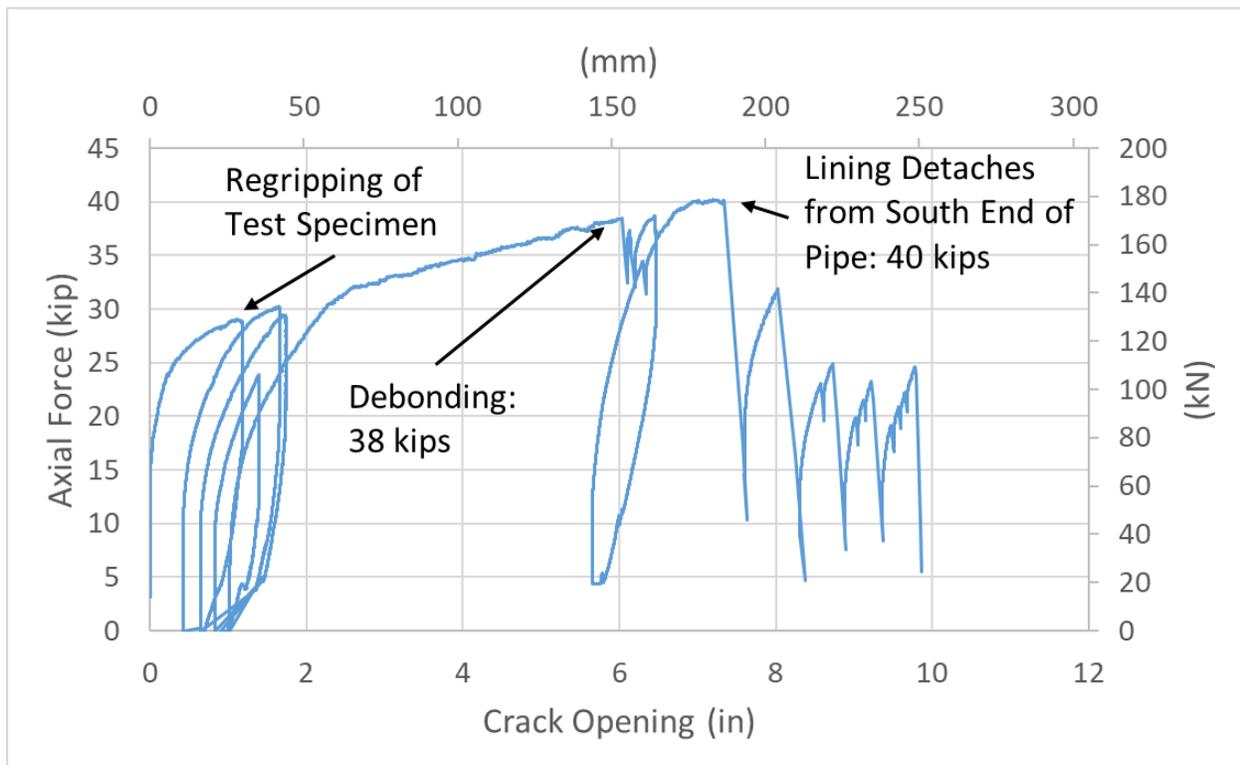
Figure 8.2 shows the axial force versus gap, or crack, opening. Initially, the gripping devices slipped so there are multiple load cycles plotted at the beginning of the test. This region is labeled as regripping of test specimen. The initial gripping device was replaced, and the axial displacement was increased to approximately 10 in. (254 mm) when the test was terminated. The reductions in strain gage measurements were used to track debonding to a maximum load of about 38 kips (169 kN). The load was then cycled once to a new maximum of 40 kips (178 kN), at which point detachment occurred at an axial displacement of about 7.5 in. (190 mm). The force then decreased rapidly as the lining was pulled from the south side of the pipeline specimen.

Figure 8.2. Axial Force vs Crack Opening for AP2 DT1

During the last phase of the axial force vs displacement response, increased axial load in the lining was accompanied by a load-induced reduction in lining diameter that caused the lining to lurch forward with decreasing axial load until the lining diameter increased again and came in contact with the inside pipe diameter. As described in Section 3, each axial load cycle was accompanied by a peak axial load and load-induced reduction in lining diameter as the lining lurched forward under constant pipe movement. During each cycle, there was an audible pop or boom as the lining lurched forward.

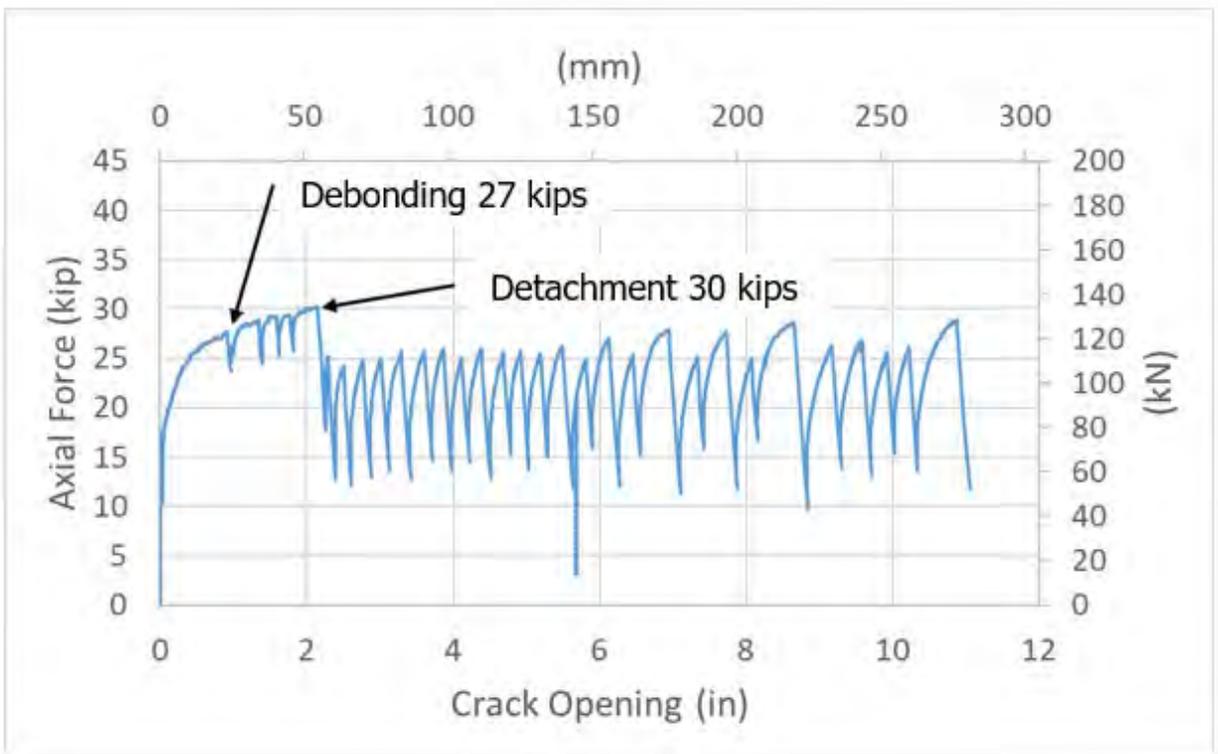
Figure 8.3 shows the axial force versus gap, or crack, opening. Using the same procedures that pertain to Figure 8.2, the maximum debonding force was estimated as 23 kips (102 kN) at about 1 in. (25 mm) of axial displacement. Detachment of the lining occurred at 27 kips (119 kN) and

Figure 8.3. Axial Force versus Crack Opening for AP2 DT2

an axial displacement of a little more than 2 in. (51 mm). There was a substantial drop in load after this, followed by cyclic forces as the lining was pulled from the south side of the pipe. The cycle forces have the same origin as explained above.

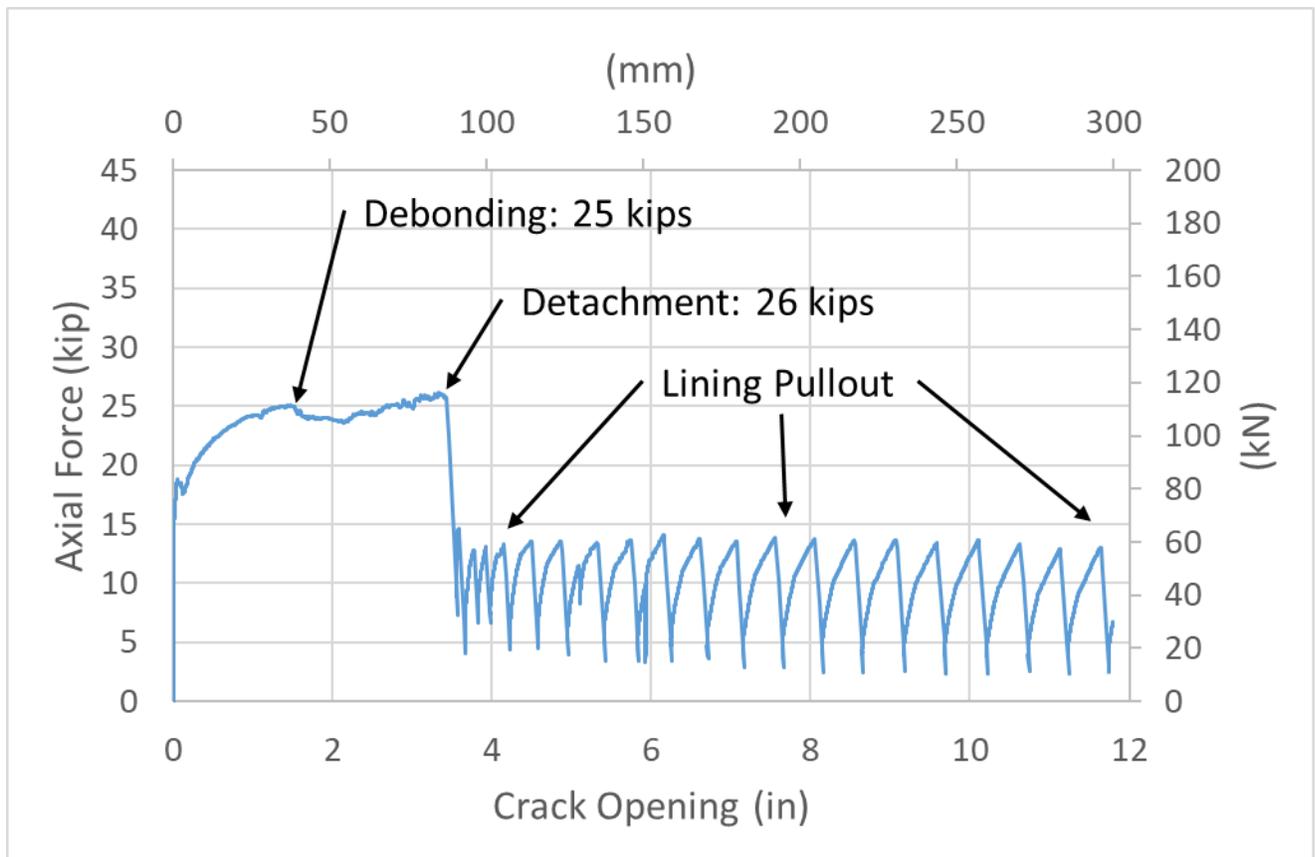
Figure 8.4 shows the axial force versus gap, or crack, opening. Using the same procedures as explained above, the maximum debonding force was estimated as 25 kips (111 kN) at about 1.5 in. (38 mm) of axial displacement. Detachment of the lining occurred at 26 kips (116 kN) and an axial displacement of about 3.5 in. (89 mm). There was a substantial drop in load after this, followed by cyclic forces as the lining was pulled from the south side of the pipe. The cycle forces have the same origin as explained above.

Figure 8.4. Axial Force vs Crack Opening for AP1 JDT1

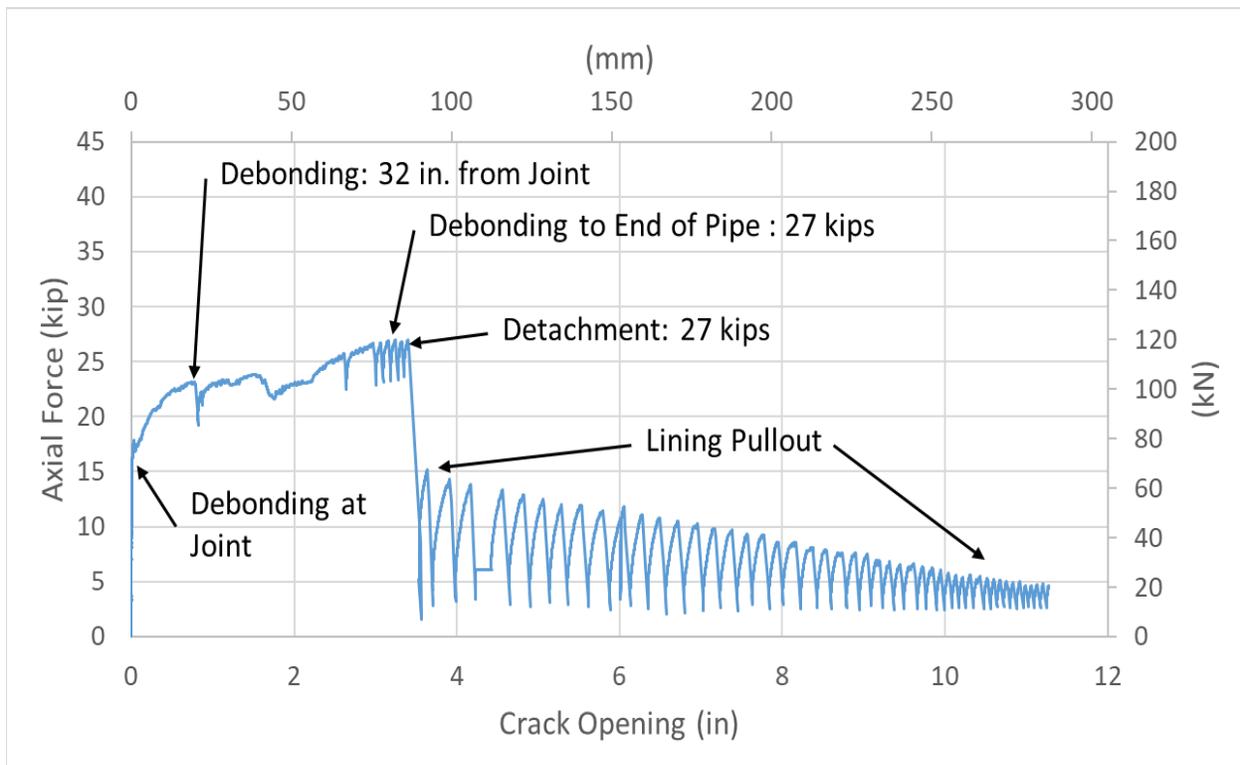
Figure 8.5 shows the axial force versus gap, or crack, opening. Using the same procedures as explained above, the debonding was estimated at several levels of crack opening as indicated on the figure. Ultimately, debonding and detachment occurred at a load of 27 kips (119 kN) and an axial displacement of nearly 3.5 in. (89 mm). There was a substantial drop in load after this, followed by cyclic forces as the lining was pulled from the south side of the pipe. The cycle forces have the same origin as explained above, and declined steadily until the test was terminated at an axial displacement of a little over 12 in. (305 mm).

Figure 8.5. Axial Force vs Crack Opening for AP1 JDT2

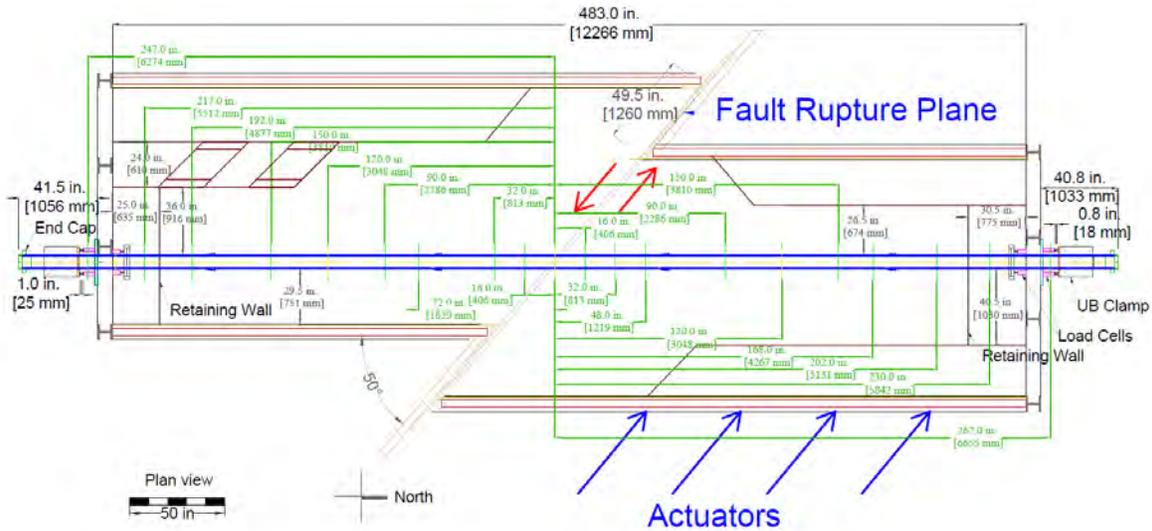
Figure 9.1 is a plan view of the test layout, which shows the fault rupture plane and approximate locations of the four actuators generating basin movement. The pipeline consisted of five DI pipe segments with four DI joints positioned at 5 ft. (1.5 m) and 15 ft. (4.6 m) on either side of the fault. The five test pipeline segments were cut by Sanexen according to directions from Cornell to the

Figure 9.1. Plan View of Pipe Centered DI Pipeline with AP2 Lining in Test Basin

dimensions in the figure, lined, and then shipped to Cornell. The intersection angle between the pipe and fault was  $50^\circ$ .

Figure 9.1, a plan view of the test layout, shows the locations of the instruments along the test pipeline. Table 9.1 provides the number of strain gage station locations with respect to the fault. The instrumentation consisted of strain gages at twenty locations (gage planes) along the pipeline, load cells at the ends of the pipeline, and string pots to measure joint displacements and rotations. Ninety-six strain gages were installed in twenty locations along the pipeline to measure strains and

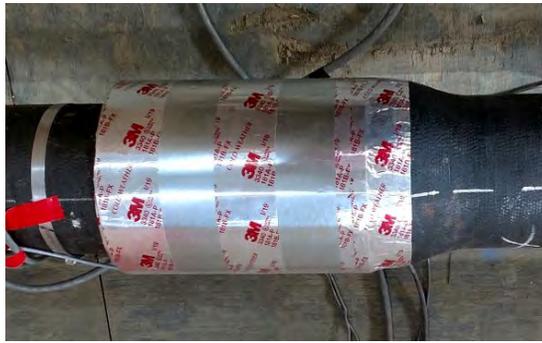
After the instrumentation was installed, protective metal shielding was wrapped around the joint. Figure 9.2 is a photo of the pipe joint with protective shielding. Three string pots were placed at each joint to measure the joint pullout and rotation, as well as spigot to bell face relative movement. Figure 9.3 is a photo of the wooden support behind the metal shielding that establishes the location and support for the string pots, and provides support for the shielding. The metal shielding consisted of two thin, metal sheets that could move longitudinally with respect to each other.

Figure 9.2. Joint Instrumentation Protective Shielding

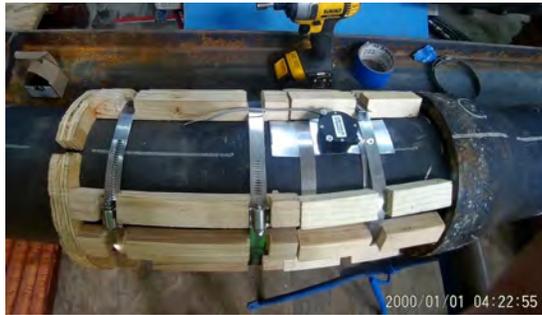
Figure 9.3. Instrumentation String Pot Set Up and Wooden Support

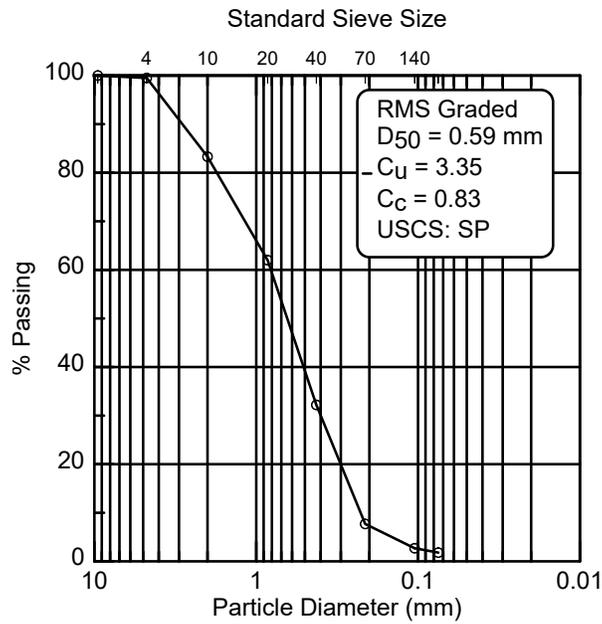
The soil used during the test was crushed, washed, glacio-fluvial sand obtained from RMS Gravel, Dryden, NY, consisting of particles mostly passing the ¼ in. (6.35 mm) sieve. Figure 9.4 is the grain size distribution of the RMS graded sand. Approximately 6-in. (152-mm)-thick lifts of soil were placed and compacted until there was about 32 in. (813 mm) cover of compacted sand above

Figure 9.4. Particle Size Distribution of RMS Graded Sand

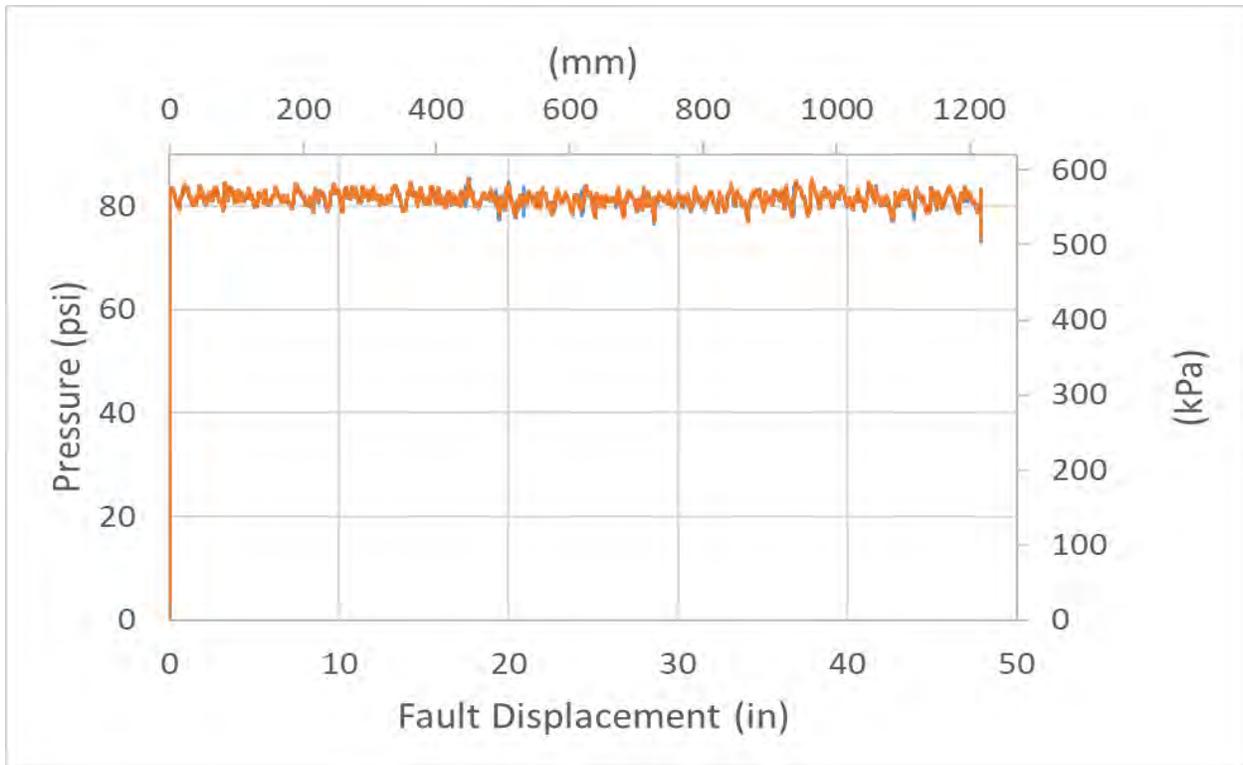
These pressure variations are shown in Figure 9.7 that displays the pipe internal pressure vs. fault displacement. When the test was stopped, water was drained from the pipe. The actuator displacement was maintained until total station positions of the excavated pipeline were surveyed.

Figure 9.7. Internal Water Pressure vs. Fault Displacement

The pipe was filled with water and pressurized to an average 81.3 psi (561 kPa). The basin movement caused the pipe to increase in overall length, causing slight fluctuations in pressure.

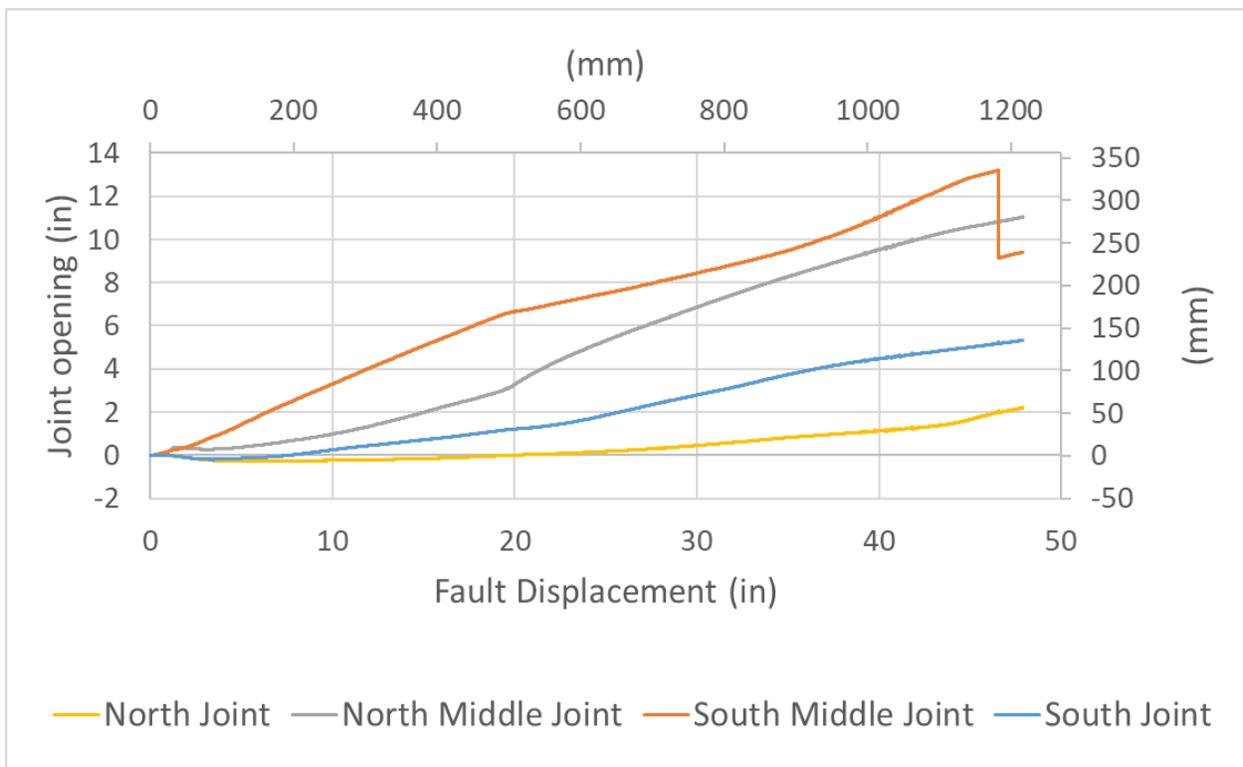
The joint pullout movements were measured using string potentiometers (string pots). The string pot locations are given in Section 9.2.2 and shown in Table 9.2. Each joint had a total of three string pots, one at the crown and two at the springline locations, which are described in connection with Figure 9.2. The pullout at each joint is plotted vs the fault displacement in Figure 9.8.

The pullout begins first on the South Middle Joint. Experimental and analytical results show that pipeline pulls towards the fault. At the South Middle joint there is axial resistance to pullout of the north facing bell, so that movement initiates as the spigot moves towards the fault. The North Middle Joint moves after the South Middle Joint because more axial resistance occurs at this joint

Figure 9.8. Joint Openings vs. Fault Displacement

as the curved bell moves toward the fault. Thus, the second joint to move is the North Middle Joint, followed by the South Joint and then the North Joint. This systematic response to fault displacement has been observed in other tests (e.g., Cornell University, 2015). At 47 in. (1194 mm) of fault displacement there is an abrupt decline in South Middle Joint movement, corresponding to distortion in the string pot readings. The axial movement is  $d_f \cos\beta$ , where  $d_f = 47$  in. (1194 mm) of fault displacement and  $\beta =$  angle of pipeline/fault intersection  $= 50^\circ$ . Thus, axial movement is  $(47 \text{ in.}) \cos\beta = (47 \text{ in.}) \cos(50^\circ) = 30.2$  in. (762 mm). The sum of the axial displacements of all four joints at 47 in. (1194 mm) of fault displacement is nearly 29.5 in. (749 mm), which is in close agreement with the theoretical extension of the pipeline.

From Figure 9.20 one can estimate the fault displacement at which debonding occurs at each joint. From Figure 9.8 one can evaluate the axial joint movement at each fault displacement. When one uses the two figures, both the joint displacement, or opening, and the debonded length can be assessed.

Figure 9.24 shows the deformation at the North Joint primarily as pullout of the spigot from the bell of the DI pipeline. The AP2 lining is visible in the gap between the spigot and the bell, which is facing northward. Please note that the longitudinal deformation at this joint has been affected by reduction in tensile load in the lining after the water pressure was turned off, but before exposure of the test pipeline for the Leica survey. Hence, the joint longitudinal deformation in the photo exceeds that shown by the measurements plotted in Figure 9.8. In contrast, the longitudinal deformation shown by the photos of the three remaining joints is consistent with the displacements shown in Figure 9.8.

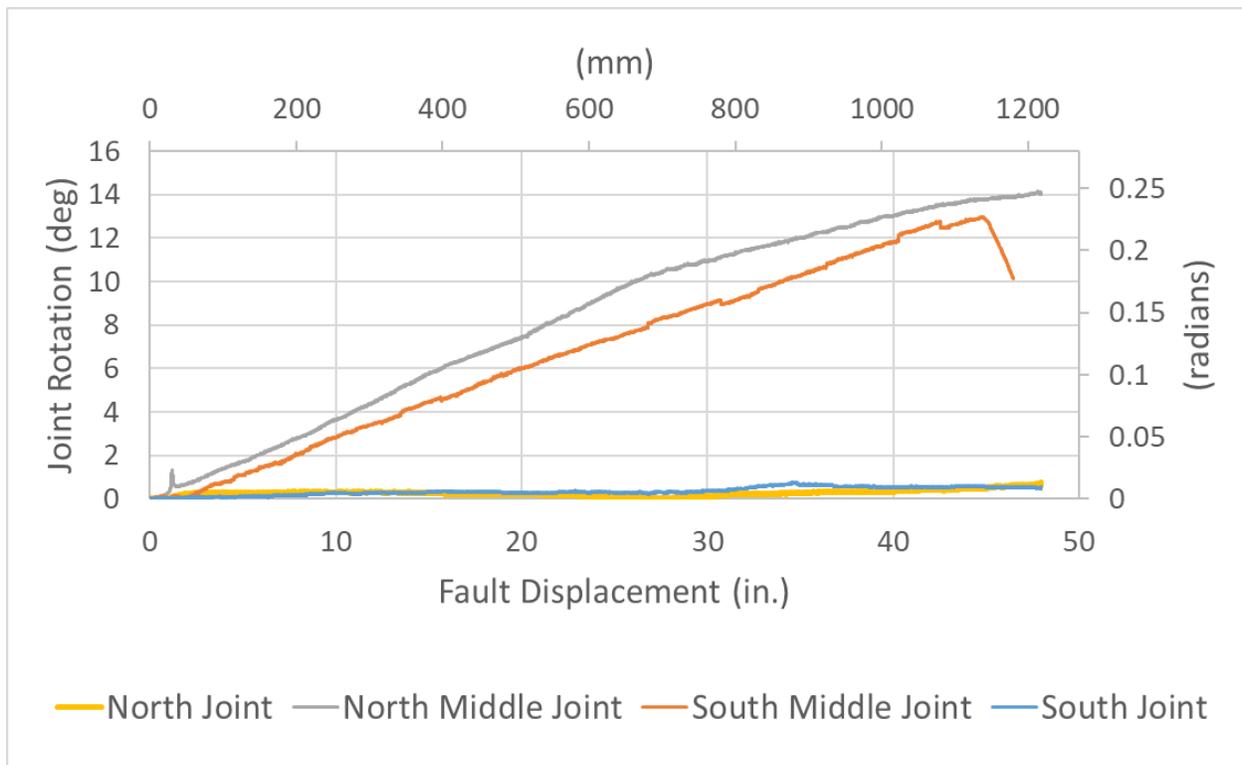
The joint deflections are shown in Figure 9.9. The predominant part of the joint rotation occurs at the south and north joints closest to the fault. At about 47 in. (1194 mm) of fault displacement there is evidence of distortion in the spring pot readings for the South Middle Joint closest to the fault. The maximum rotation of the joints closest to the fault must account for an increase in pipeline length equal to the sum of the South Middle and North Middle Joints at 47 in. (1194 mm) of fault displacement. From Figure 9.8 this sum is 24 in. (610 mm). The average rotation of the joints nearest to the fault are  $\alpha = \tan^{-1}[(47 \text{ in.})\sin(50^\circ)/(120 + 24)\text{in.}] = 14.0^\circ$ . The actual rotation of these joints was measured as  $13.0^\circ - 14.0^\circ$ . The measured and theoretical rotations are in good agreement.

Figure 9.9. Joint Rotation versus Fault Displacement

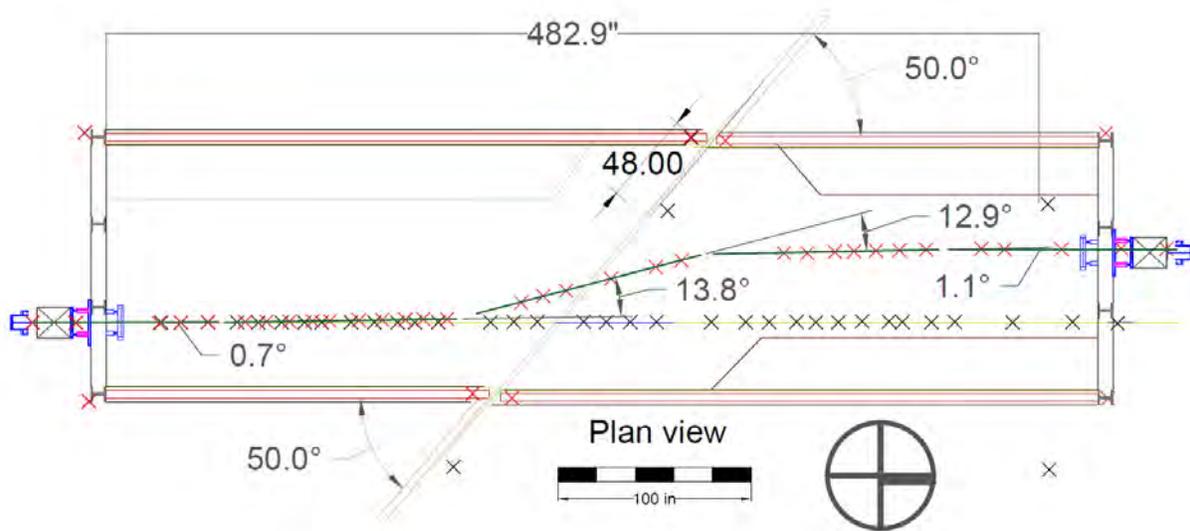
Figures 9.10 shows, at actual scale, the Leica data for the initial and final pipeline positions. The survey data were used to estimate the overall joint rotations, or deflections, at the South and North Middle Joints of 13.8° and 12.9°, respectively. These survey measurements are very close to the maximum rotations between 13.0° and 14.0° of the South and North Middle Joints as measured by the string pots.

Figure 9.10. Leica Survey Showing Deformed Pipeline with AP2 Lining after Fault Rupture Test

Figure 9.26 shows the deformation of the South Middle Joint in the form of pullout and rotation. The metal shielding has also slipped longitudinally to the north. Curvature in the lining is visible where it is exposed between the bell face and spigot end. Approximately 10 in. (254 mm) of separation between the bell and lining can be seen. This adds to the 3.34 in. (85 mm) of spigot insertion into the bell before the fault rupture test to result in total pullout of 13.34 in. (339 mm), which is nearly equal to the maximum South Middle Joint movement plotted in Figure 9.10.

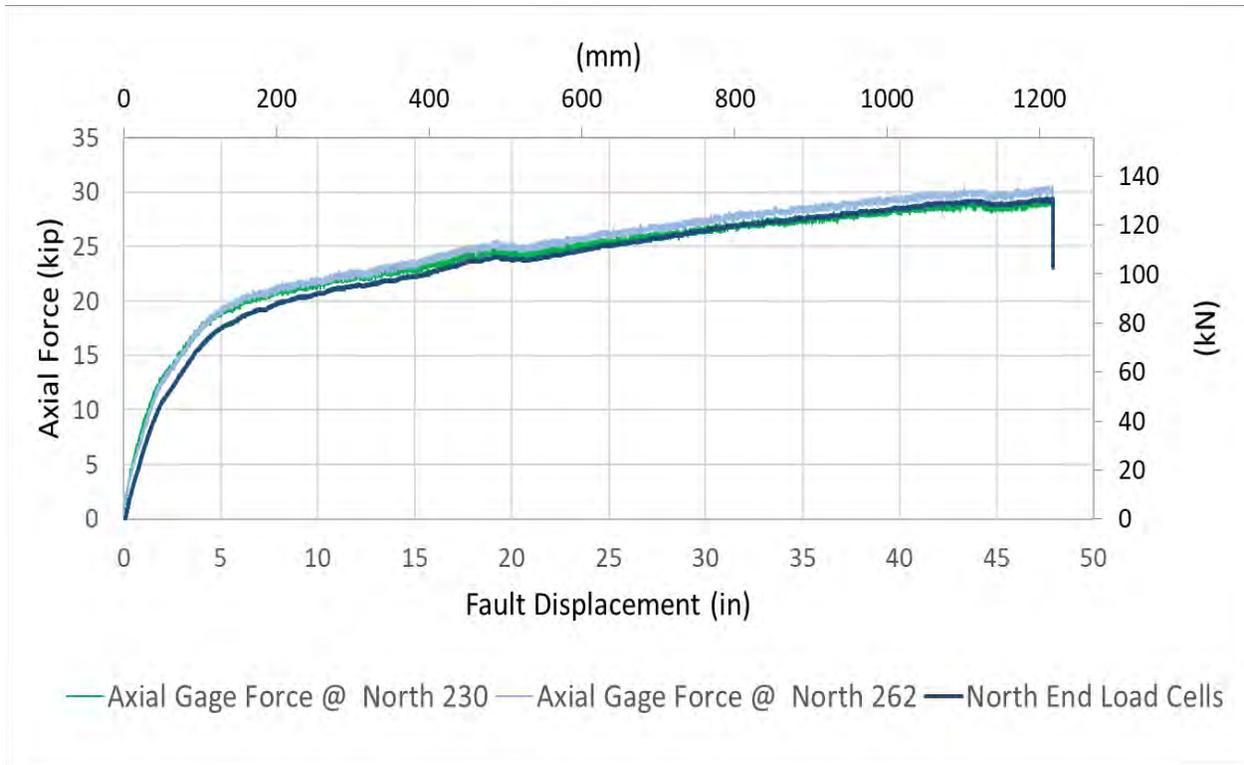
Figure 9.11 plots with respect to fault displacement the axial load from the north end load cells and the combined axial force in both the DI pipe and AP2 lining,  $F_{PL}$  (Equation 9.2), for the gage planes at 230 and 262. The loads are nearly equal at all magnitudes of fault displacement, with a maximum load of approximately 30 kips (133 kN) at 48 in. (1.22 m) of fault movement.

Figure 9.11. Axial Force in Both Pipe and Lining Measured by North End Load Cells and Strain Gage Planes 230 and 262.

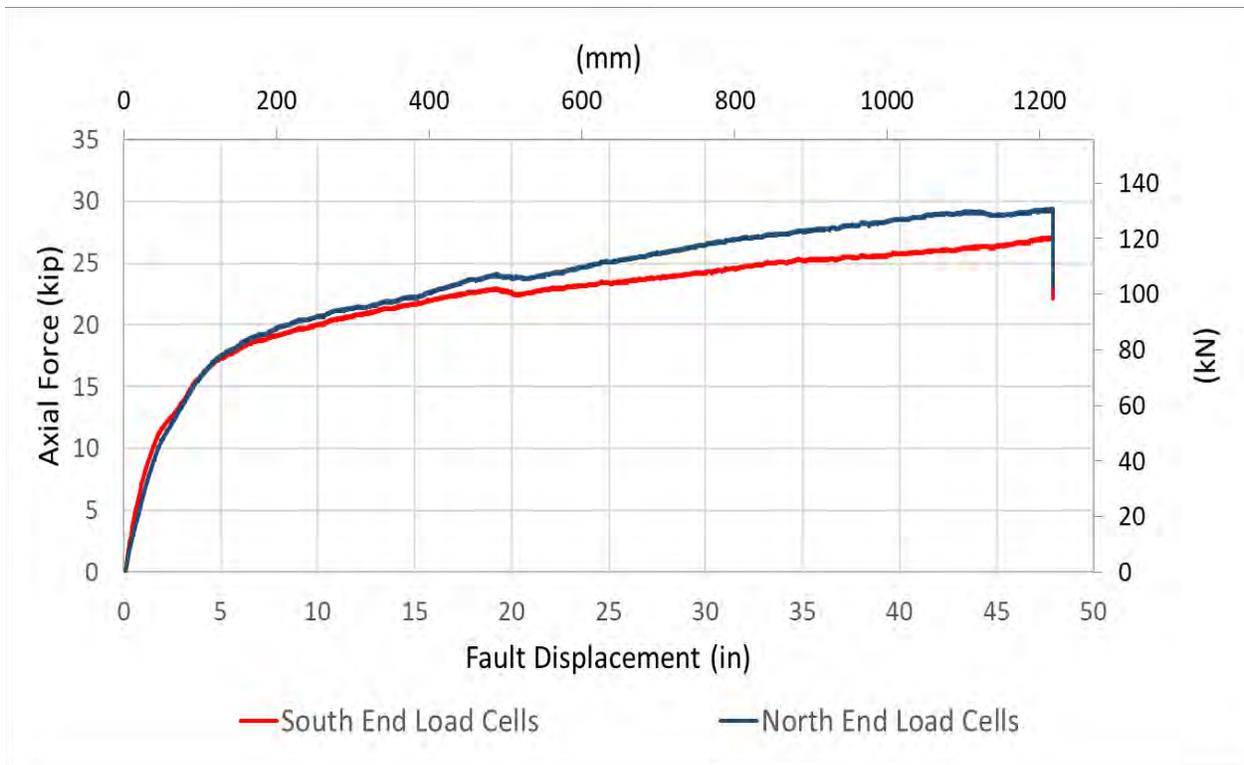
Figure 9.12 plots with respect to fault displacement the axial load from both the north and south end load cells. The axial load is smaller at the south end than at the north end at most of the fault displacements. The south end load is a maximum of approximately 27 kips (120 kN) at 48 in. (1.22 m) of fault movement.

Figure 9.12. Axial Force in Both Pipe and Lining Measured by North and South End Load Cells

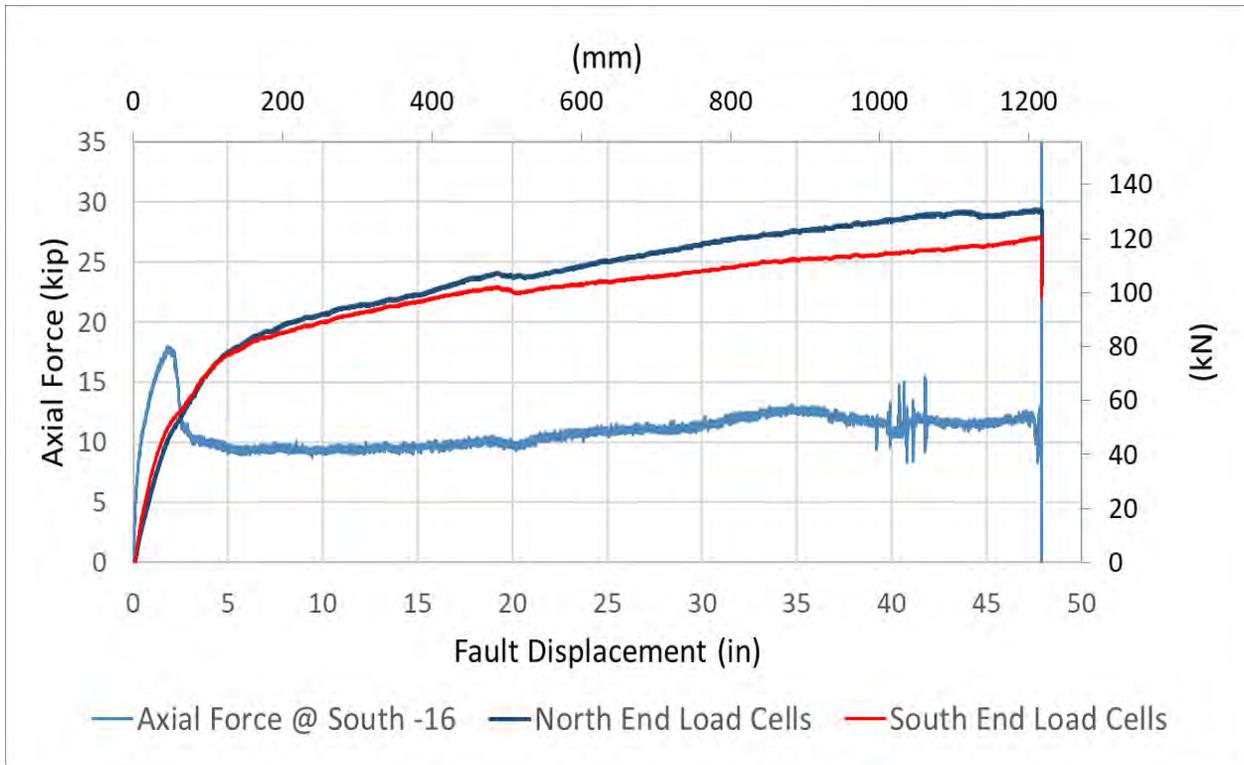
Figures 9.13 and 9.14 show plots of the axial forces relative to the base case for Stations -16 and 16, respectively. These stations are 16 in. (406 mm) south and north of the fault (see Figure 9.1). As previously discussed, joint pullout was initiated at the South Middle Joint closest to the fault. Debonding occurred northward from the closest south joint. At approximately 2 in. (51mm) of fault displacement there is a decrease in strain at Station -16 as shown in Figure 9.13. The difference between the base case and axial force at 2 in. (51 mm) of fault movement is approximately an additional 7 kips (31 kN) of pipe force. Under  $K_0$  conditions the axial force generated by friction between the pipe and adjacent soil is approximately 7 kips (31 kN) from the closest end of the basin to the strain gage station.

Figure 9.13. Axial Force at Station -16 Relative to the Base Case

shown in Figure 9.15. Figure 9.13 and Figure 9.14 show that debonding occurred both northward and southward from the South Middle Joint. The difference between the base case and axial force at 1 in. (25 mm) of fault movement is approximately an additional 5 kips (22 kN) of pipe force. Under  $K_0$  conditions the axial force generated by friction between the pipe and adjacent soil is approximately 5 kips (22 kN) from the closest end of the basin to the strain gage station.

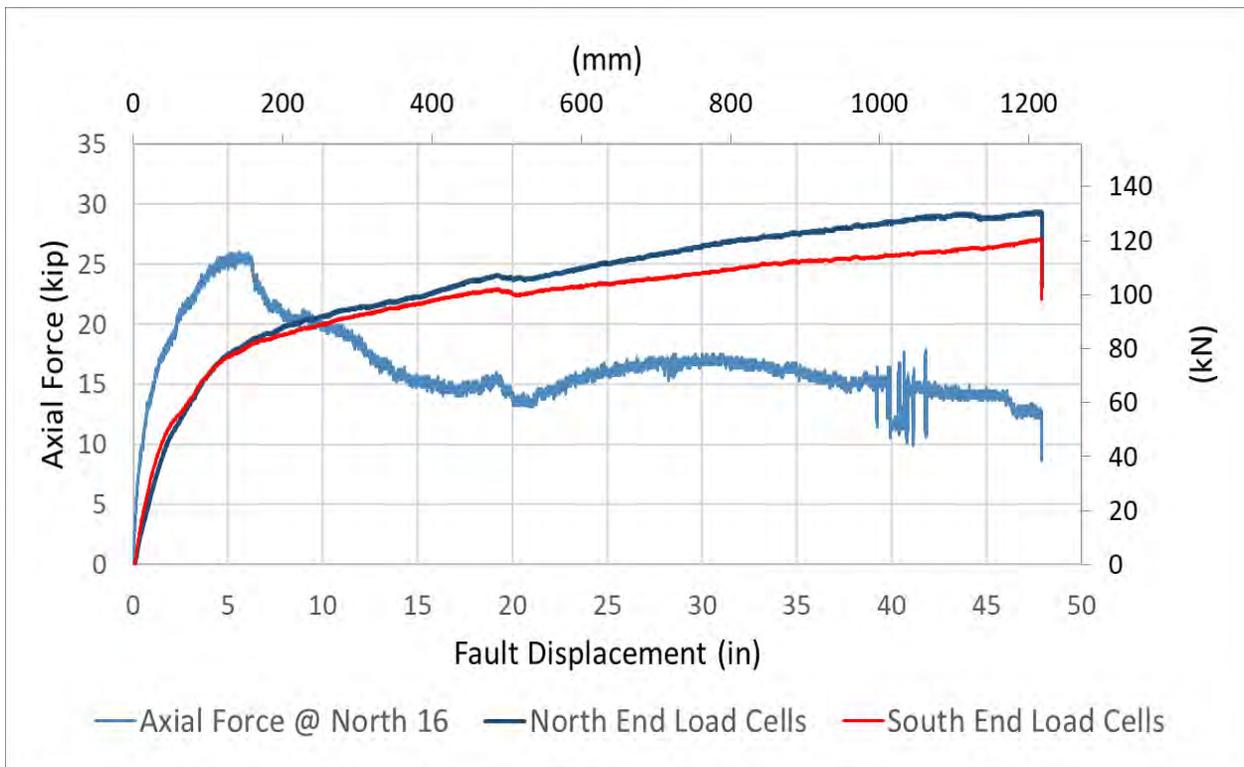
The axial force at Station 16 in Figure 9.14 peaks at approximately 6 in. (152 mm) of fault displacement after which debonding occurs. Again the difference between the base case and maximum axial force in the pipe is approximately an additional 7 kips (31 kN). As for the south joint, the force difference at the closest north joint is equal to the axial force generated by friction between the pipe and adjacent soil under  $K_0$  conditions. The debonding south of the Middle North Joint proceeds more slowly than its southern counterpoint as indicated by the joint axial movements summarized in Figure 9.8.

Figure 9.14. Axial Force at Station 16 Relative to the Base Case
