# Performance Evaluation of Aqua-Pipe under Earthquake-Induced Ground Deformation

## Interim Report

Cornell University

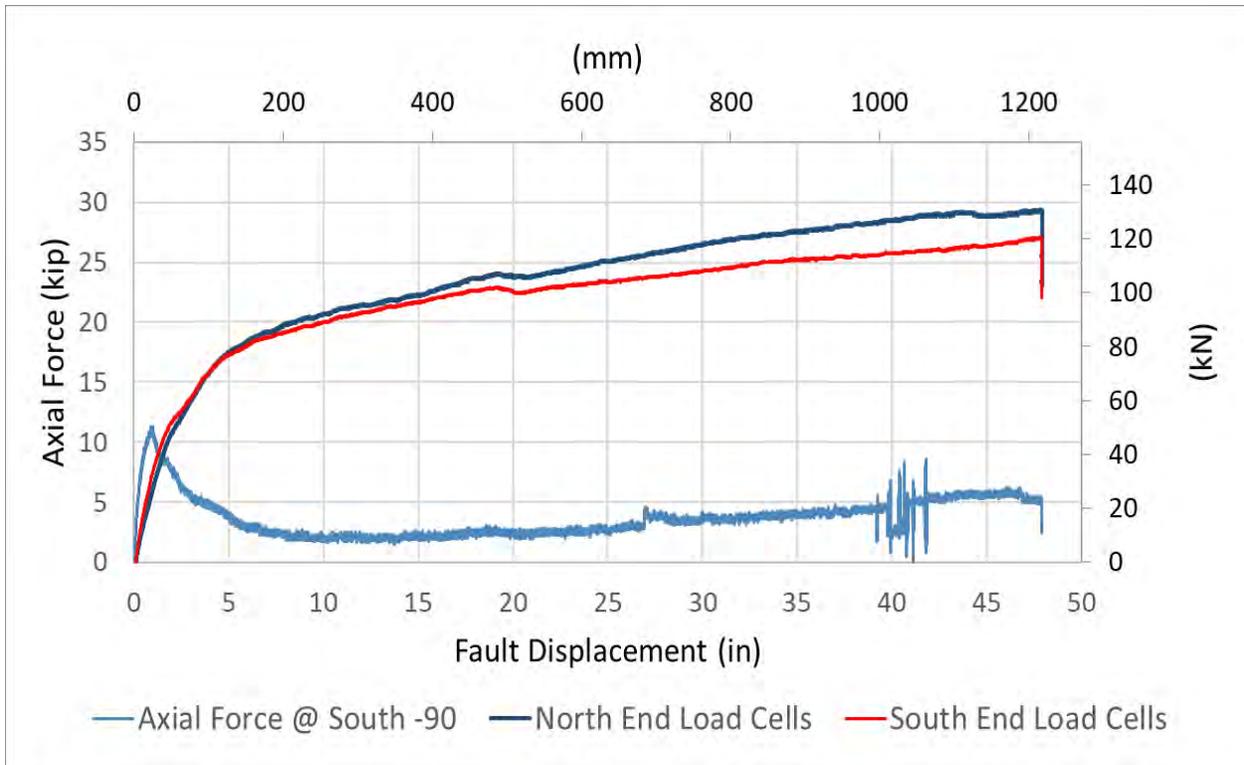
Figures 9.15 and 9.16 show plots of the axial forces relative to the base case for Stations -90 and 90, respectively. These stations are 90 in. (406 mm) south and north of the fault (see Figure 9.1). At approximately 1 in. (25 mm) of fault displacement there is a decrease in strain at Station -90 as

Figure 9.15. Axial Force at Station -90 Relative to the Base Case

shown in Figure 9.15. Figure 9.13 and Figure 9.14 show that debonding occurred both northward and southward from the South Middle Joint. The difference between the base case and axial force at 1 in. (25 mm) of fault movement is approximately an additional 5 kips (22 kN) of pipe force. Under  $K_0$  conditions the axial force generated by friction between the pipe and adjacent soil is approximately 5 kips (22 kN) from the closest end of the basin to the strain gage station.

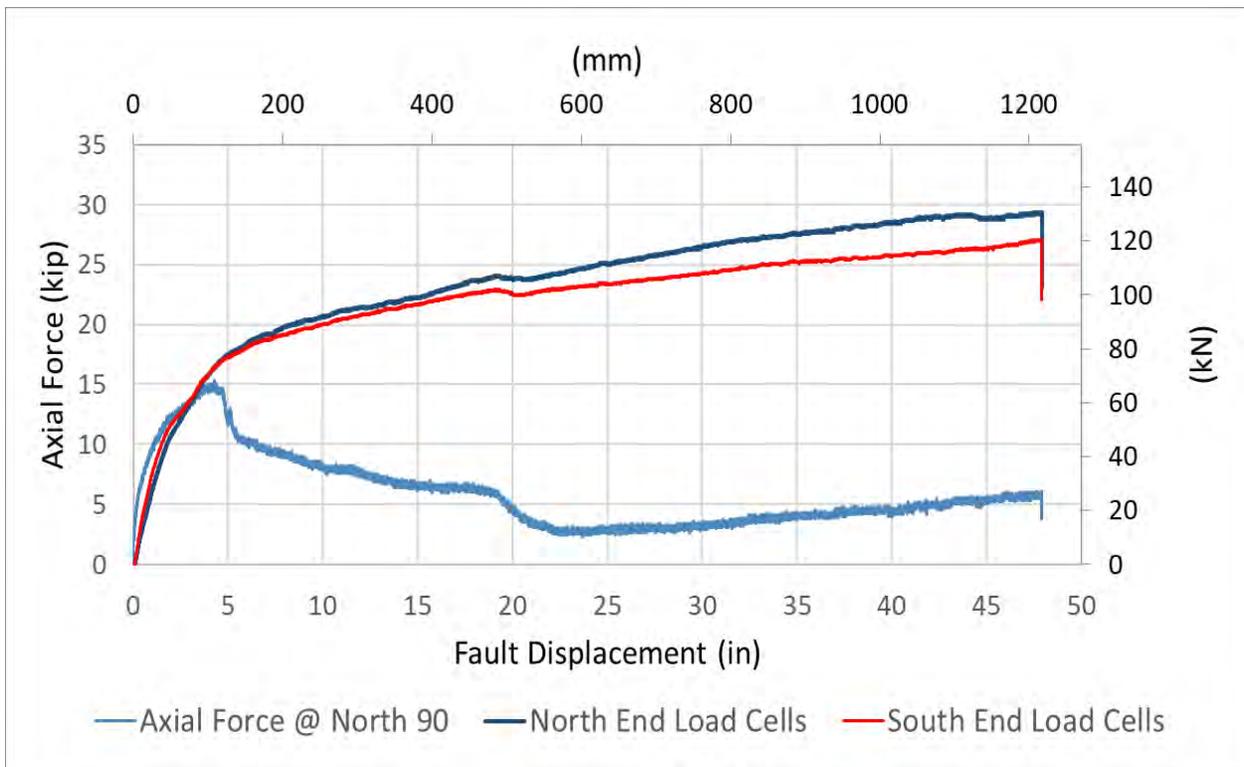
The axial force at Station 90 in Figure 9.16 peaks at approximately 4.5 in. (114 mm) of fault displacement after which debonding occurs. The difference between the base case and maximum pipe axial force is approximately an additional 2.5 kips (11 kN)). Thus, the force at the north joint closest to the fault shows the effects of friction between the pipeline and adjacent soil.

Figure 9.16. Axial Force at Station 90 Relative to the Base Case

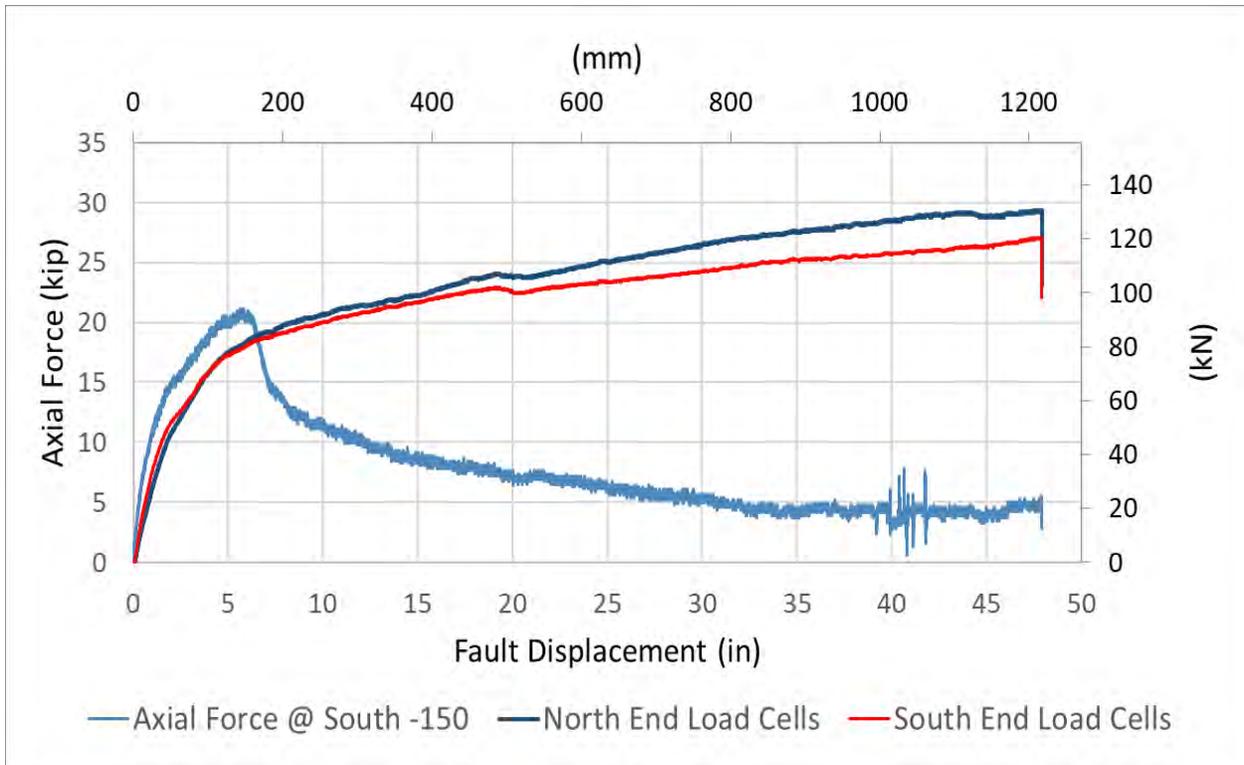
Figures 9.17 and 9.18 show plots of the axial forces relative to the base cases for Stations -150 and 150, respectively. These stations are 150 in. (406 mm) south and north of the fault (see Figure 9.1). At approximately 6 in. (152 mm) of fault displacement there is a decrease in strain at Station -150 as shown in Figure 9.17. Debonding occurred southward from the Middle South Joint. The difference between the base case and axial force at 6 in. (152 mm) of fault movement is an additional 2 kips (9 kN) of pipe force. Under  $K_0$  conditions the fictional force between the pipe and adjacent soil is about 2 kips (9 kN) from the closest end of the basin to the strain gage station.

Figure 9.17. Axial Force at Station -150 Relative to the Base Case

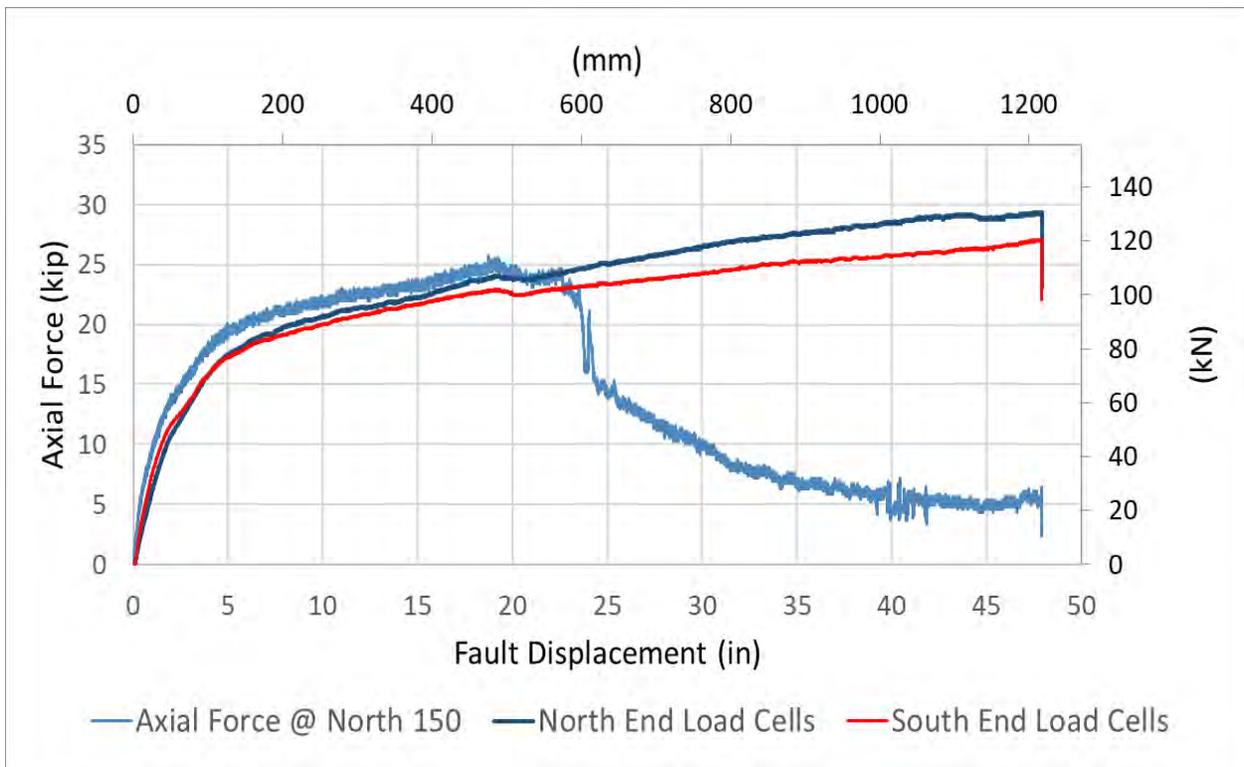
The axial force at Station 150 in Figure 9.18 peaks at approximately 20 in. (508 mm) of fault displacement after which debonding occurs. The difference between the base case and maximum axial force in the pipe is approximately an additional 1 kip (4.45 kN). The force differential is close in magnitude to the axial force difference at Station -150 at an equal distance south of the fault. Debonding occurs at this station at a relatively large fault movement of 20 in. (508 mm), and thus progresses more slowly in the northern part of the test pipeline.

Figure 9.18. Axial Force at Station 150 Relative to the Base Case

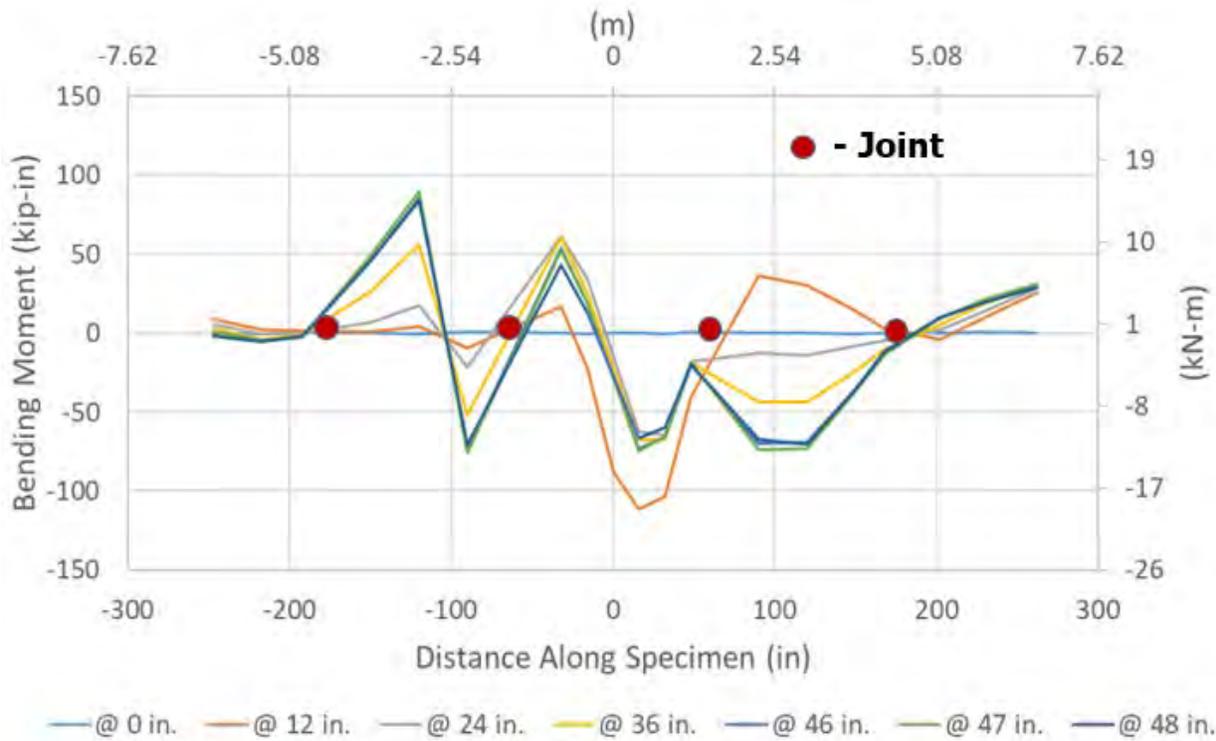
Figure 9.19 presents the bending moments measured along the pipeline corresponding to fault displacements of 0, 12 in. (305 mm), 24 in. (610 mm), 36 in. (914 mm), 47 in. (1194 mm), and 48 in. (1291 mm). Also shown in the plot as full red circles are the pipeline joints. The strain gage measurements show a complex pattern in which the moments are very low or nearly zero at the joints at all levels of fault displacement. The low moments occur at these locations because the moments are resisted mostly or entirely by the AP2 lining.

At 12 in. (305 mm) of fault displacement there was little debonding in the northern portion of the test pipeline; most of the debonding was concentrated in the southern portion. Thus at 12 in. (305 mm), the maximum bending strains were measured at relatively low debonding conditions on the

Figure 9.19. Bending Moments in Pipeline vs. Distance from Fault

northern part of the test pipeline. At higher levels of fault displacement, debonding continued in a complex pattern in which bending strains increased then decreased, resulting in the measurements shown in Figure 9.19.

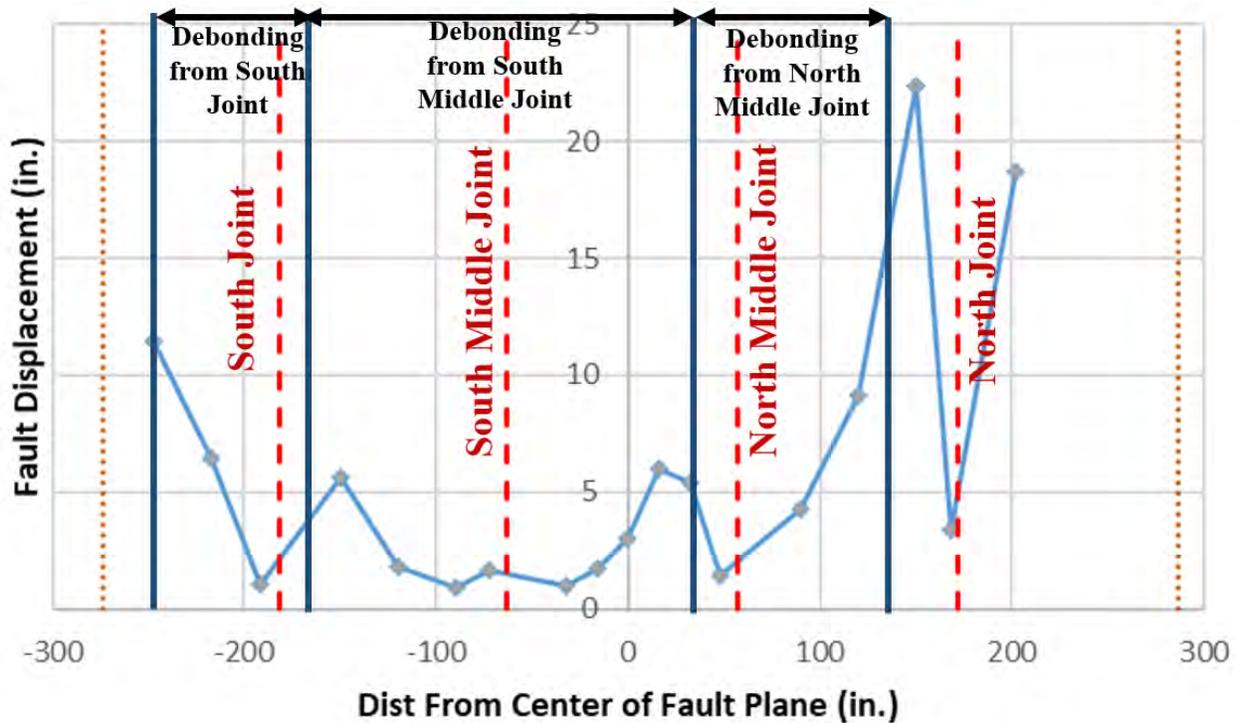
Figure 9.20 is a plot of the fault displacement at each station relative to the station location as distance from the center of the fault plane. As indicated in Section 9.3.3 Joint Pullout, debonding began first at the South Middle Joint and progressed both north and south of that joint over the distance shown in the figure. North Middle and South Joints debonding lengths could also be estimated, as shown in the figure. Because Figure 9.8 showed little or no North Joint opening at fault displacements related to debonding, the debonding of the North Joint could not be estimated

Figure 9.20. Fault Displacement at Debonding for Each Gage Station

reliably. Please note that the gages at 72 in. south of the fault were not used because of instability with the gage readings. All others were used. In each instance the axial load at the ends of the debonded length were checked for equality. This check helped to determine the direction of debonding.

From Figure 9.20 one can estimate the fault displacement at which debonding occurs at each joint. From Figure 9.8 one can evaluate the axial joint movement at each fault displacement. When one uses the two figures, both the joint displacement, or opening, and the debonded length can be assessed.

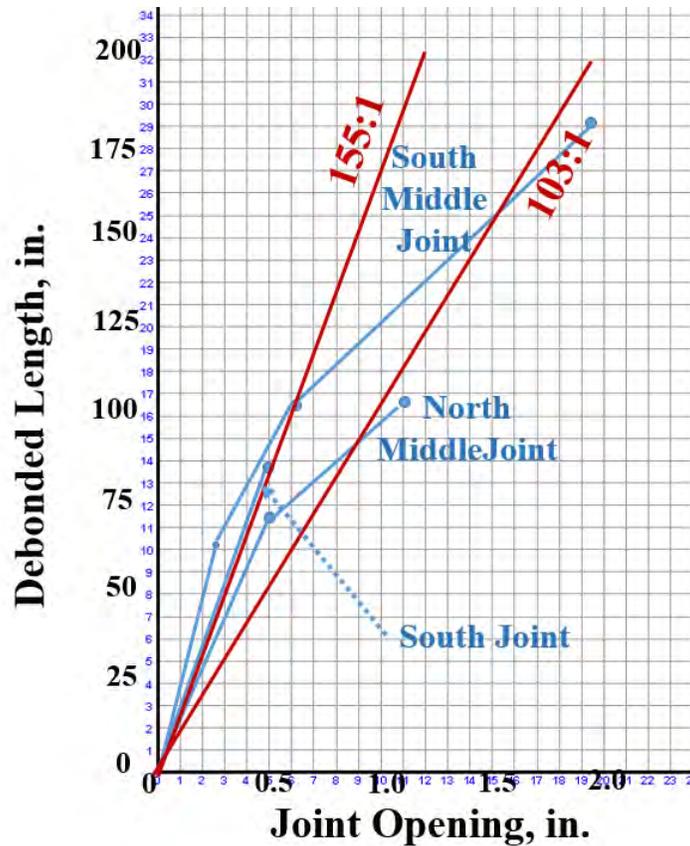
Figure 9.21. Debonded Length versus Joint Opening

Figure 9.21 shows the debonded length vs joint opening from the data for the South Middle, North Middle, and South Joints plotted relative to  $L/\delta$  for  $P = 10$  and 15 kips, both in the elastic range and representative of loads measured at debonding. As shown in the figure,  $L/\delta$  for the fault rupture test data are consistent with the appropriate elastic range.

constant below  $P = 15.5$  kips. For debonding loads of  $P$  equal to 10 and 15 kips, the values of  $L/\delta = 103$  and 155, respectively. For strains  $\leq 1\%$  the elastic displacement can be calculated very closely from  $E$  in the warp direction.

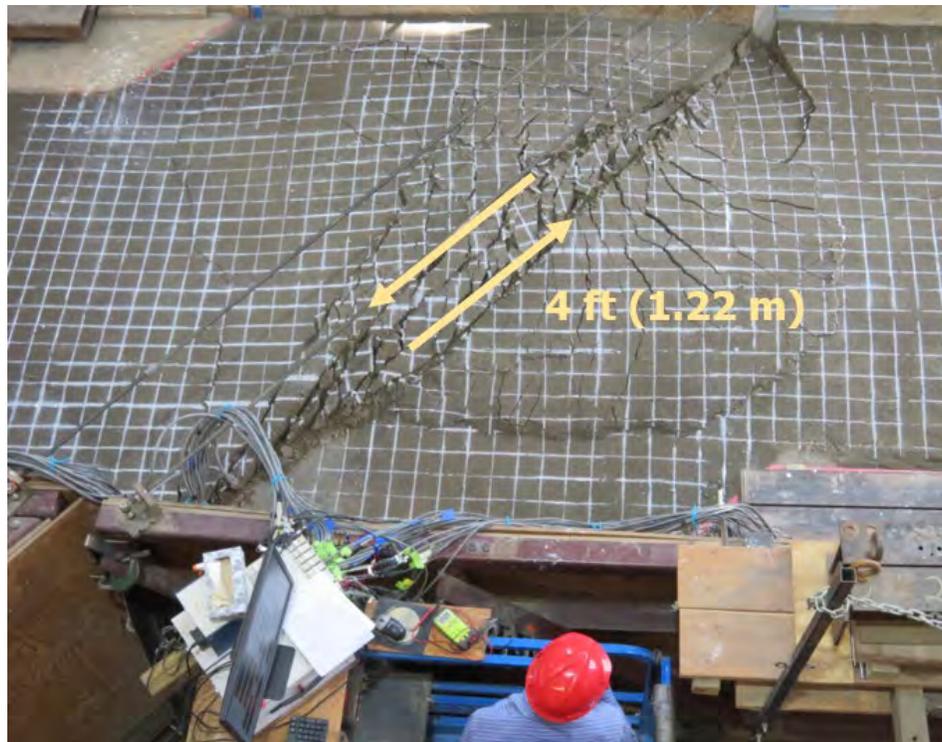
Figure 9.22 shows the maximum fault rupture of 4.00 ft. (1.22 m) or 48 in. (1,220 mm). The project consultant who operated the instrumentation, Blake Berger, is also shown in the photograph for scale. Figure 9.23 presents a photo of the pipeline upon excavation and exposure for survey measurements after the fault rupture test. The four test pipeline joints are identified in the figure. The Leica survey measurements of 13.8° and 12.9° for the South and North Middle Joints, respectively, are shown on the photo. These measurements are the same that are presented in Figure 9.10. These data provide test pipeline movements at locations very close to the maximum at the largest basin displacement. Figure 9.24, Figure 9.25, Figure 9.26, and Figure 9.27 are photos after the fault rupture test of the deformation at the North Joint, North Middle Joint, South Middle Joint, and South Joint.

Figure 9.22. Maximum Fault Rupture

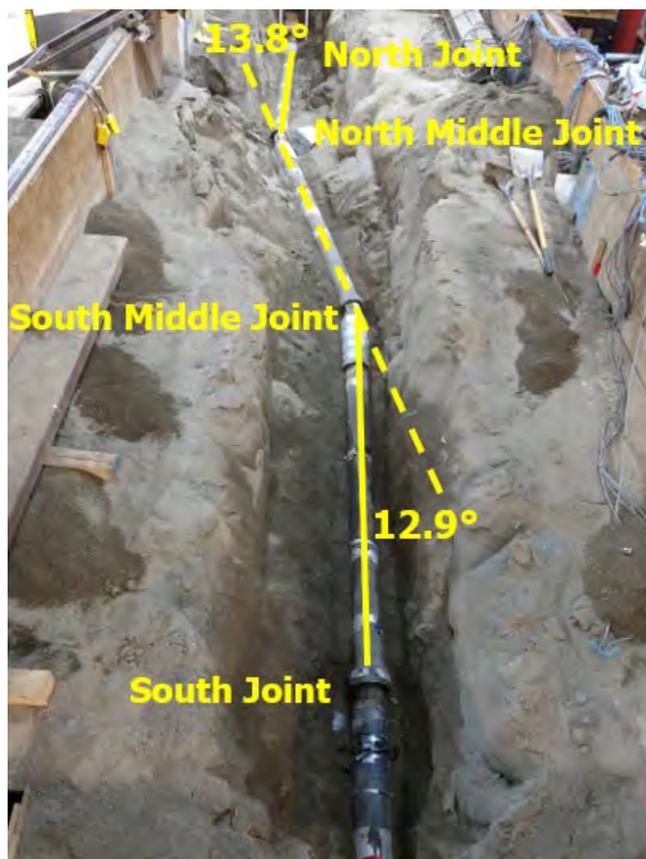
Figure 9.23. Test Pipeline Deformation after Fault Rupture Test

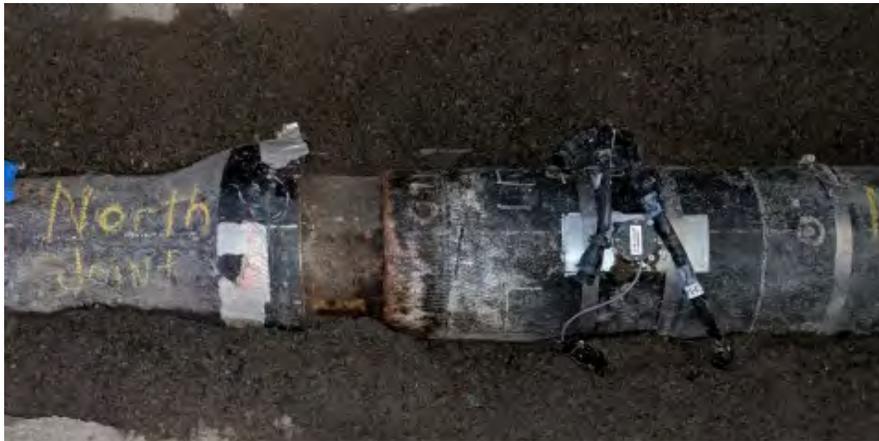
Figure 9.24 shows the deformation at the North Joint primarily as pullout of the spigot from the bell of the DI pipeline. The AP2 lining is visible in the gap between the spigot and the bell, which is facing northward. Please note that the longitudinal deformation at this joint has been affected by reduction in tensile load in the lining after the water pressure was turned off, but before exposure of the test pipeline for the Leica survey. Hence, the joint longitudinal deformation in the photo exceeds that shown by the measurements plotted in Figure 9.8. In contrast, the longitudinal deformation shown by the photos of the three remaining joints is consistent with the displacements shown in Figure 9.8.

Figure 9.24. Deformation at North Joint

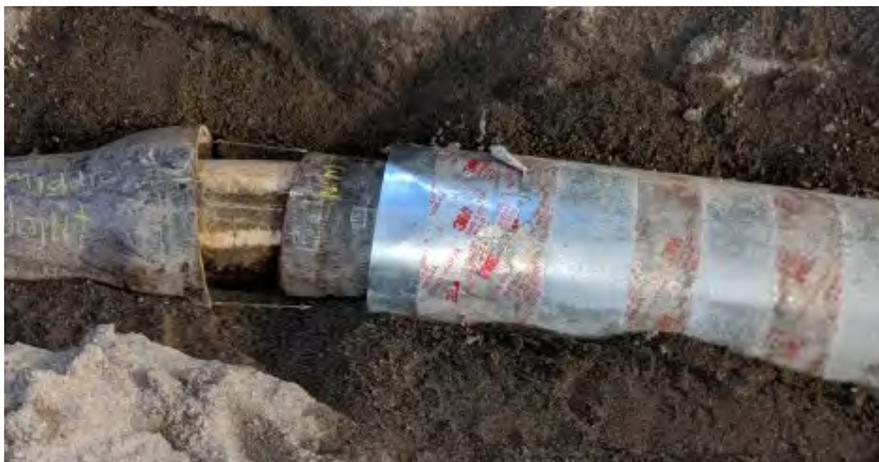
Figure 9.25 shows the deformation of the North Middle Joint in the form of pullout and rotation. The metal shielding has slipped longitudinally to the north. The AP2 lining is visible in the gap between the spigot and the bell. Curvature in the lining can be seen.

Figure 9.25. Deformation at North Middle Joint

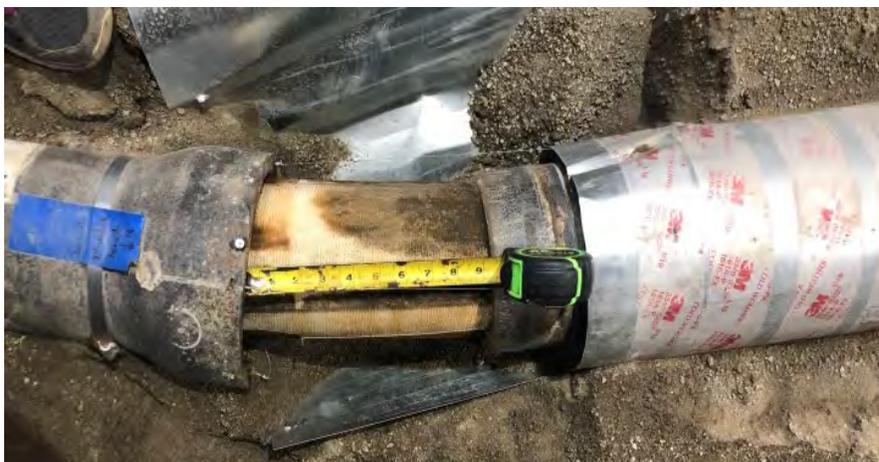
Figure 9.26. Deformation at South Middle Joint

Figure 9.26 shows the deformation of the South Middle Joint in the form of pullout and rotation. The metal shielding has also slipped longitudinally to the north. Curvature in the lining is visible where it is exposed between the bell face and spigot end. Approximately 10 in. (254 mm) of separation between the bell and lining can be seen. This adds to the 3.34 in. (85 mm) of spigot insertion into the bell before the fault rupture test to result in total pullout of 13.34 in. (339 mm), which is nearly equal to the maximum South Middle Joint movement plotted in Figure 9.10.

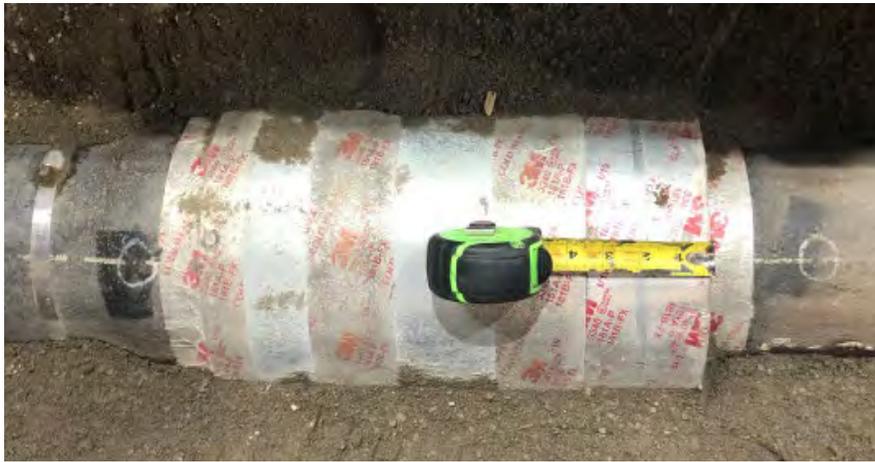
Figure 9.27. Deformation at South Joint

Figure 9.27 shows the deformation of the South Joint primarily in the form of pullout. The metal shielding has remained intact, and longitudinal slip between the two levels of metal shielding is about 3.75 in. (95 mm) as measured by the tape. The actual movement of the spigot with respect to the bell face cannot be ascertained in this photo.

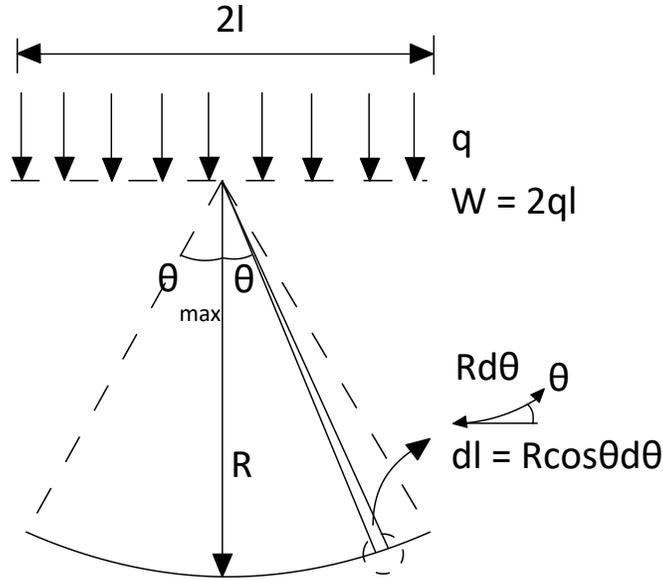
Weight applied to a circular arc sliding surface must be resolved into its component normal to the sliding surface to evaluate friction. Figure A.1 is a transverse cross-section of a symmetrical circular arc sliding surface, defined by radius,  $R$ , and the maximum angle,  $\theta_{\max}$ , relative to the vertical.

Figure A.1. Transverse Cross-section of a Uniformly Distributed Weight on a Circular Arc

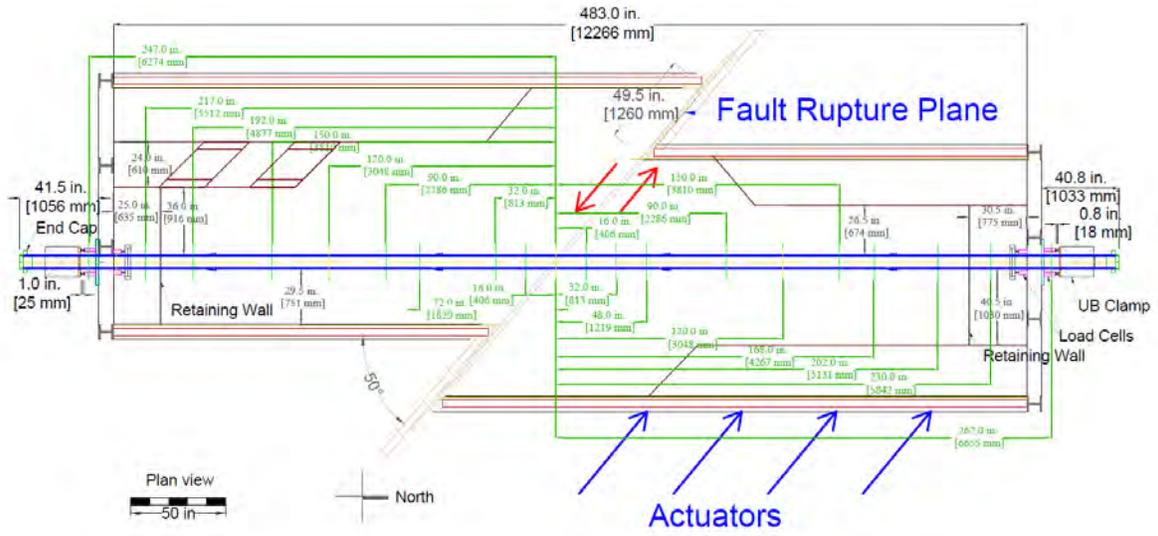
Figure C.1 (identical to Figure 9.1) is a plan view of the test layout that shows the fault rupture plane and approximate locations of the four actuators generating basin movement. The strain gage stations are numbered according to distance north (+) and south (-) of the fault plane in inches. As listed in Table 9.1, the Strain Gage Stations are (-247), (-217), (-192), (-150), (-120), (-90), (-72), (-32), (-16), (0), (+16), (+32), (+48), (+90), (+120), (+150), (+168), (+202), (+230), and (+262), which coincide with Figures C.2 through C.21, respectively.

Figure C.1. Plan View of Test Pipeline with AP2 Lining and Gage Station Locations

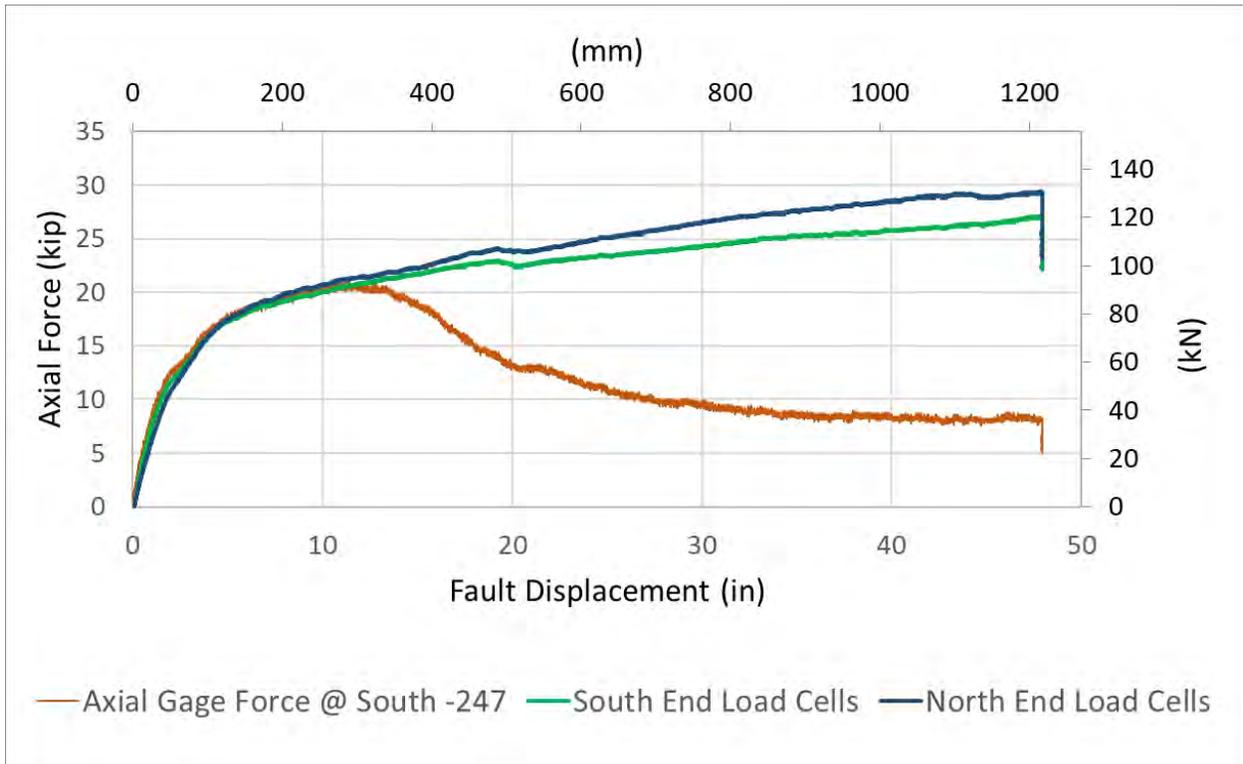
Figure C.2. Axial Force versus Fault Displacement for Strain Gage Station -247

In Appendix C at each strain gage station there are plots of axial force given by Equation 9.2 and the axial load at that station. When plotted relative to the axial force given by Equation 9.2 for the ends of the test pipeline, the reduction in axial load at a given station is easily located. This value coincides with the fault displacement where the axial force starts to decrease because of debonding.

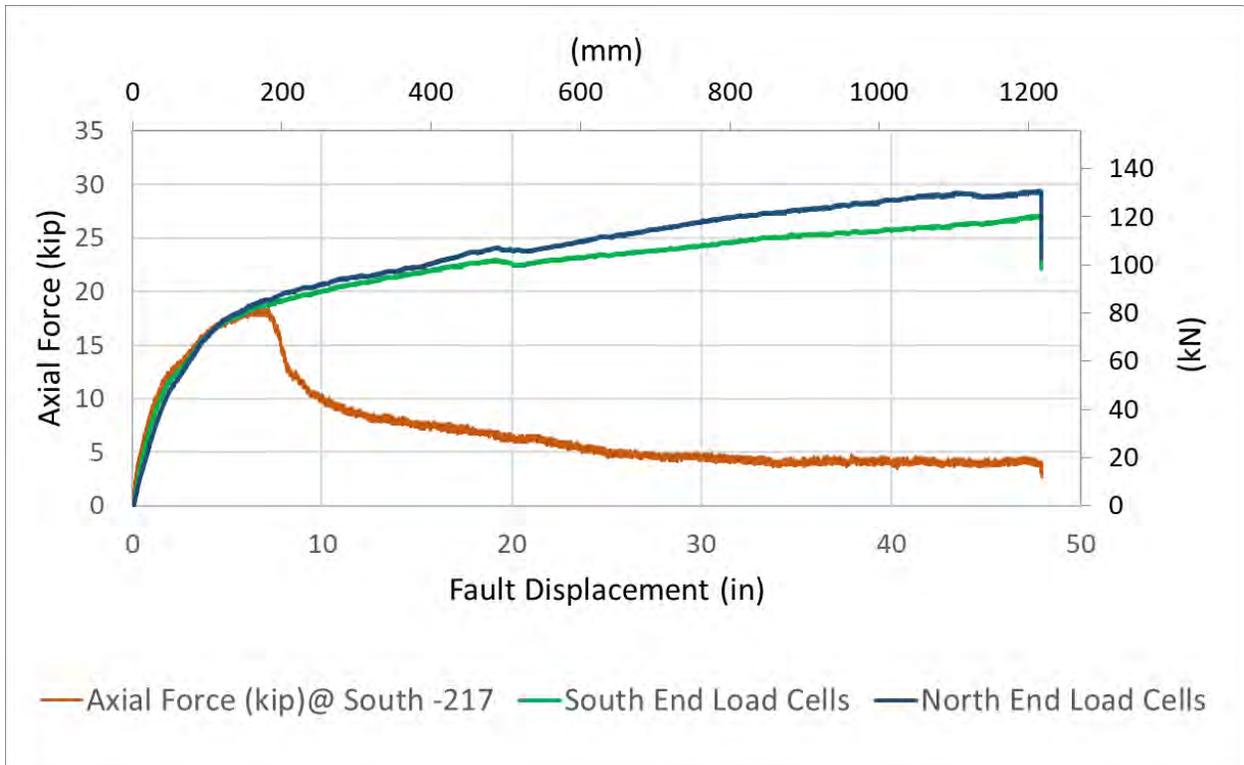
Figure C.3. Axial Force versus Fault Displacement for Strain Gage Station -217

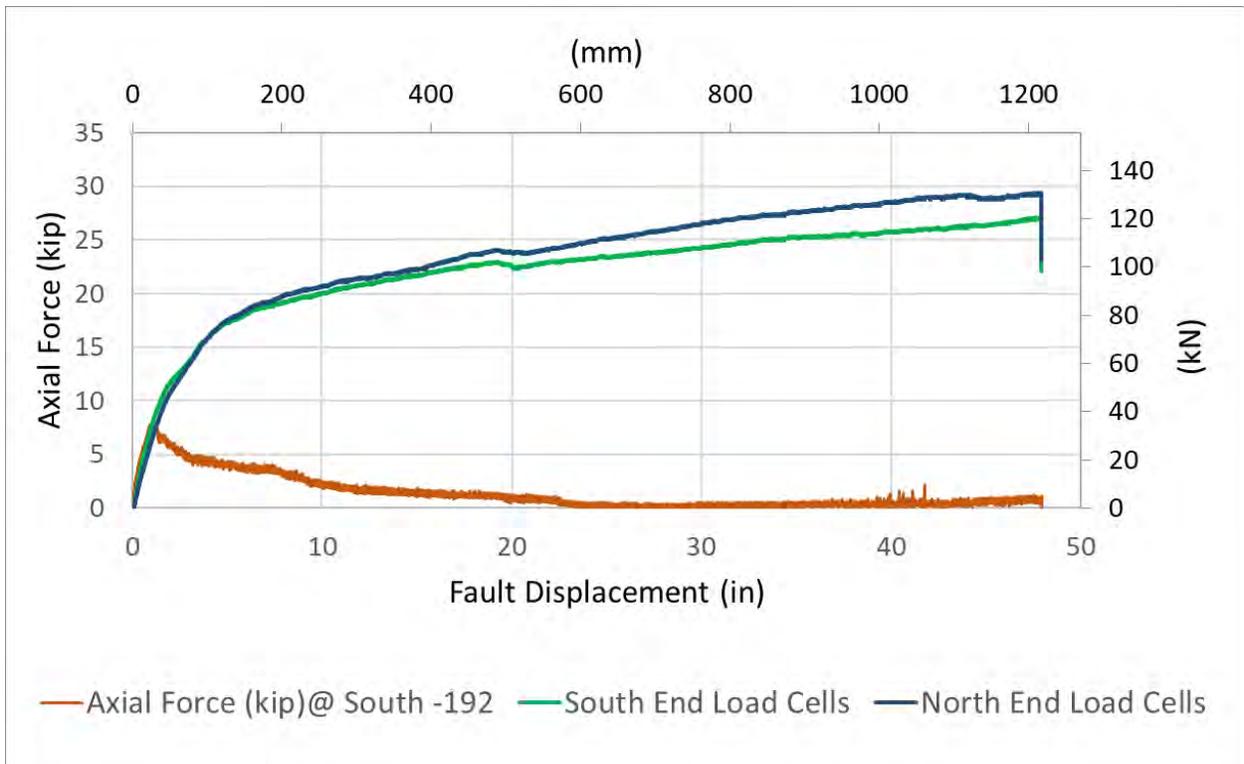
Figure C.4. Axial Force versus Fault Displacement for Strain Gage Station -192

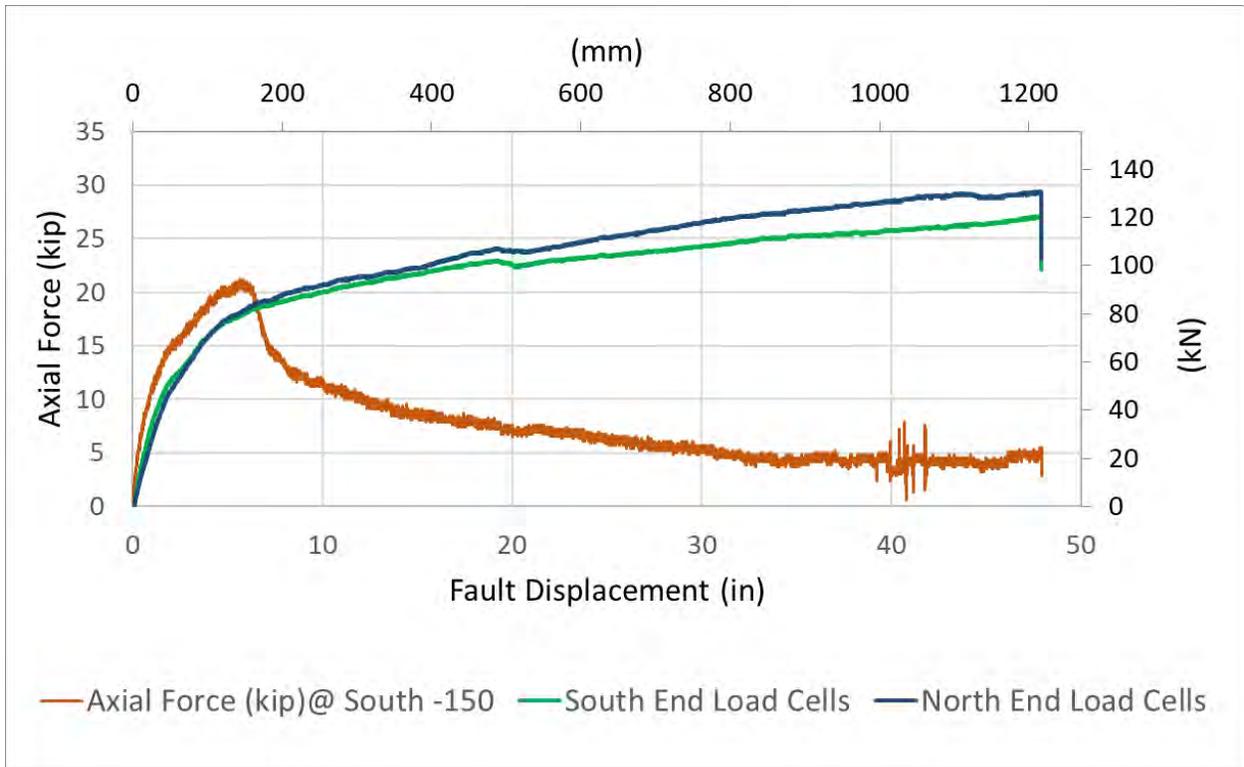
Figure C.5. Axial Force versus Fault Displacement for Strain Gage Station -150

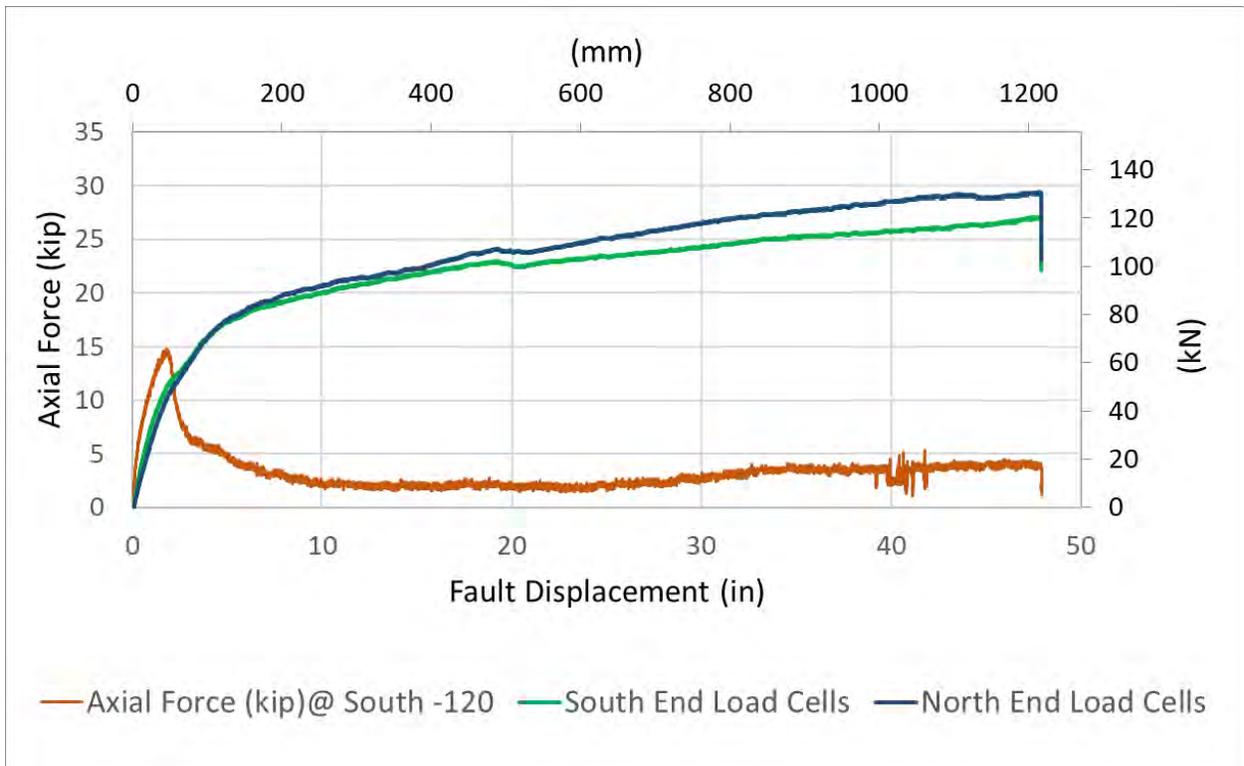
Figure C.6. Axial Force versus Fault Displacement for Strain Gage Station -120

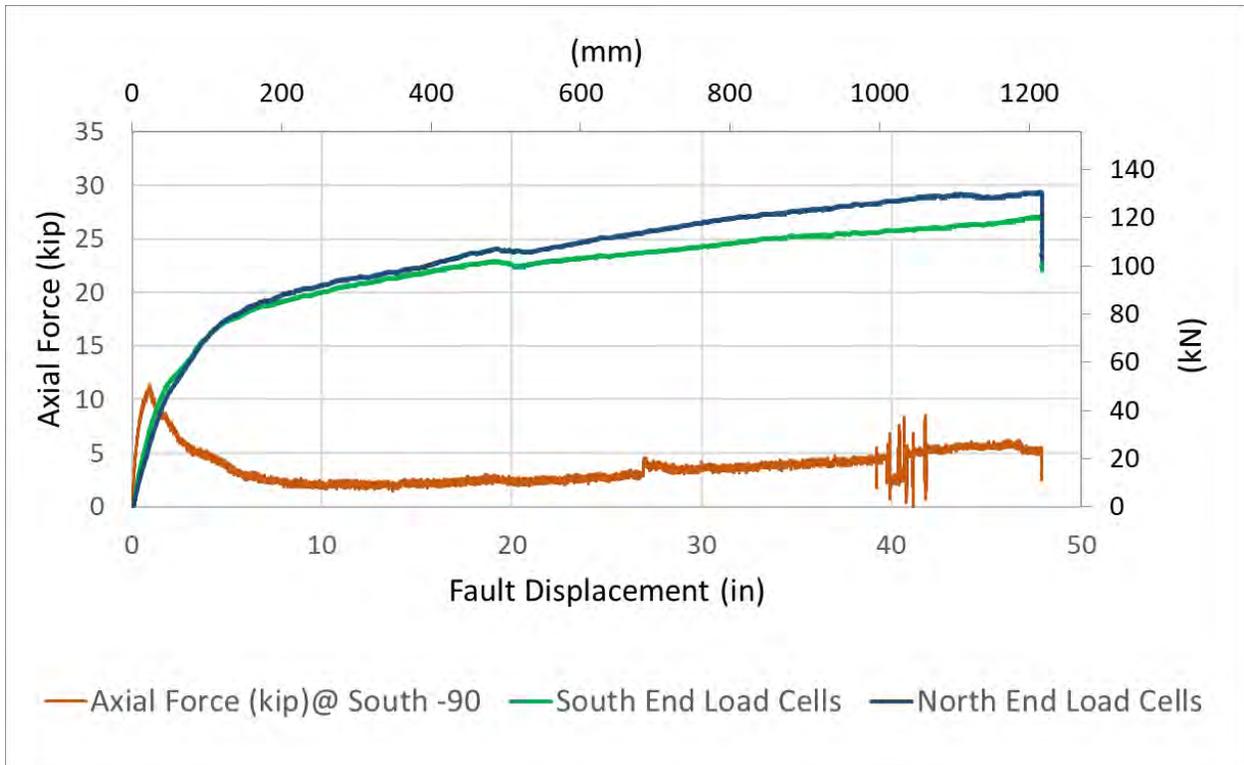
Figure C.7. Axial Force versus Fault Displacement for Strain Gage Station -90

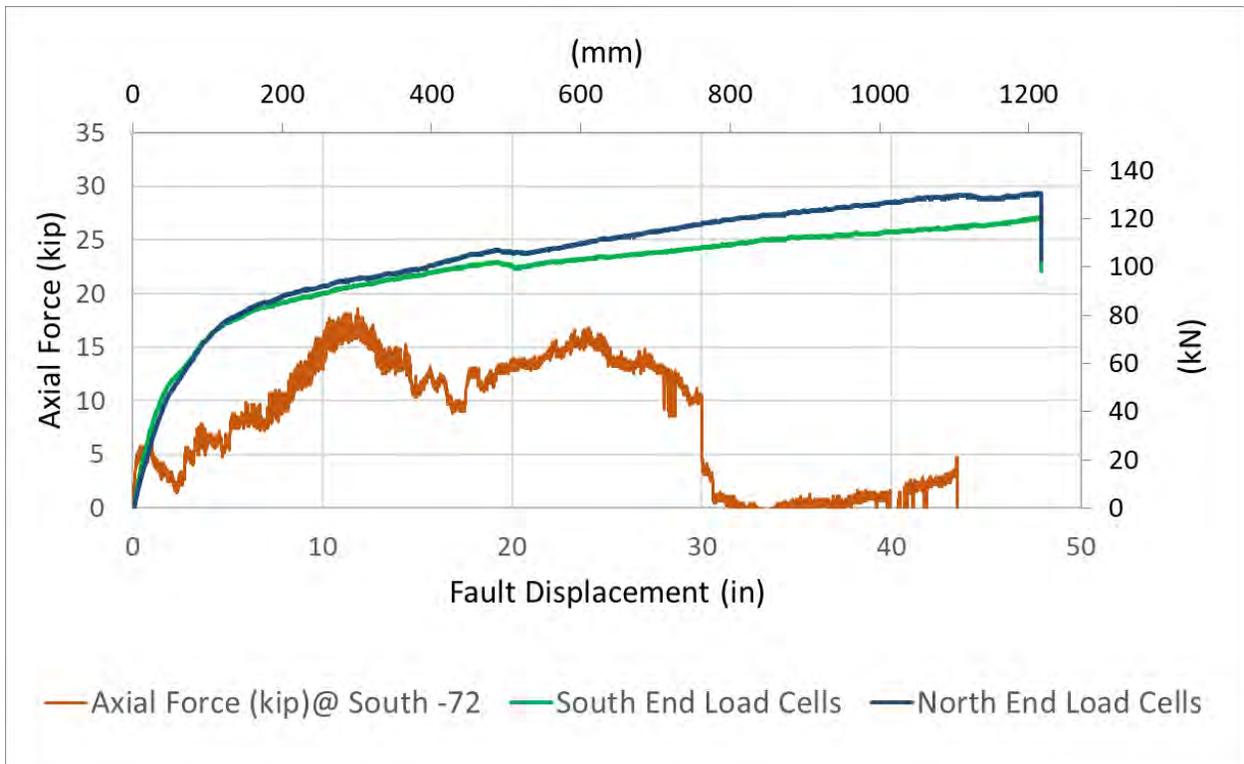
Figure C.8. Axial Force versus Fault Displacement for Strain Gage Station -72

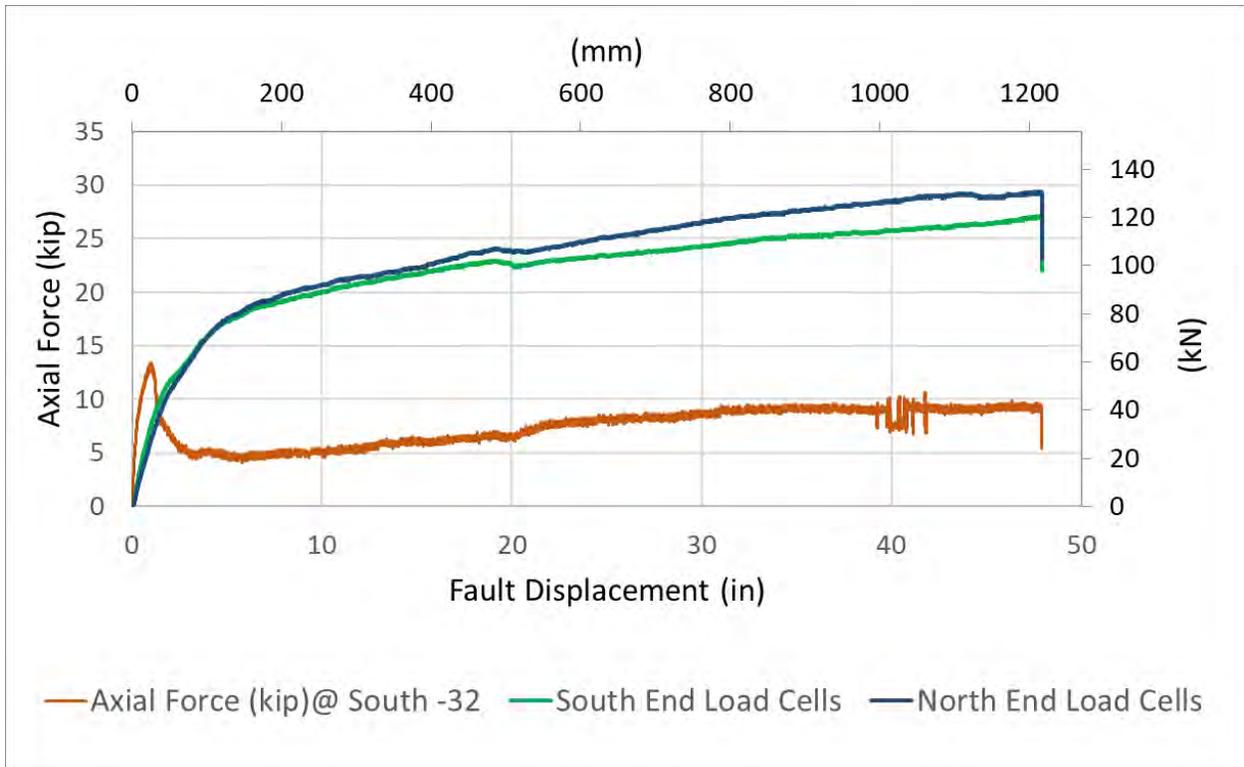
Figure C.9. Axial Force versus Fault Displacement for Strain Gage Station -32

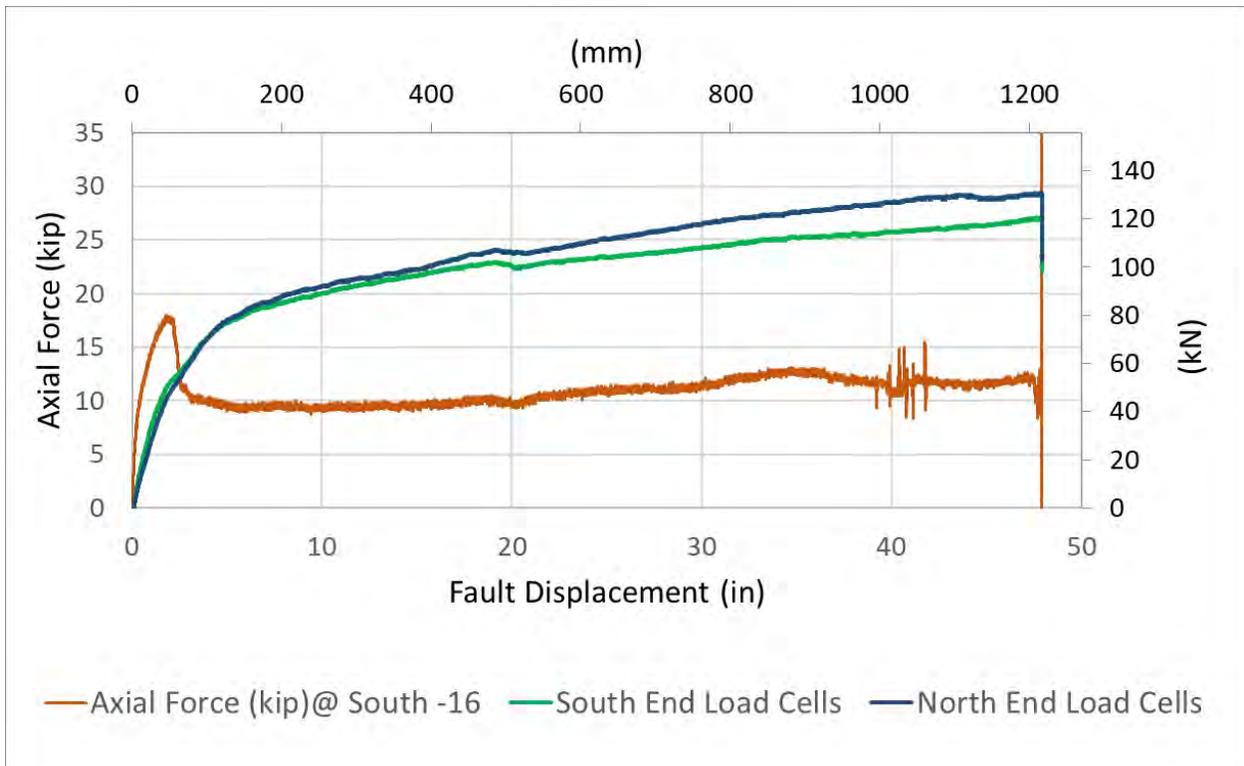
Figure C.10. Axial Force versus Fault Displacement for Strain Gage Station -16

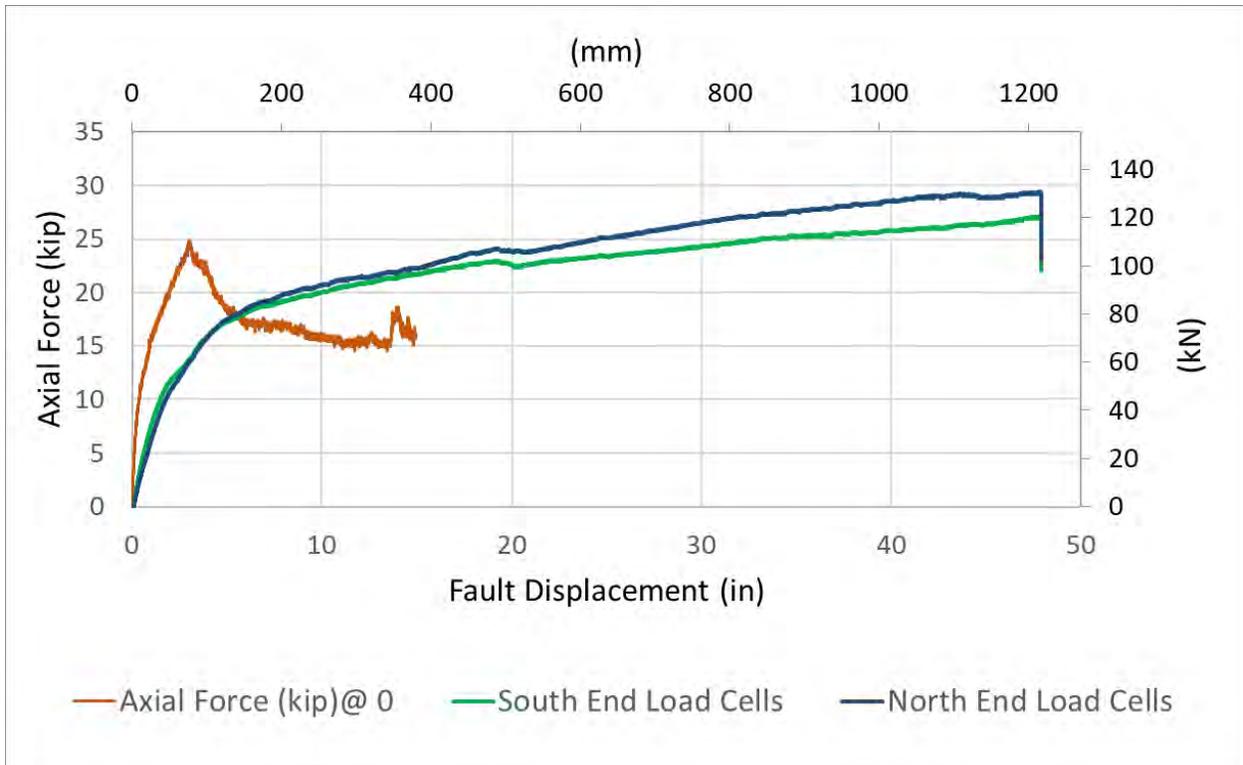
Figure C.11. Axial Force versus Fault Displacement for Strain Gage Station 0
