# Performance Evaluation of Aqua-Pipe under Earthquake-Induced Ground Deformation

## Interim Report

Cornell University

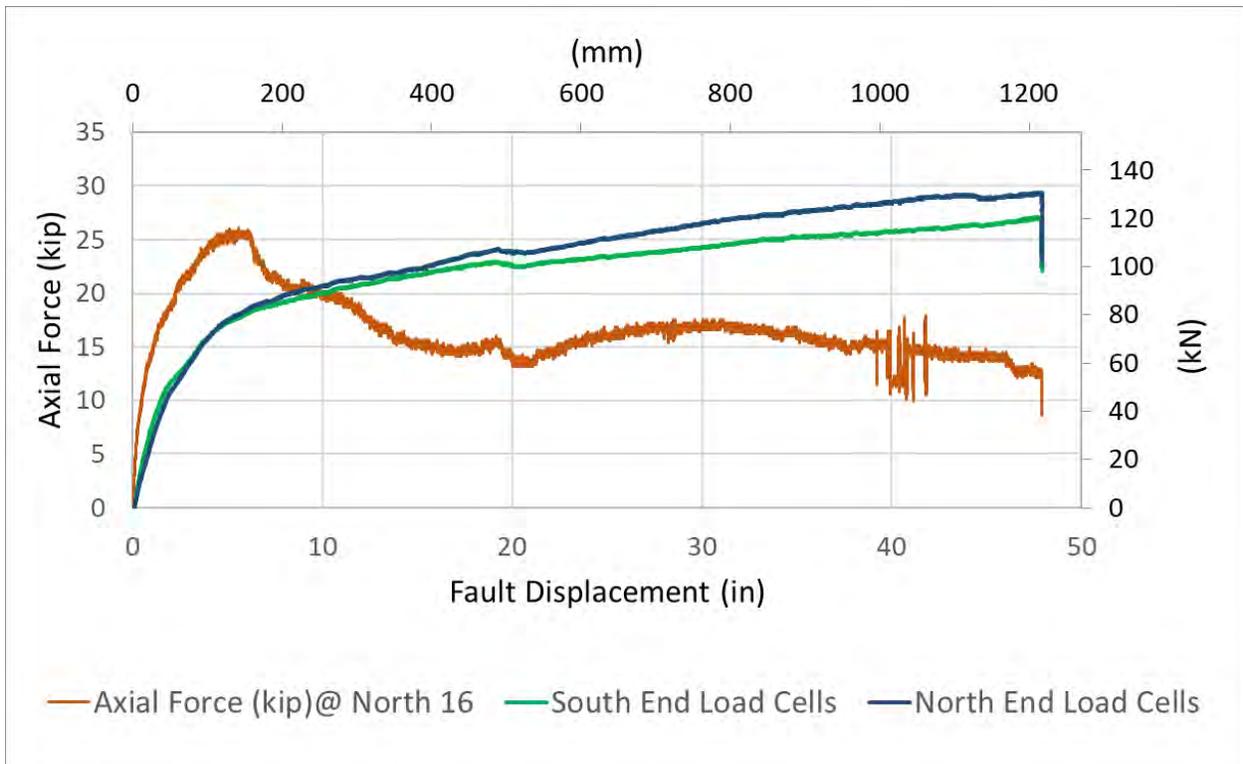
Figure C.12. Axial Force versus Fault Displacement for Strain Gage Station 16

Figure C.1 (identical to Figure 9.1) is a plan view of the test layout that shows the fault rupture plane and approximate locations of the four actuators generating basin movement. The strain gage stations are numbered according to distance north (+) and south (-) of the fault plane in inches. As listed in Table 9.1, the Strain Gage Stations are (-247), (-217), (-192), (-150), (-120), (-90), (-72), (-32), (-16), (0), (+16), (+32), (+48), (+90), (+120), (+150), (+168), (+202), (+230), and (+262), which coincide with Figures C.2 through C.21, respectively.

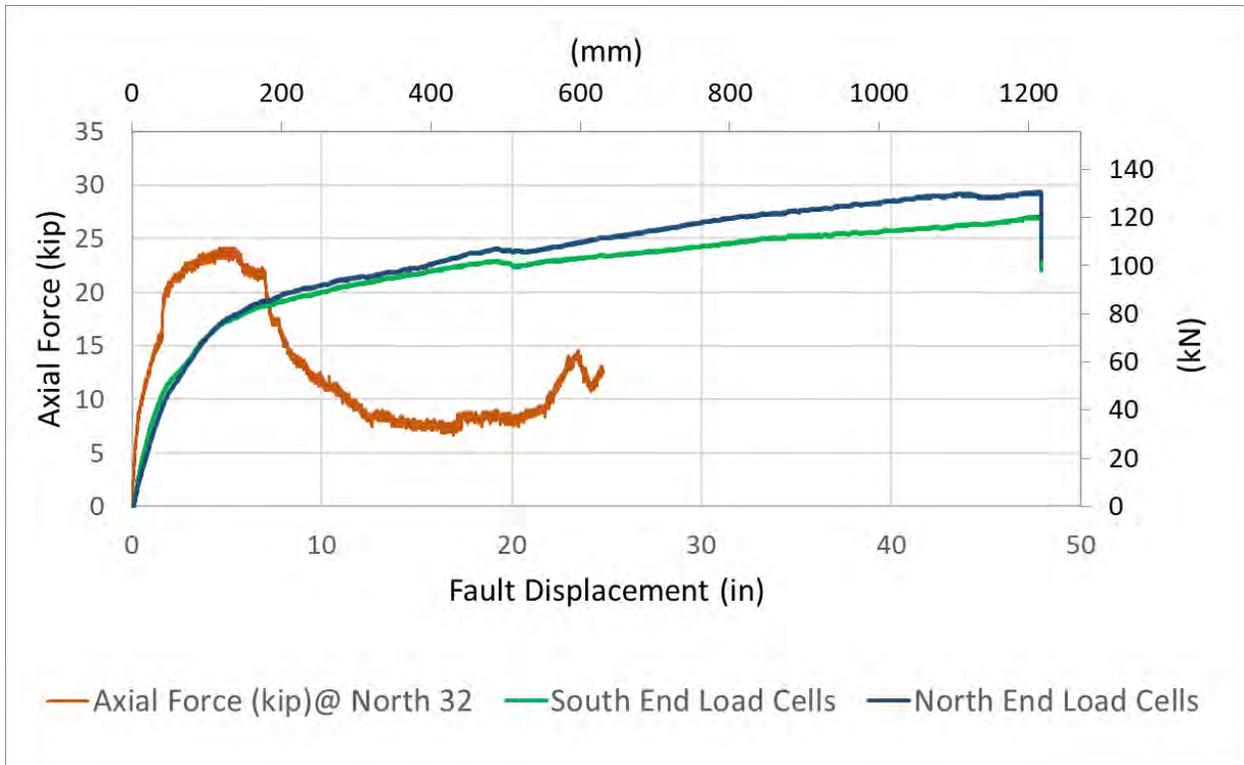
Figure C.13. Axial Force versus Fault Displacement for Strain Gage Station 32

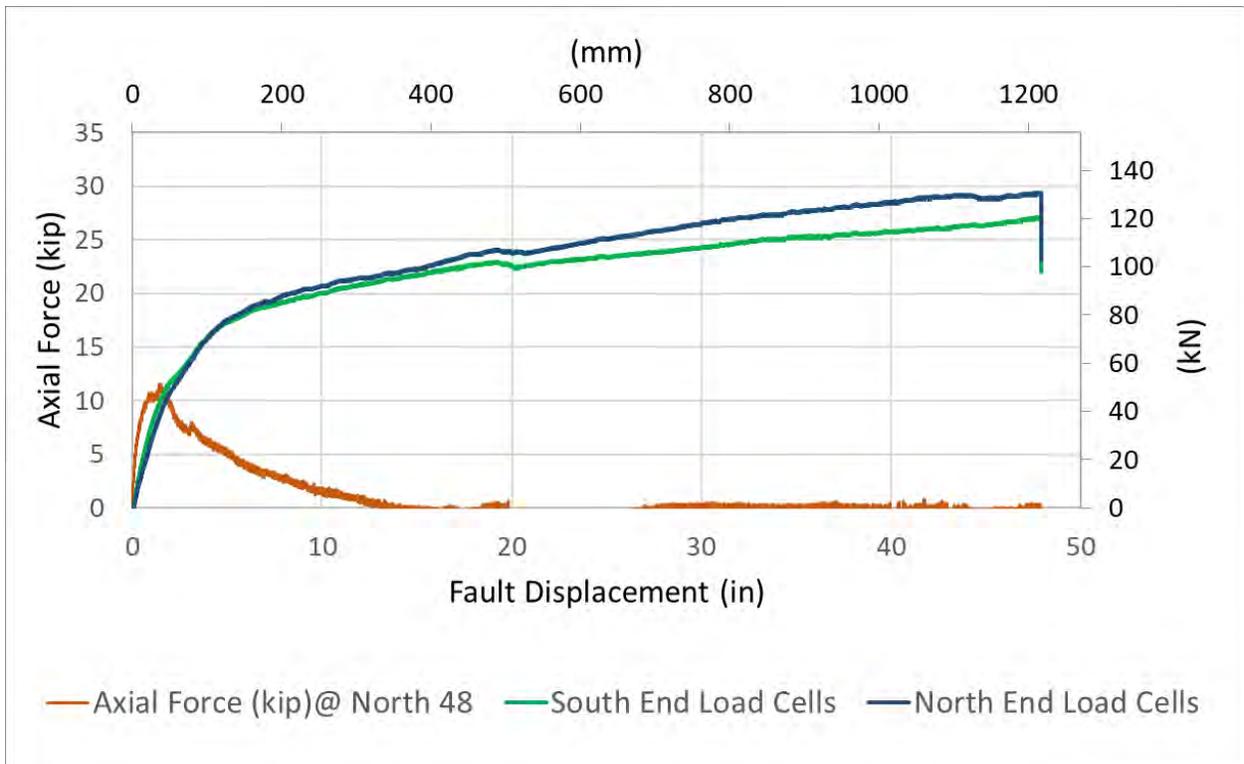
Figure C.14. Axial Force versus Fault Displacement for Strain Gage Station 48

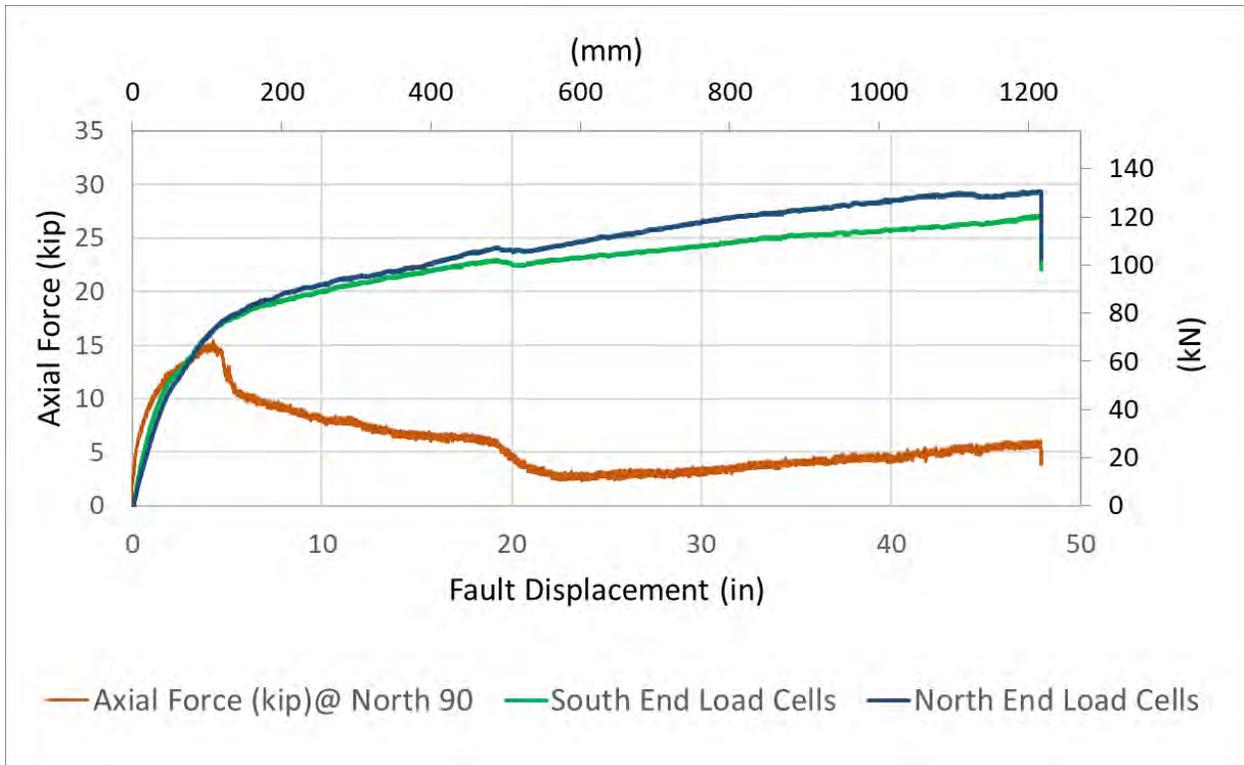
Figure C.15. Axial Force versus Fault Displacement for Strain Gage Station 90

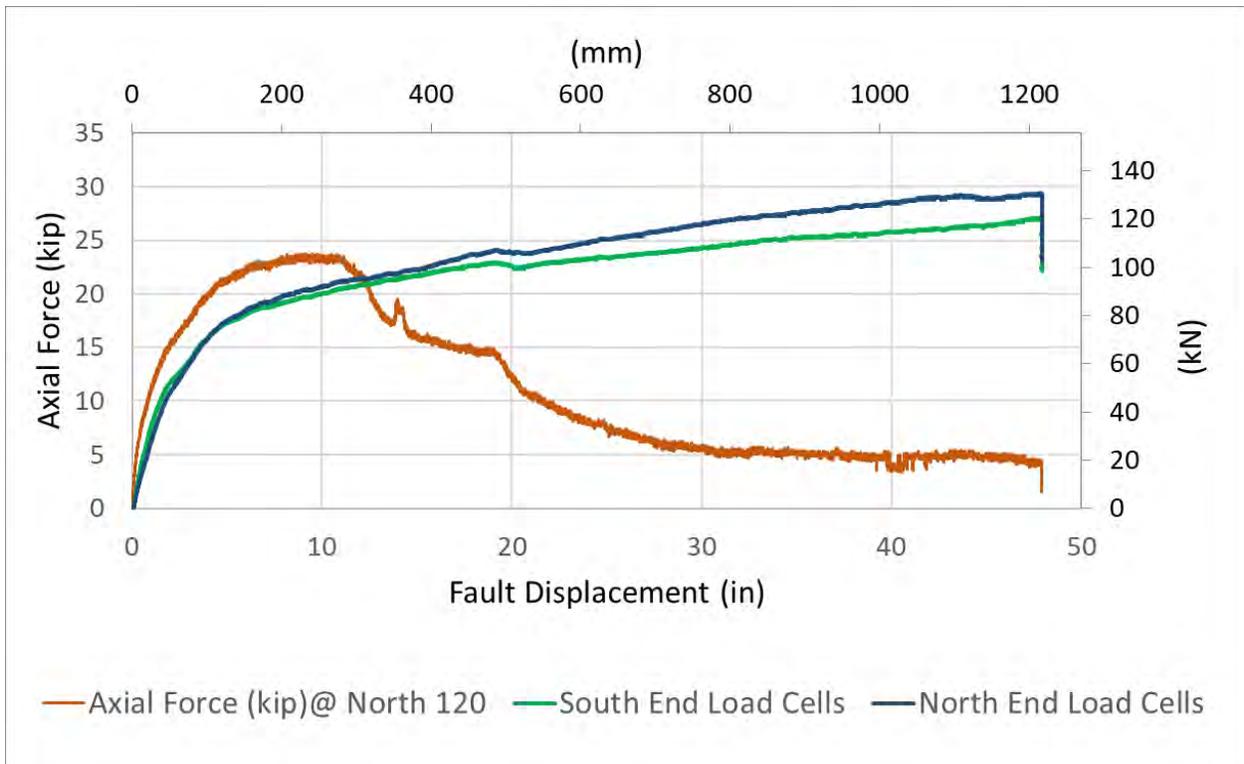
Figure C.16. Axial Force versus Fault Displacement for Strain Gage Station 120

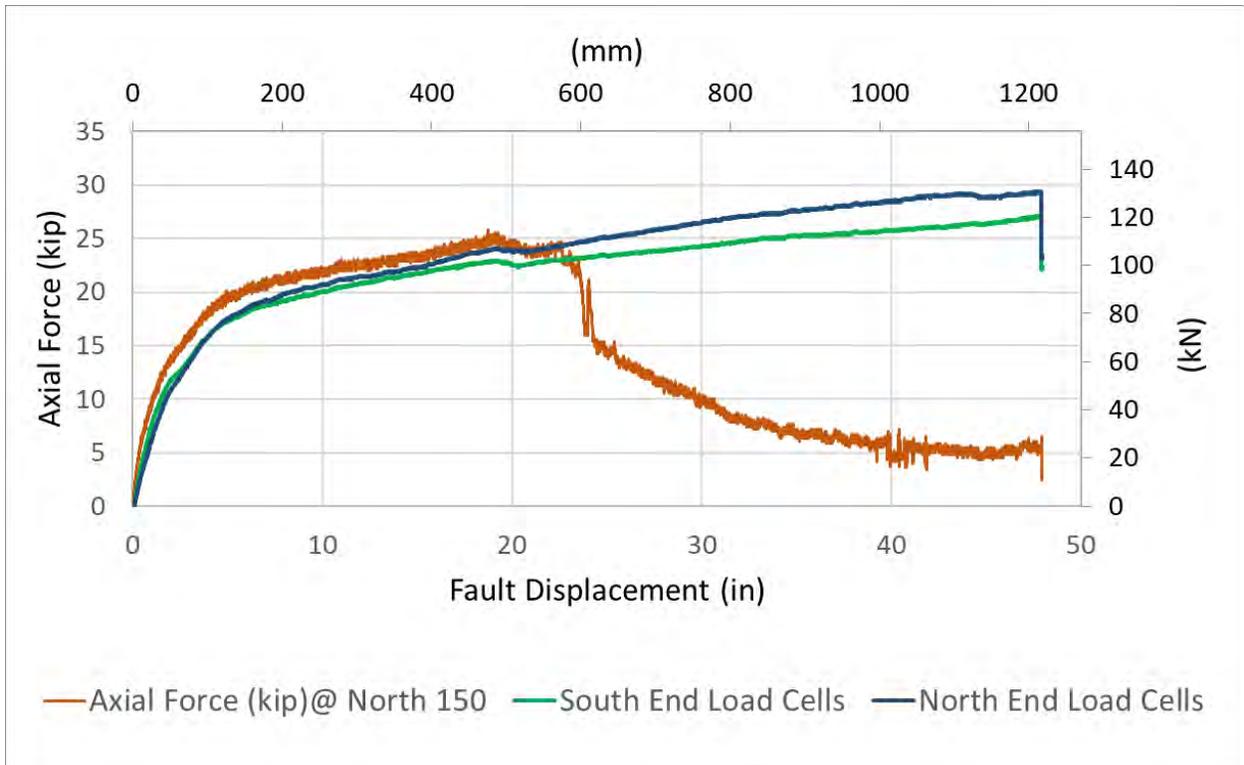
Figure C.17. Axial Force versus Fault Displacement for Strain Gage Station 150

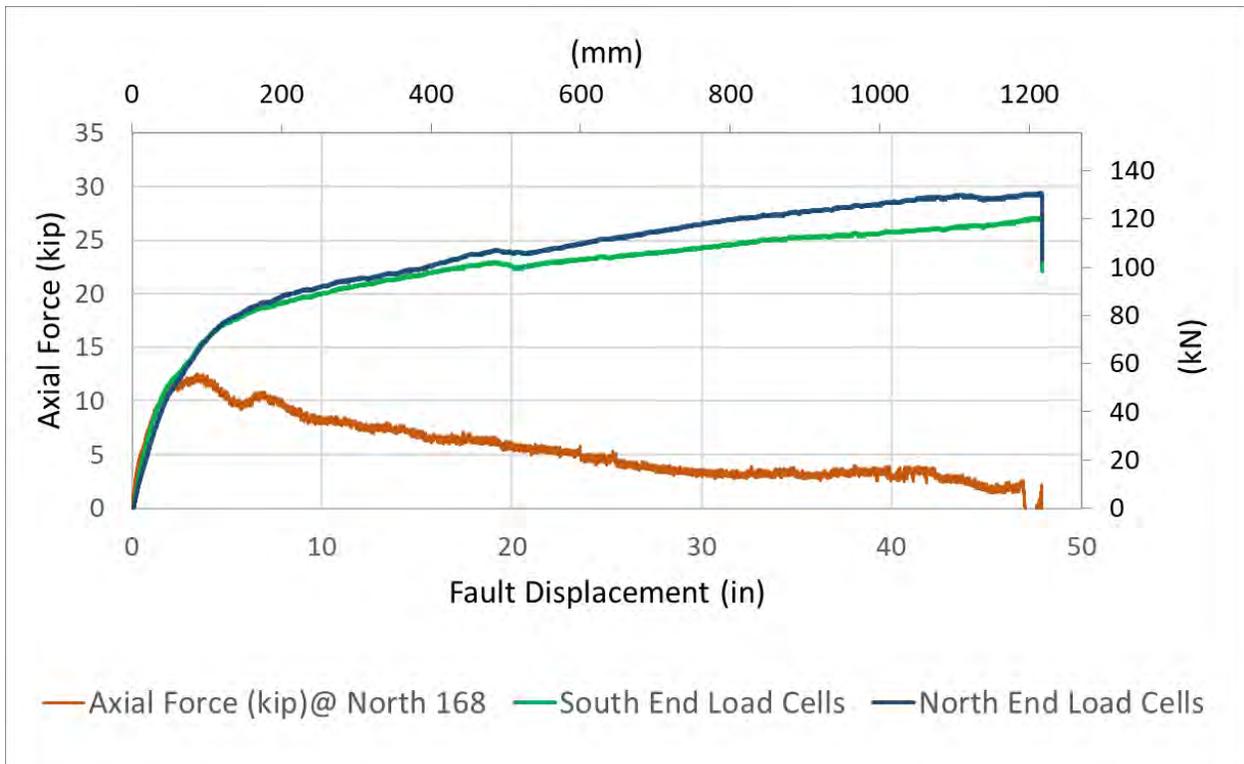
Figure C.18. Axial Force versus Fault Displacement for Strain Gage Station 168

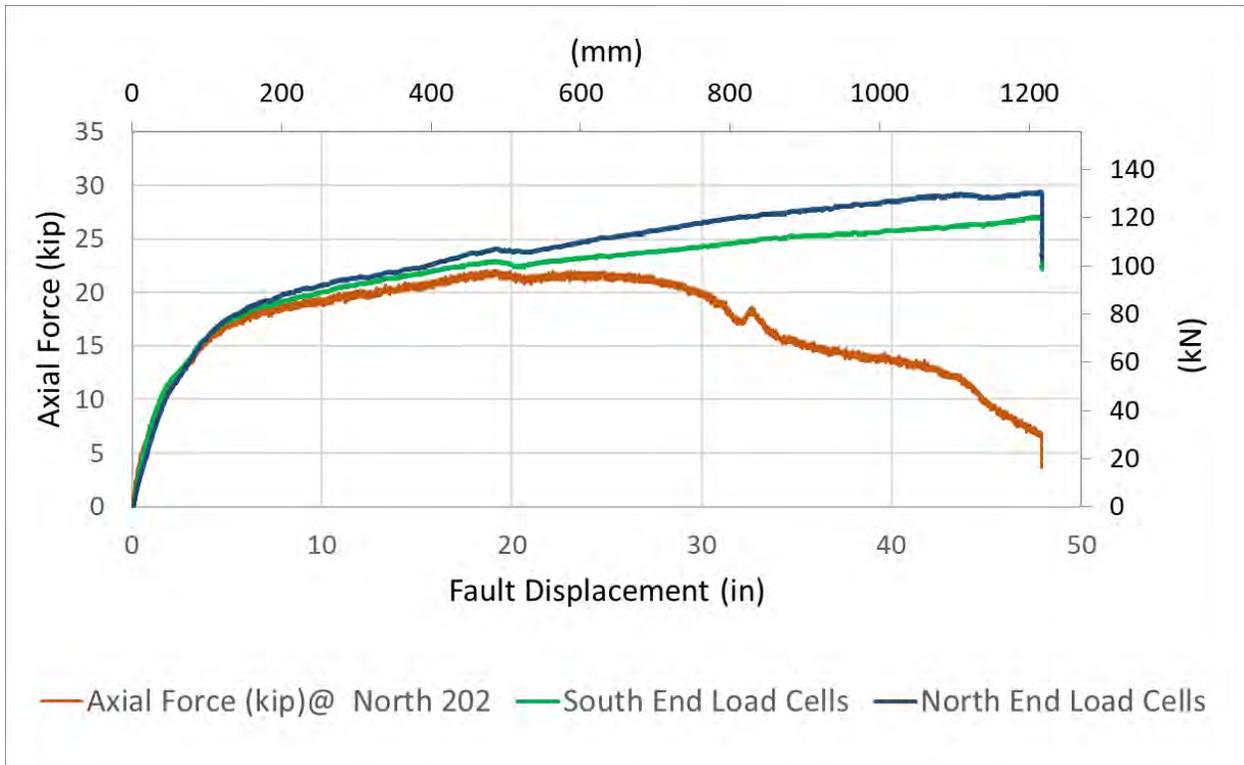
Figure C.19. Axial Force versus Fault Displacement for Strain Gage Station 202

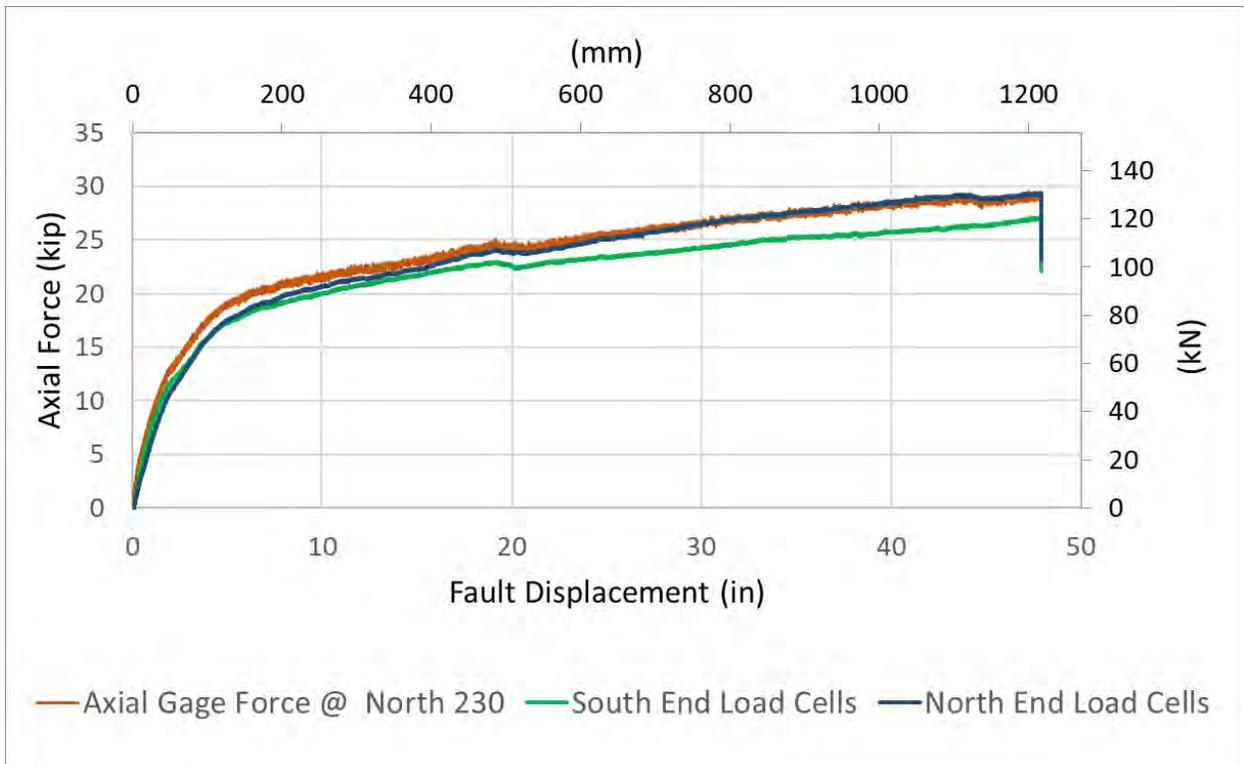
Figure C.20. Axial Force versus Fault Displacement for Strain Gage Station 230

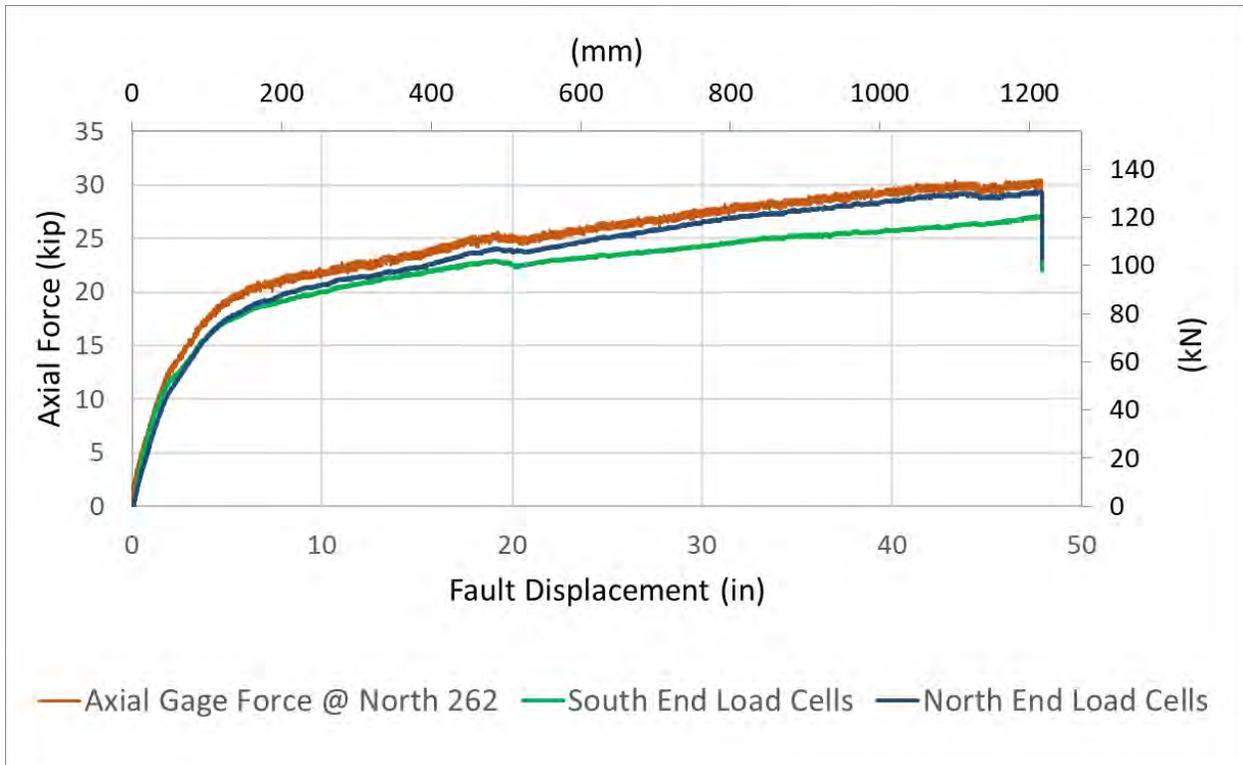
Figure C.21. Axial Force versus Fault Displacement for Strain Gage Station 262
